Evidence supporting

Depleting the Deer Creek Aquifer

*A Rapid
Decline*

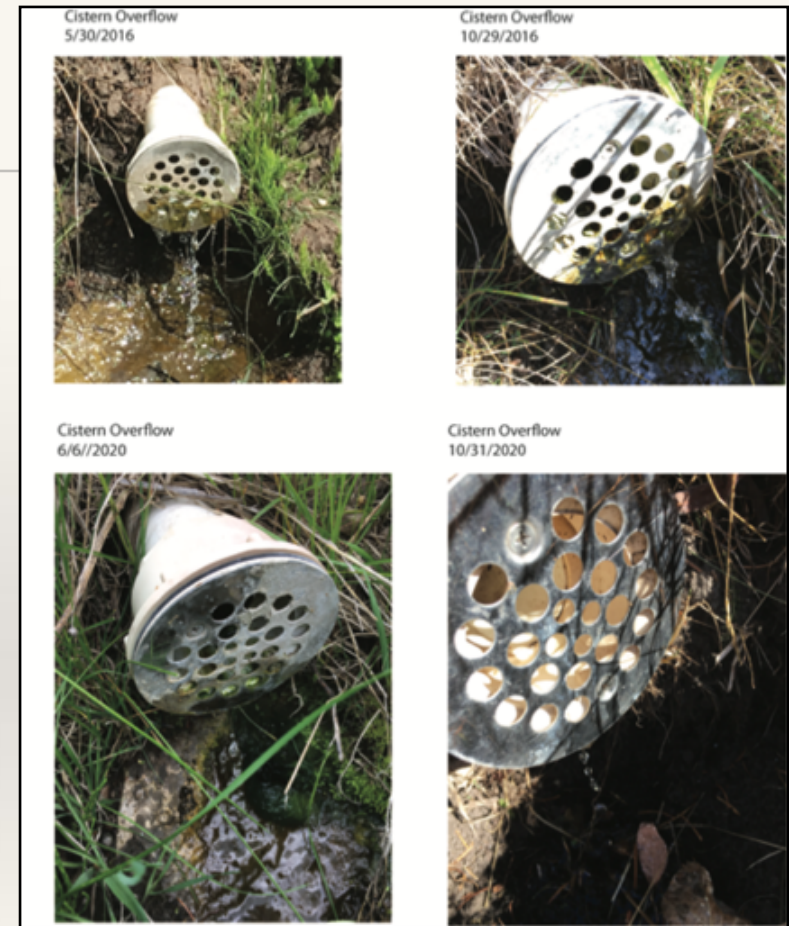
Lot 182 Cistern Overflow Visual Comparison Max
& Min 2016 and 2020

- ❖ Lot 182 spring 2000-2006. Lowest flow was 2 quarts/minute.
- ❖ Lot 182 spring flow has recently dropped each year.
- ❖ 2020 butterflies no longer attracted to Bernt seep.
- ❖ Lot 184 spring pool frozen Winter 2021 for first time.
- ❖ Tobias seep well flow reported down 2020
- ❖ In the Falls of 2019 & 2020 Deer Creek did not flow to pond below Hess lot.
- ❖ Bernt's well ran dry in 2000, two tries to find water again
- ❖ Not a lot of water. Well logs show dry holes and re-drilling after producing wells fail (Big Bear area too)
- ❖ **Conclusion:** Springs, Seeps, wells and Deer Creek show evidence of decline

Top Row 2016. Bottom Row 2020
Left column: 1st Week June.
Right column: Last Week October

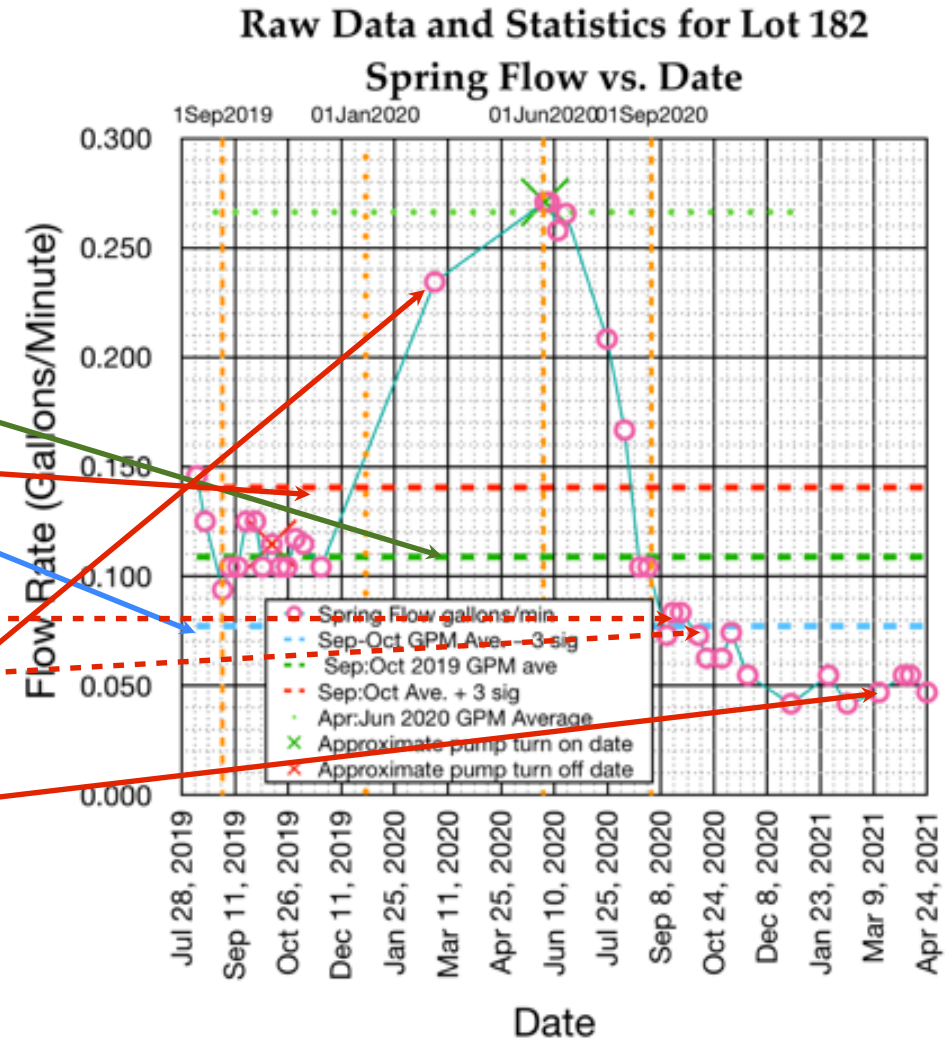
- ❖ In August 2019, began measuring Lot 182 spring flow.
- ❖ “Runs Chart” based on 2019 Aug.-Nov. data to compare low flow year to year. Features:
 - ❖ A trend when 5 measurements in a row below average.
 - ❖ +/- 3 std. deviations includes all baseline data
- ❖ How did 2020 Aug.-Nov. do?
 - ❖ Late Aug. 5 in a row below average!
 - ❖ Early October outside of -3 std. deviation limit
 - ❖ Has stayed below -3 std. deviation limit since.
 - ❖ 2021 NOT seeing recovery like in March 2020!
- ❖ **Conclusion:**
 - ❖ 95% confidence that 2020 worse than 2019
 - ❖ Spring 2021 beginning WORSE than worst of 2020.

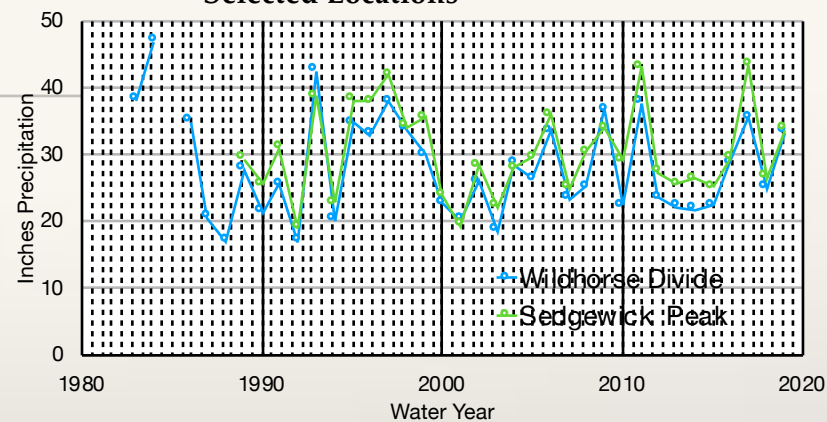
Total Precipitation in August of Water Year for

- ❖ SNOTEL system measures precipitation. Two nearby stations:
 - ❖ Wildhorse divide outside of Pocatello. Elevation 6490'
 - ❖ Sedgewick peak, East of Dempsy Creek. Elevation 7850'
- ❖ The Sedgewick peak data 1989-2019 was analyzed.
 - ❖ The data point error bars show ± 3 std. deviations ($\pm 3\sigma$)
 - ❖ The only excursions below -3σ are 2001 and 1992
 - ❖ The only excursions above $+3\sigma$ are 2016, 2011 and 1997
 - ❖ For 2010-2019, 2018 was the lowest, 2017 and 2019 were highest, 2001 and 2017 significantly so.
- ❖ **Conclusion:** Currently no indication of drought at Lava Ranch.

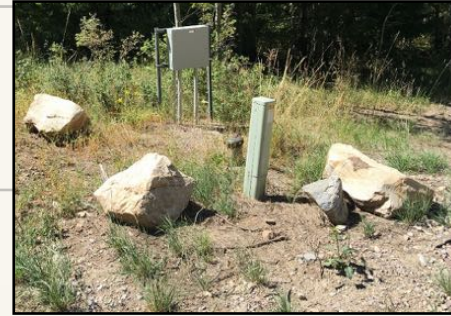
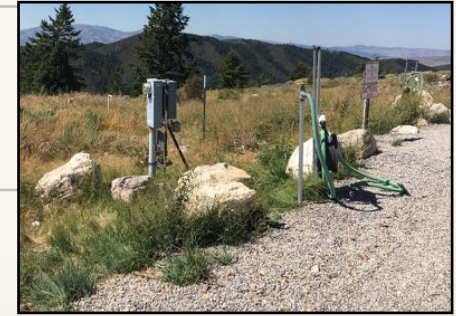
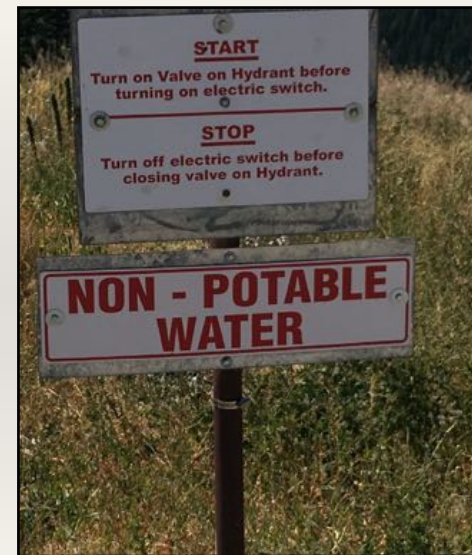
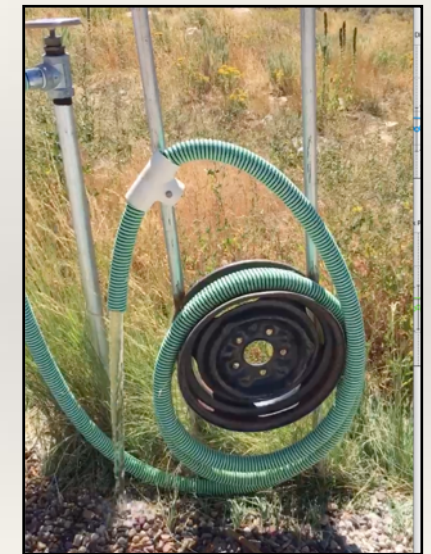
"Upgraded Water Supply", June 2016 Lava Ranch newsletter

- ❖ Beginning in 2016, the Lava Ranch Property Association (LRPOA) began using a preexisting stock well near the junction of Smith Canyon and Wolverine Pass Roads as a community water source.
- ❖ This well is on the unnamed fault at the S. end of Wolverine Pass Rd.
- ❖ Water is pumped from the well to two 1700 gallon storage tanks at the N. end of High Country Rd..
- ❖ Any of hundreds of Lava Ranch property owners are encouraged to take up to 250 gallons at a time (honor system).
 - ❖ At times the demand has exceeded the capacity of the well pump.
 - ❖ An unknown yearly or daily amount of water is withdrawn.
- ❖ **Conclusion:** This is the only investigated cause that fits the data for both time frame of change in water usage and proximity to lot 182.

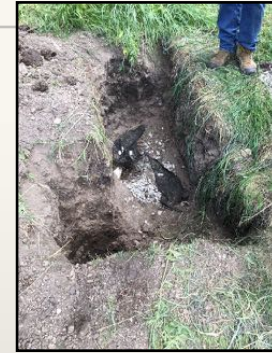
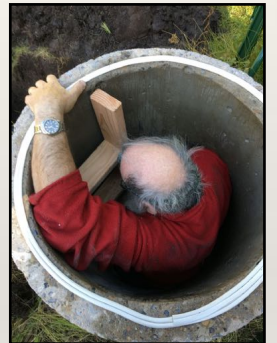
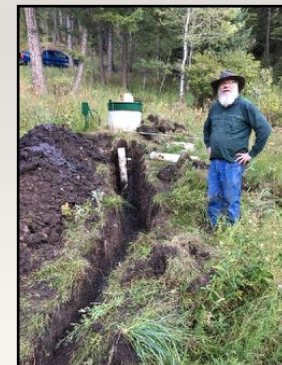
- ❖ Summer 2019 the system was partially excavated for inspection:
 - ❖ Spring pool and perforated pipes inspected, no obstructions, spring pool at expected elevation. **O.K.**
 - ❖ Cistern drained and inspected. No leaks, Pump connected. **OK.**
 - ❖ Overflow system excavated and inspected. **O.K.**
- ❖ **Conclusion:** System still functioning as designed.
