# Validation Study

Priest Lake Thoroughfare and Breakwater Replacement Study near Priest River, Idaho

for Bonner County Public Works

January 20, 2010

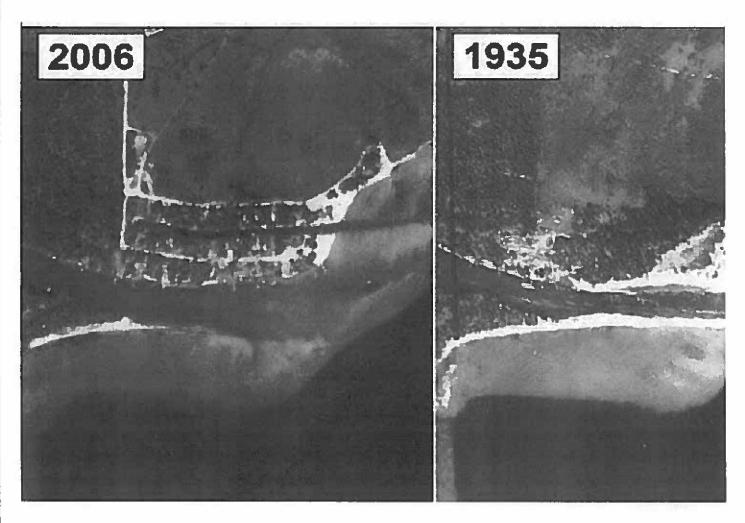
Rectified Aerial Years 2006 ;

Geo-referenced historical aerial photographs for the project site were compiled, rectified, and analyzed. A total of 14 historical geo-referenced aerials were compiled for the period from 1935 to present time (2006). Two aerial photographs showing conditions in the site vicinity are shown in Rectified Aerial Photographs, Years 2006 and 1935, Figure 11.

The historical aerials, specifically the 2006 photo, also show that land on the south side of the breakwater has eroded with time. Consequently, most of the spit has eroded and the Breakwater has been exposed to direct wave impact during high wind conditions. Waves have continued scouring soil at the toe of the Breakwater, and some scour holes have developed beneath the structure. The scour holes have increased sediment migration from the south to north, into the Thoroughfare. Also, flow from the Thoroughfare has transmitted through the breakwater and scour holes, thus reducing the flushing effect during spring runoff.
