DEPARTMENT OF
WATER RESOURCES

Enclosed please find photos of the diversion on Eddy Creek at the IDWR GPS location A0002590 which is owned by Sidlo.

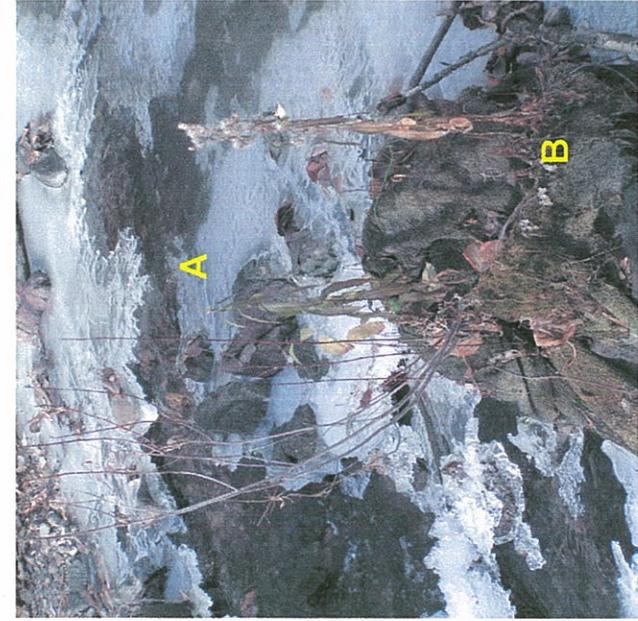
Photo 1 :

At position A Wall of rocks placed to divert flow in the creek. While not illegal, it does prevent the natural flow and delivery of other Water rights.

At Position B Pile of Rocks and Man made objects, including Carpet placed in the creek.

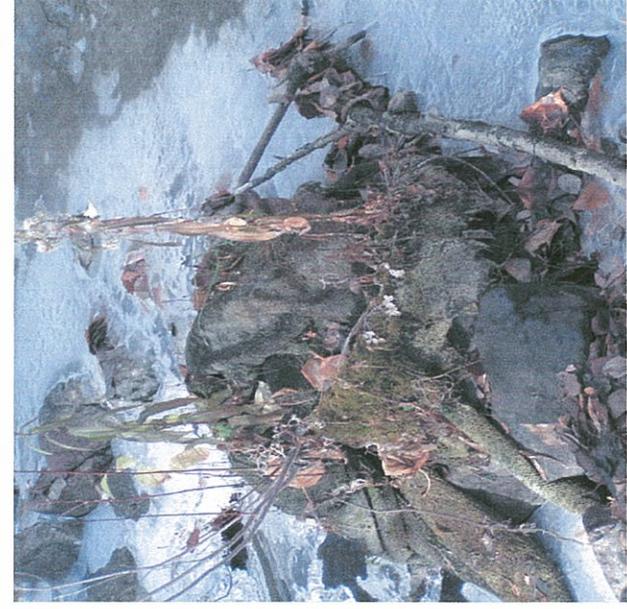
Photo 1 B

Photo 1B :

Clearly shows Carpeting which had been placed in the Creek.

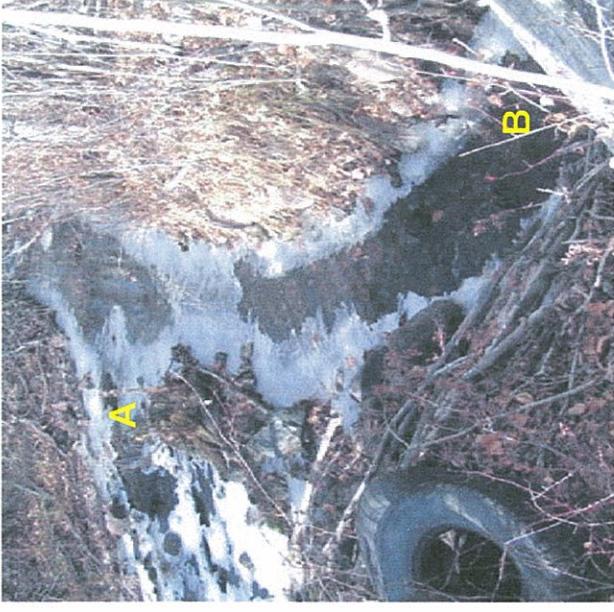
Photo 2 :

At Position A The man made dam is seen to divert a majority of the creek.

At Position B The piece of dimensional Lumber designates the end of the diversion area and the start of a ditch.

Please Note in Photos 2, 3, and 4 The Walls of the Diversion area and the walls of the Ditch can clearly be seen to be substantially Vertical and to have been cut with a mechanical means such as an excavator or a backhoe.

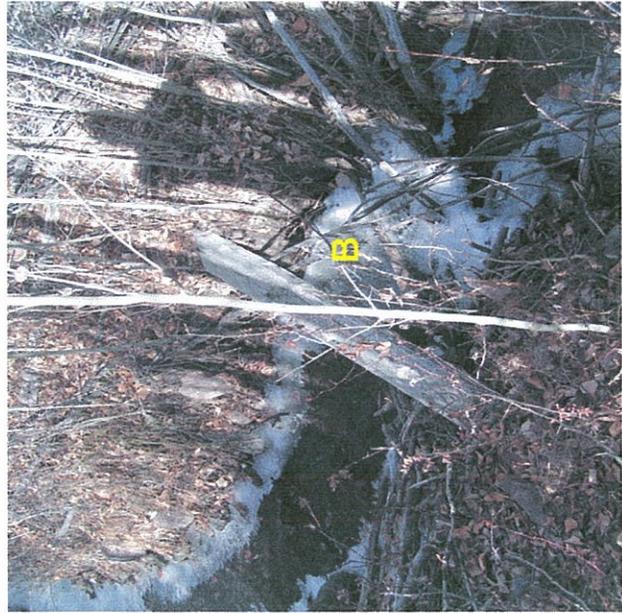
Photo 3 :

Again at Position B The piece of dimensional Lumber again designates the end of the diversion area and the start of a ditch.

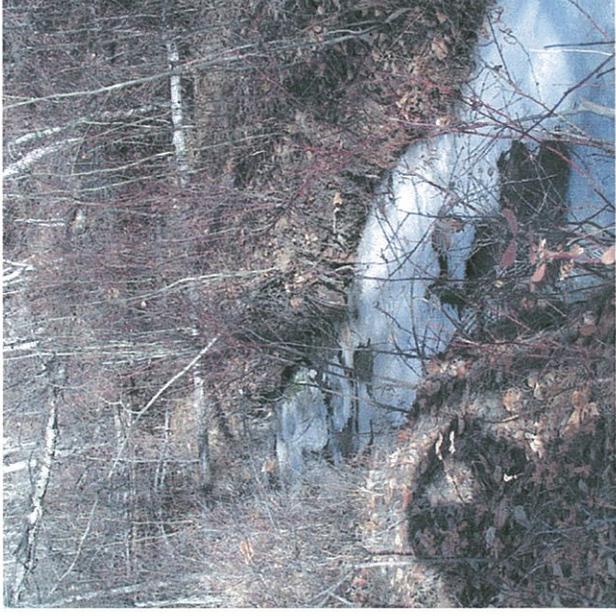
Photo 4 :

Shows the ditch as it travels the distance to the Headgate.

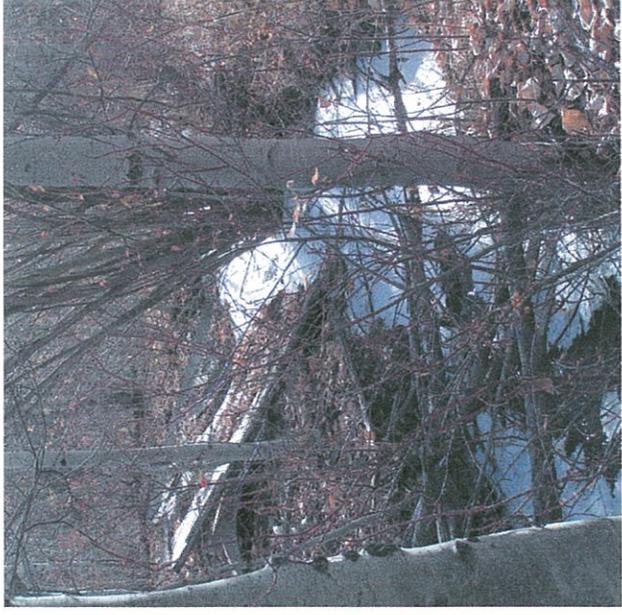
Photo 5 :

Shows the ditch as it travels a further distance to the Headgate. This also shows trash diverting the ditch flow.

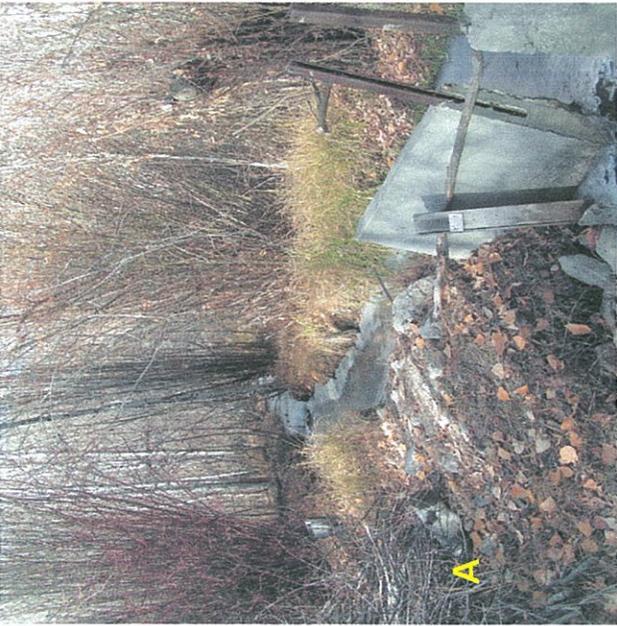
Photo 6 :

From the Headgate area, This again shows the ditch and another distance required to reach the Headgate. At A it shows that the bank had to be substantially built up to maintain the ditch flow.

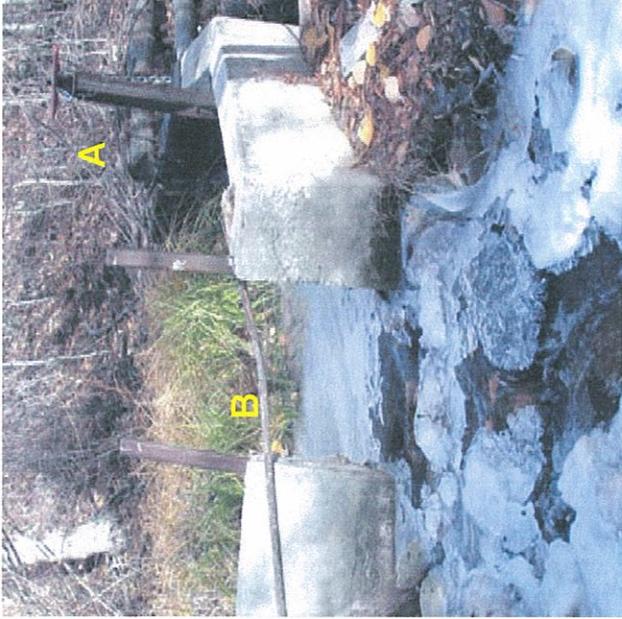
Photo 7 :

At position A The locked Headgate which is mandated by law to be secured.

At Position B The Flow can be seen to be Dumped onto the ground, instead of remaining in the Creek and Not diverted, especially since this is Not Irrigation Season.

If the headgate were to be placed on the creek, as are the other headgates in the district, only the correct water right amount would be diverted and the excess water would not be dumped onto the ground but would remain in the creek where it belongs.

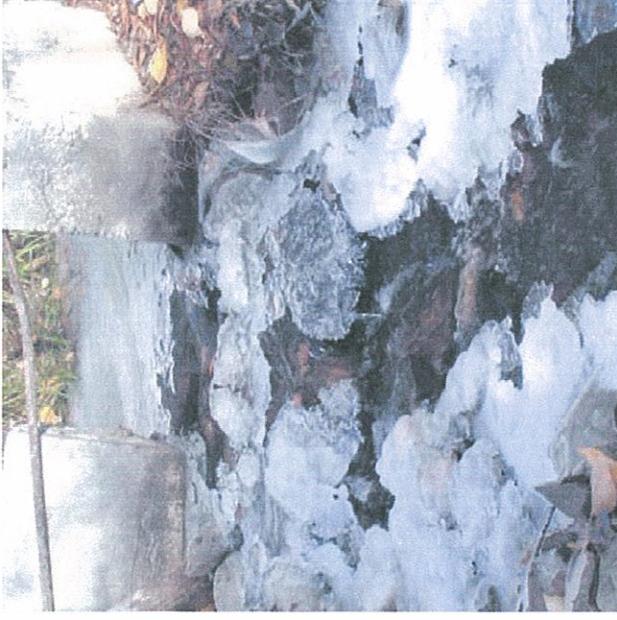
Photo 7B :

Clearly shows the Quantity of the Flow improperly diverted.

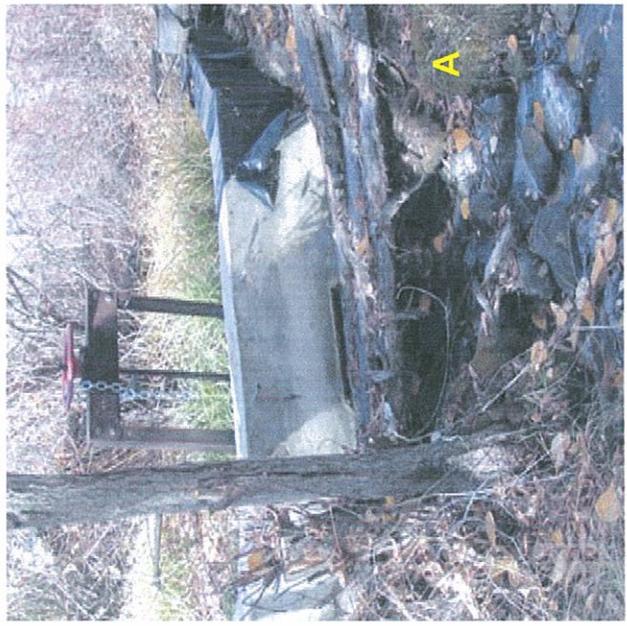
Photo 8 :

Clearly shows the Quantity of water which flows through the secured Headgate.

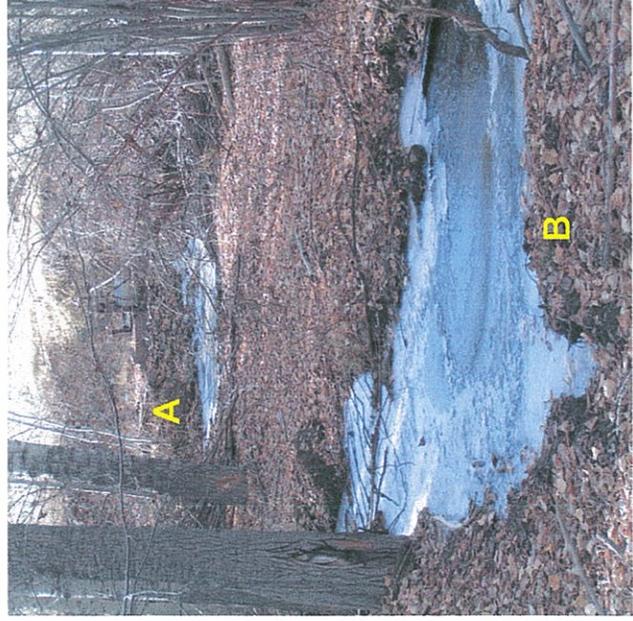
Photo 9 :

At position A The Next Diversion on the creek, secured, and the normal flow of the creek. This area is the access to that Diversion.

At Position B This clearly shows the Quantity of water which has been wrongfully diverted from the creek and dumped on the ground.

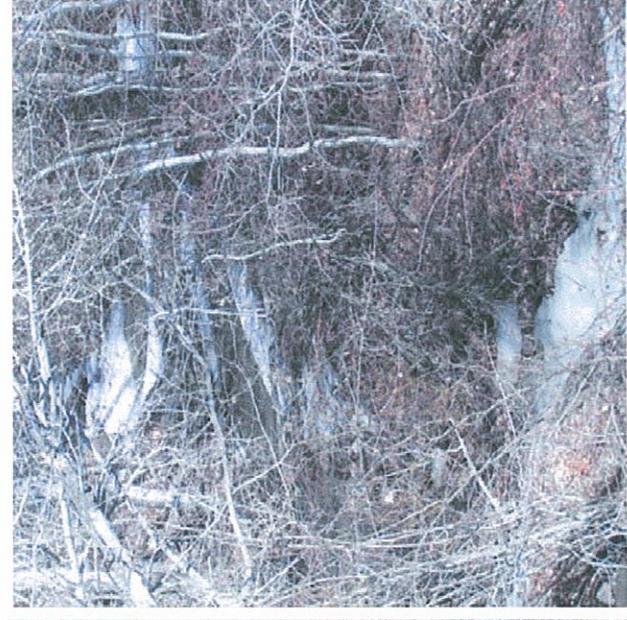
Photo 10 :

This shows the water which has been diverted and dumped on the ground as it is spread across the ground before it trickles back into the creek.
