Surface Water and Spring Flow Measurements for Upper Deer Creek in Smith Canyon, Bannock County ID

A report prepared by Mike and Lori Beer in response to the June 28, 2021 request by James Cefalo of the IDWR

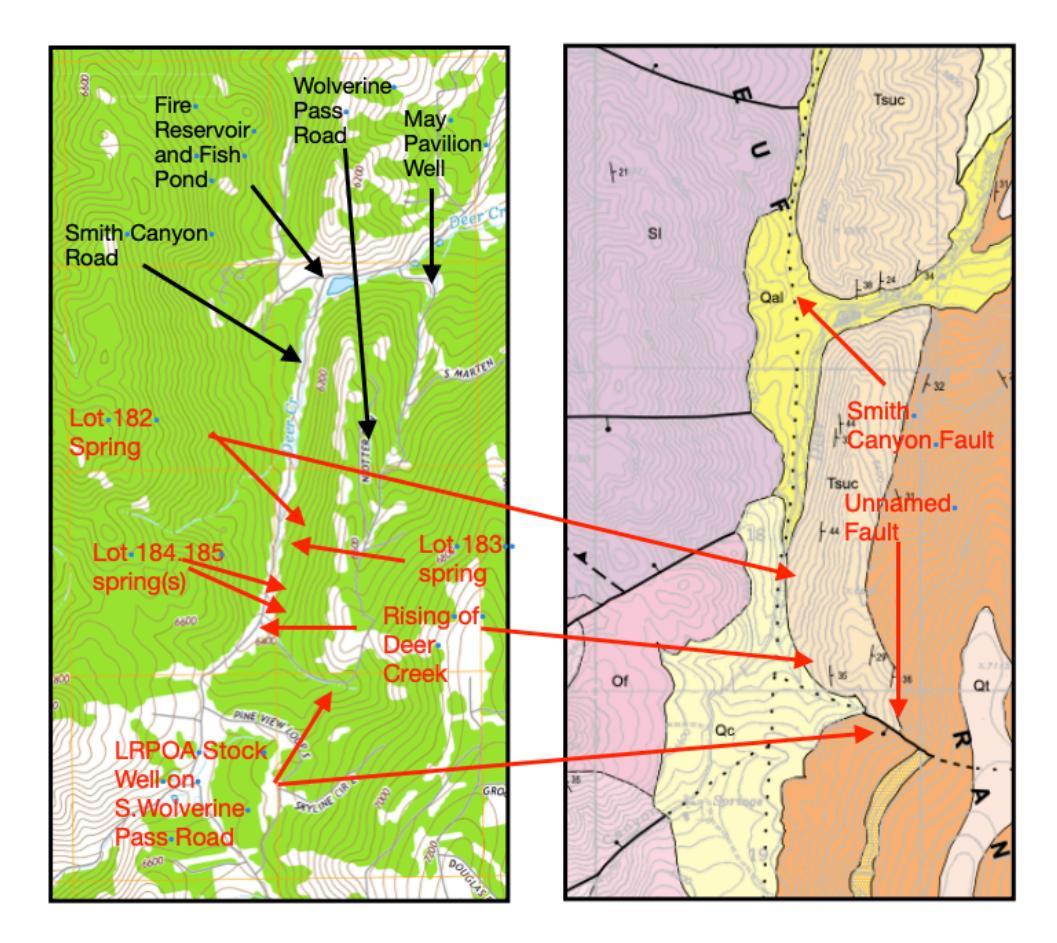
Relationship of surface features in the Upper Deer Creek drainage to underlying geology. The maps have north up and are centered on section 18 of Township 10 South Range 38 East. Section 19 is to the south and section 7 to the north. Section 19 drains both into Deer Creek and Marsh Creek Valley. South of section 19, the topography drops into Marsh Creek Valley. Scale is provided by the intersection of the section lines at mile intervals.

The rising of Deer Creek appears to be influenced by the intersection of the Smith Canyon Fault and an unnamed fault intercepting the Deer Creek fault at right angles from the east. The

The LRPOA stock well is near the two faults' intersection. Removing water with this well lowers the aquifer's head, influencing flow in the springs at the rising of Deer Creek.

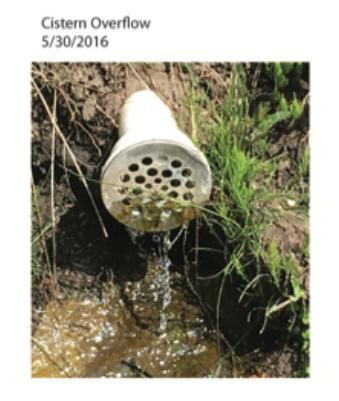
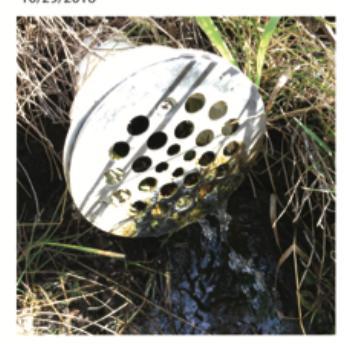
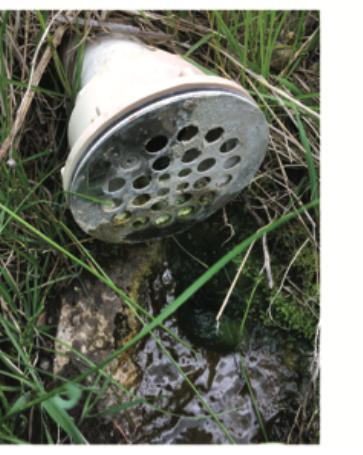
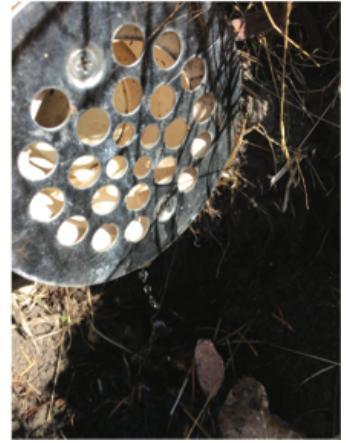
Cistern Overflow 6/6//2020 Cistern Overflow 10/29/2016

Cistern Overflow 10/31/2020

Upper row: flow in 2016. Lower row: flow in 2020. Left column: flow in early June. Right Column: flow in late October.

From these photographs, it is possible to tell that there has been a decrease year on year for a given season. The photographs in Appendix I show that the change has not been concentrated in any one year, but that it has been continually decreasing from 2016 to the present. In the mid winter and spring of 2021 there was no cistern overflow. This is unprecedented.

Not shown in these photographs is the effects on the area surrounding the cistern overflow. The area between the overflow outlet and Deer Creek used to be quite marshy and soggy. It is now hard and dry.

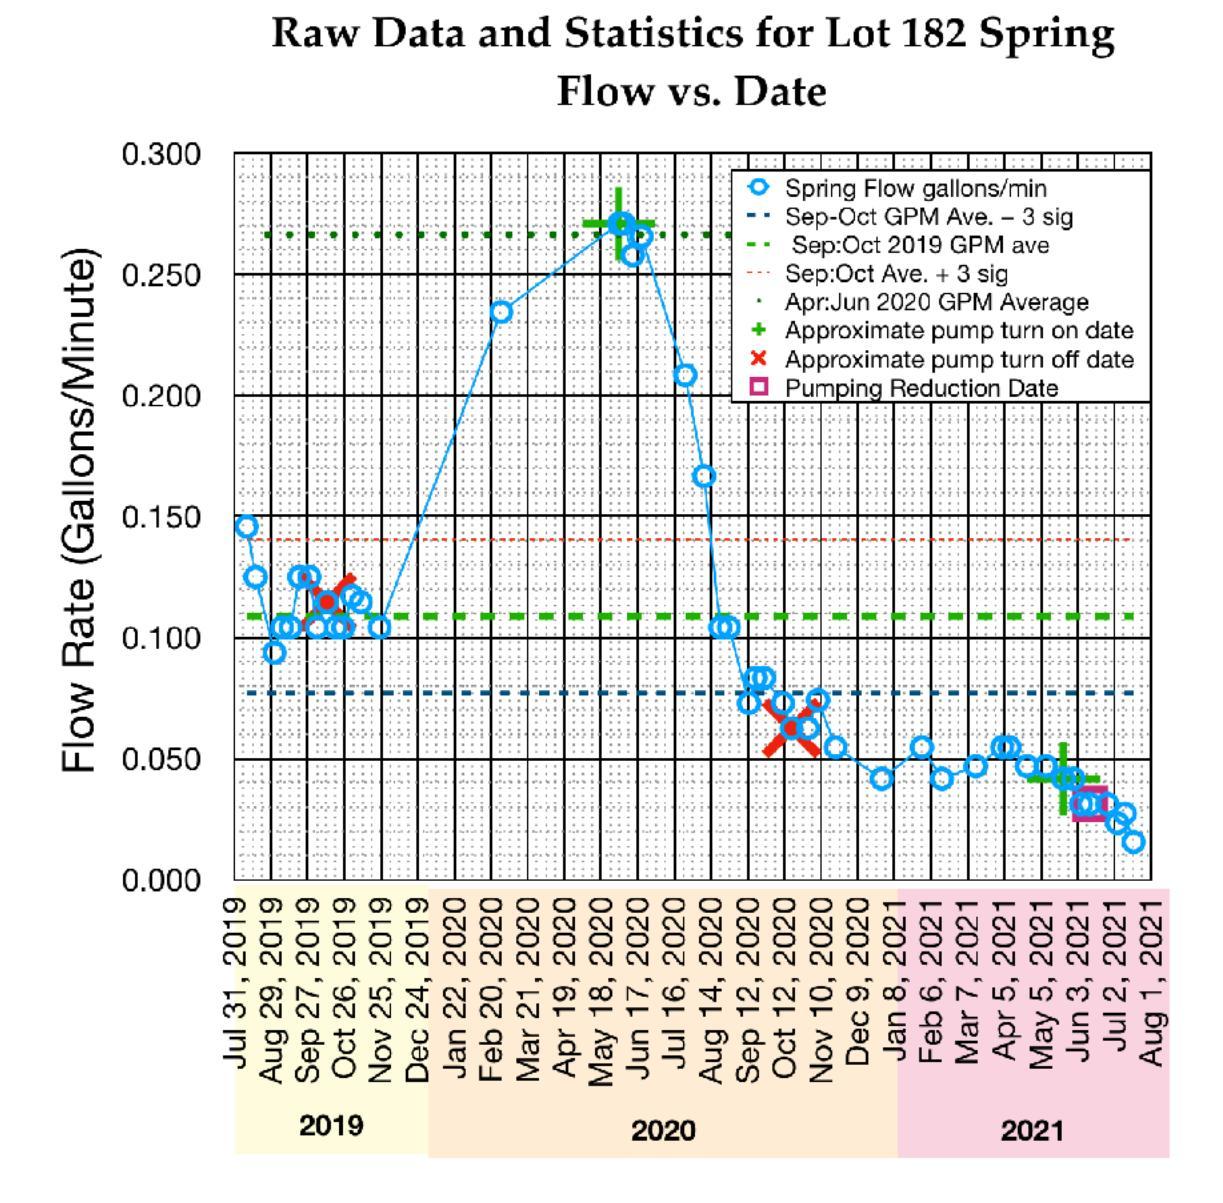
The September to October 2019 measurements were allowed a calculation of reliable statistics. References were determined and added to the chart for: average flow (green horizontal dashed line), average plus three standard deviation flow (dashed red horizontal line) and average minus three standard deviation flow (horizontal dark blue dashed line). During the fall of 2020 and all of 2021 the spring flow has been less than 3 standard deviations below the average for the late summer and fall of 2019. Note that during the winter 2019 to spring 2020 interval the Lot 182 Spring flow increased. This did not occur during the winter 2020 to spring 2021 interval.

Dates are annotated on the graph when the LRPOA stock well pump is turned on (dark green

plus signs) and when the pump is turned off (red Xs). During June of 2021 the LRPOA was obligated to reduce the pumping rate to half the peak daily rate that had been previously possible. This date is indicated with a hollow magenta box.

In the fall of 2019 there was a period of relative flow stability after the LRPOA pump was turned off. The flow increased in the spring of 2020. There was a sharp decline in flow when pumping was resumed. This decline ended in September when the number of people visiting Lava Ranch declined. This pattern of decline and increase is also seen in the pictorial data for most years, with the exception of 2020-2021. In the spring of 2021 there was not an increase of flow, but a decline began when pumping resumed. Something in 2021 has reduced the rate of flow decline as the 2021 rate is lower than the 2020 rate, particularly after the maximum

LRPOA stock well pumping rate was reduced in June 2021.

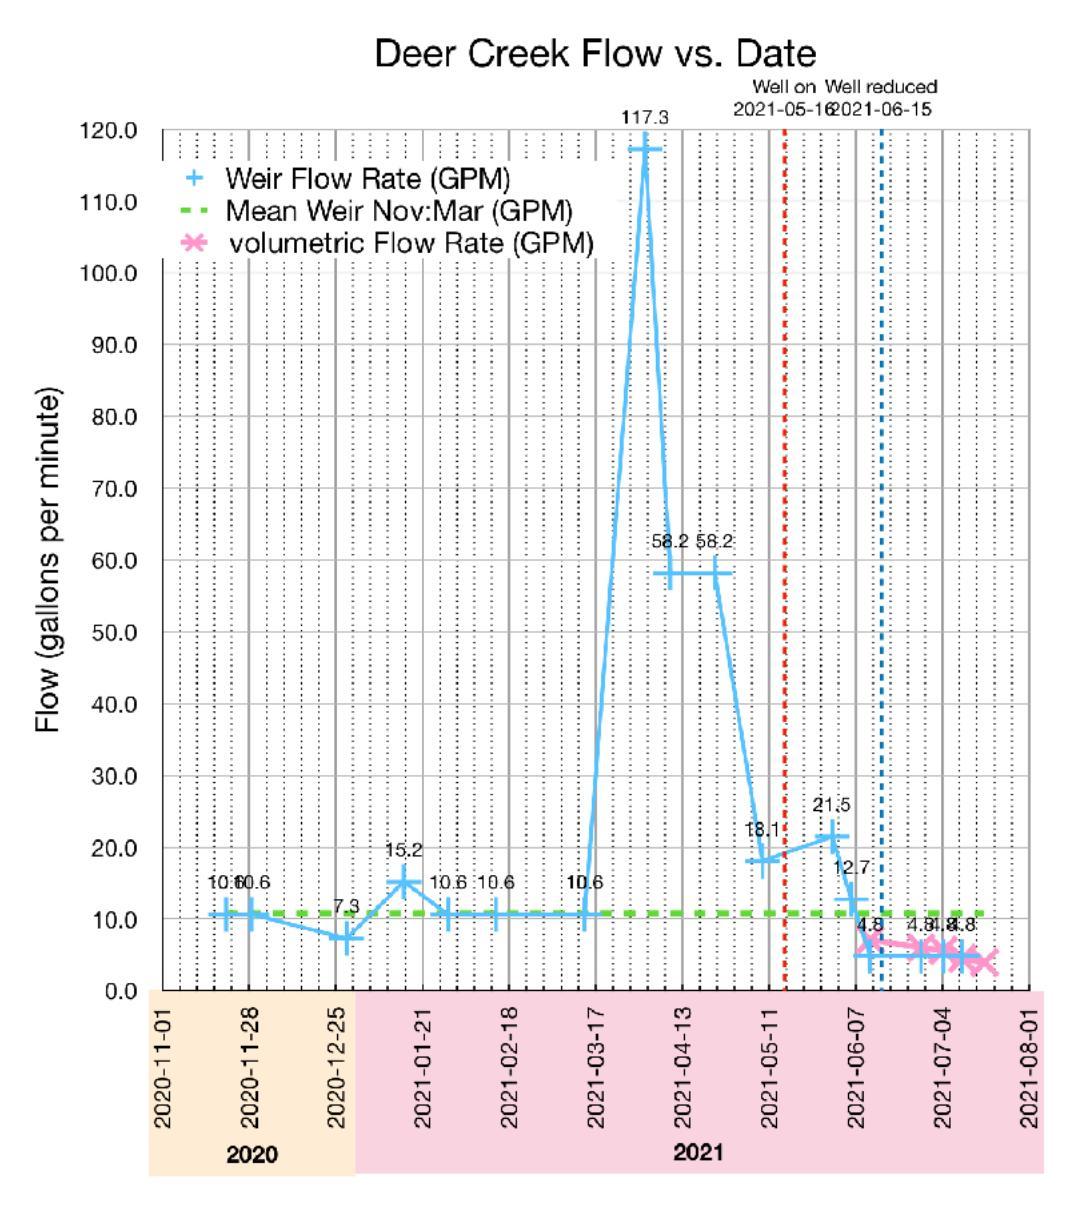
The weir on Deer Creek was constructed in November 2020 and has been in operation and monitored since. Measurement intervals of one week are hoped for, but not always possible. Note that as of July 18th, there is insufficient head for weir measurements. On and after this date only volumetric measurements exist.

Winter conditions were for the most part steady. Flow measurements peaked mid March during the spring melt. Significant precipitation occurred in May and June. All these show up as increased flow in Deer Creek.

The graph contains a vertical red dashed line indicating the date at which the LRPOA stock well pump was observed to have been turned on in 2021. A vertical dashed blue line indicates the data (June 15th) that the amount of pumping was reduced to bring the peak water use into

compliance with state law and regulations. It is interesting that the rate of flow decline in Deer Creek levels off at this time.

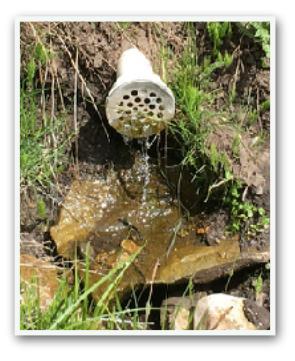
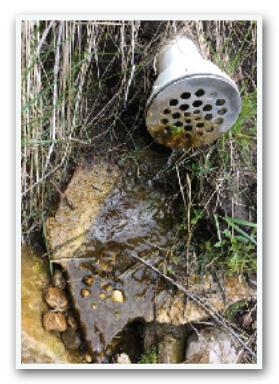
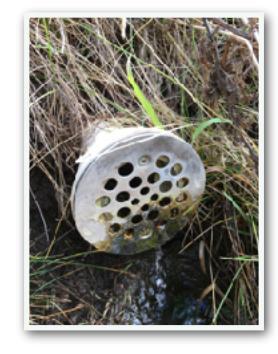
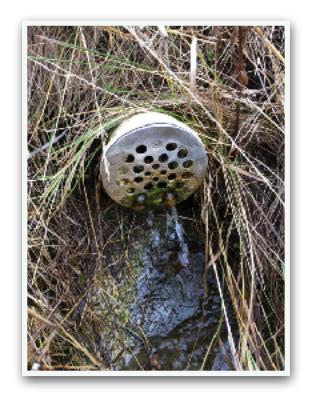
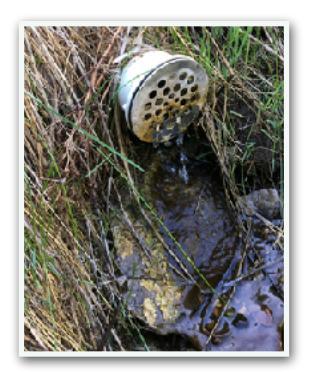
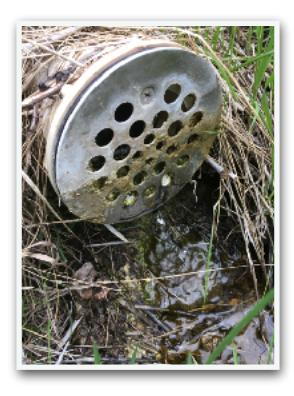
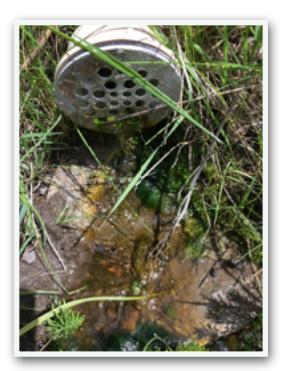
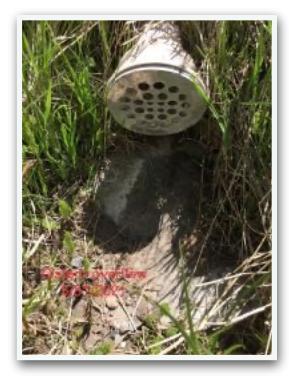
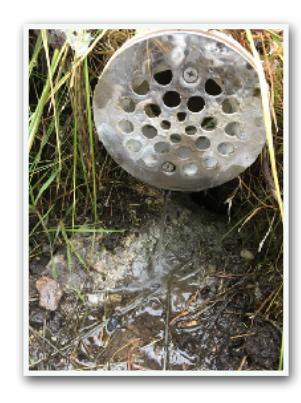
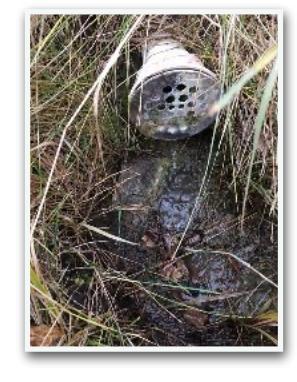
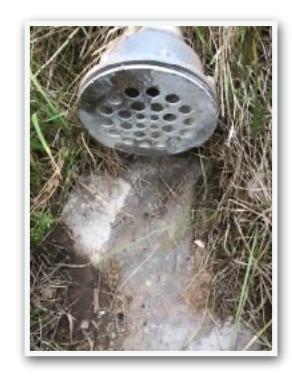
The following set of photographs shows the Cistern overflow for the years 2016 to 2020. The left hand column of photogram indicates the flow before or shortly after the LRPOA stock well pump is turned on in the Spring. The right hand column of photographs indicates the flow after the pump has been turned off in the Fall.

There is a seasonal decline across rows, and a general decline year to year down columns for a particular season.

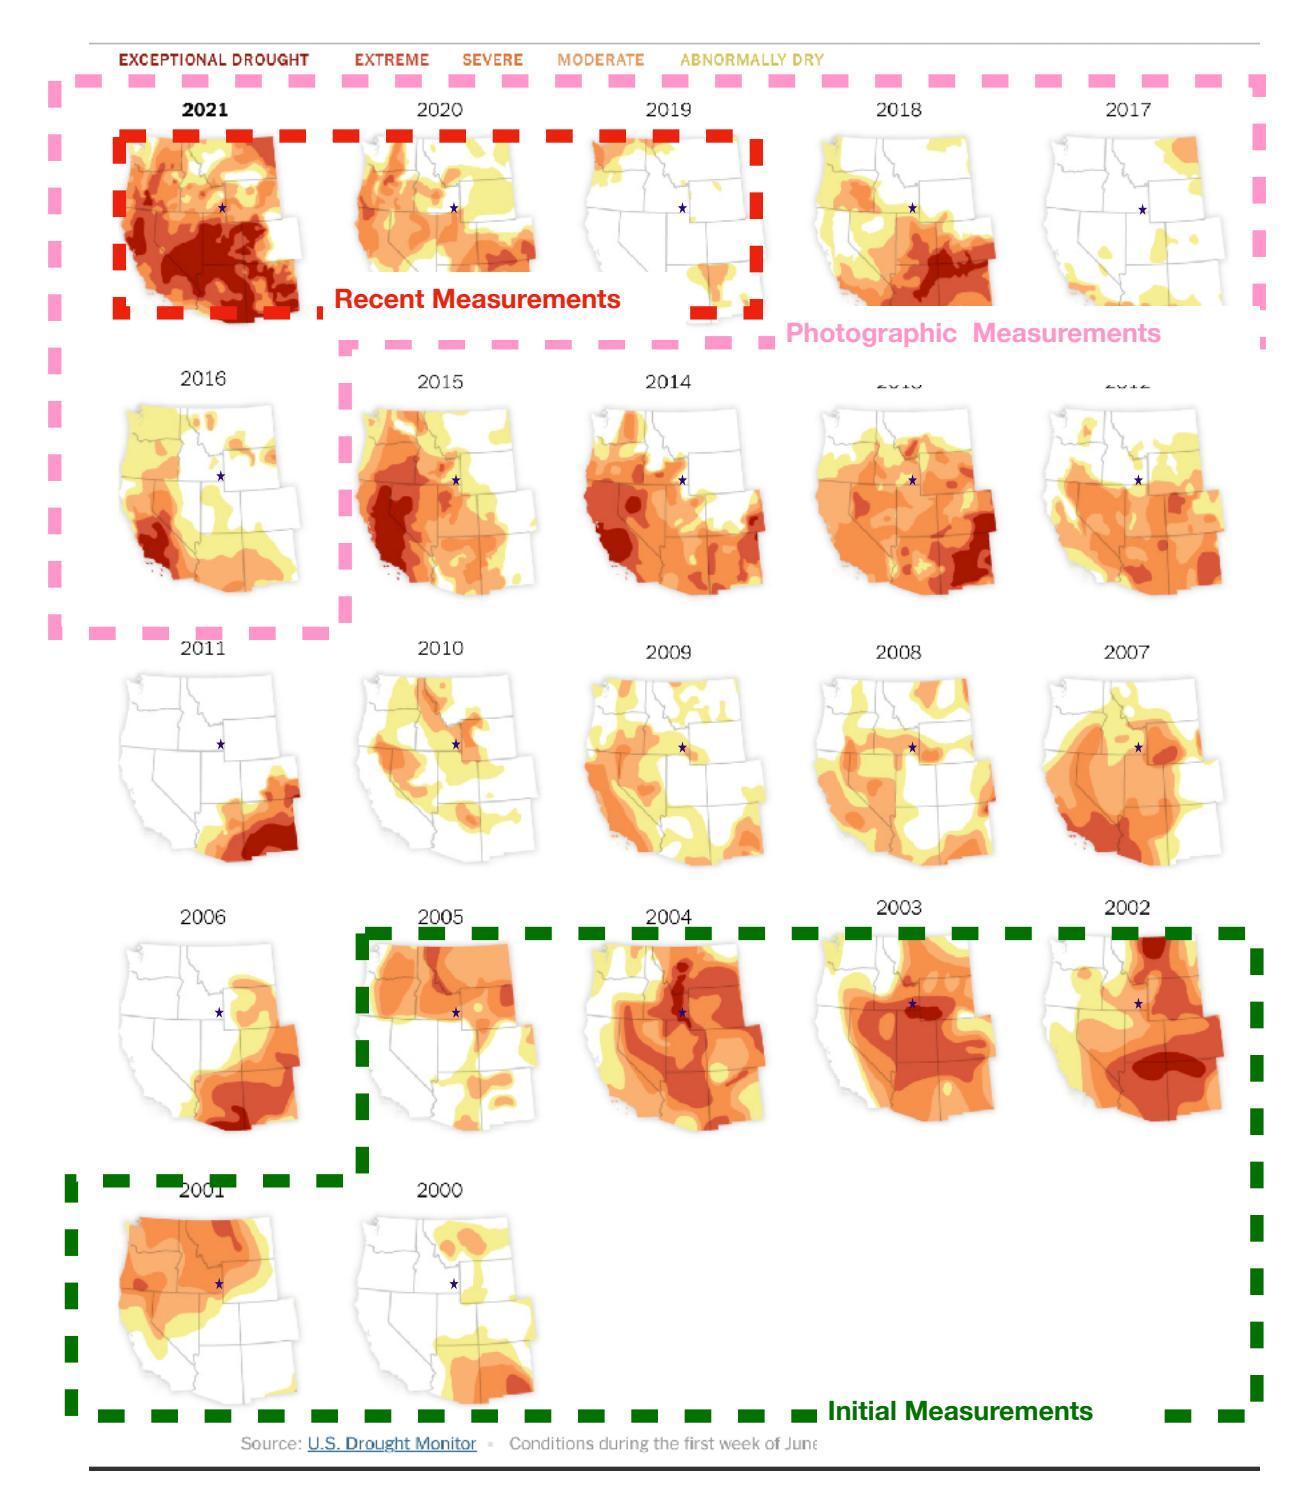
From this, it is should be clear that the initial measurements represent a time period where SE Idaho experienced severe to exception drought, yet the Lot 182 Spring had no problems producing 1/4 GPM or better flow rate.

The photographic measurements show a spring decline beginning in 2017, a non-drought year. 2018 was an abnormally dry year, but 2019 was not. 2019 is the time the Lot 182 Spring decline became increasingly apparent, but was not a drought year.

The recent measurements began in 2019, a very wet year. This was the first year that there were periods of NO cistern overflow, a situation that had not occurred previously.

Measurements intervals correlated with Regional drought. The small stars on each map show the location of SE Idaho. Initial Measurements interval outlined with dashed green outlined polygon. Photographic measurement interval outlined with dashed pink outlined polygon. Recent measurement interval outlined polygon
