Idaho Department of Water Resources

Open File Report

ADDENDUM TO FLUORESCENT DYE TRACER TESTS AT THE MALAD GORGE STATE PARK

November 6, 2009

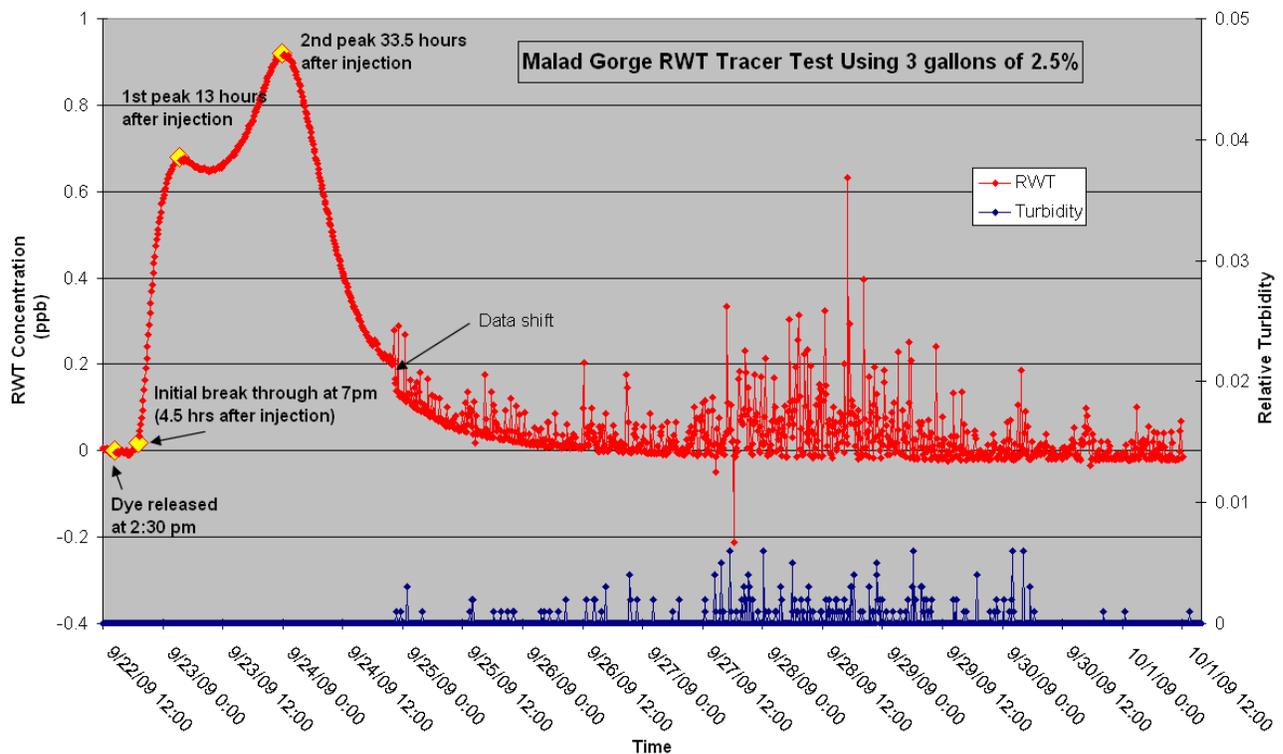
Figure 18. RWT tracer test #3 concentration breakthrough curve from injecting 3 gallons or 3 times the mass of previous tests.

Results of the test are shown in the Figure 18 concentration breakthrough curve that has the same response pattern as the two previous tests with a maximum concentration of approximately 0.9 ppb or just over twice the previous concentration. This suggests a non-linear function between injected mass and resultant spring water concentration. There is a data shift noted in the graph which is attributed to the instrument detection limit of 0.04 ppb in combination with an introduction of some turbidity. The turbidity channel started to record effects starting on September 25th which apparently created some 'noise' in the fluorescence data but the recession limb trend is still clear. Figure 19 shows all three RWT tests shifted to match the starting injection time zero. This test provides valuable data for gauging the amount of dye injected to obtain desirable concentrations in springs.

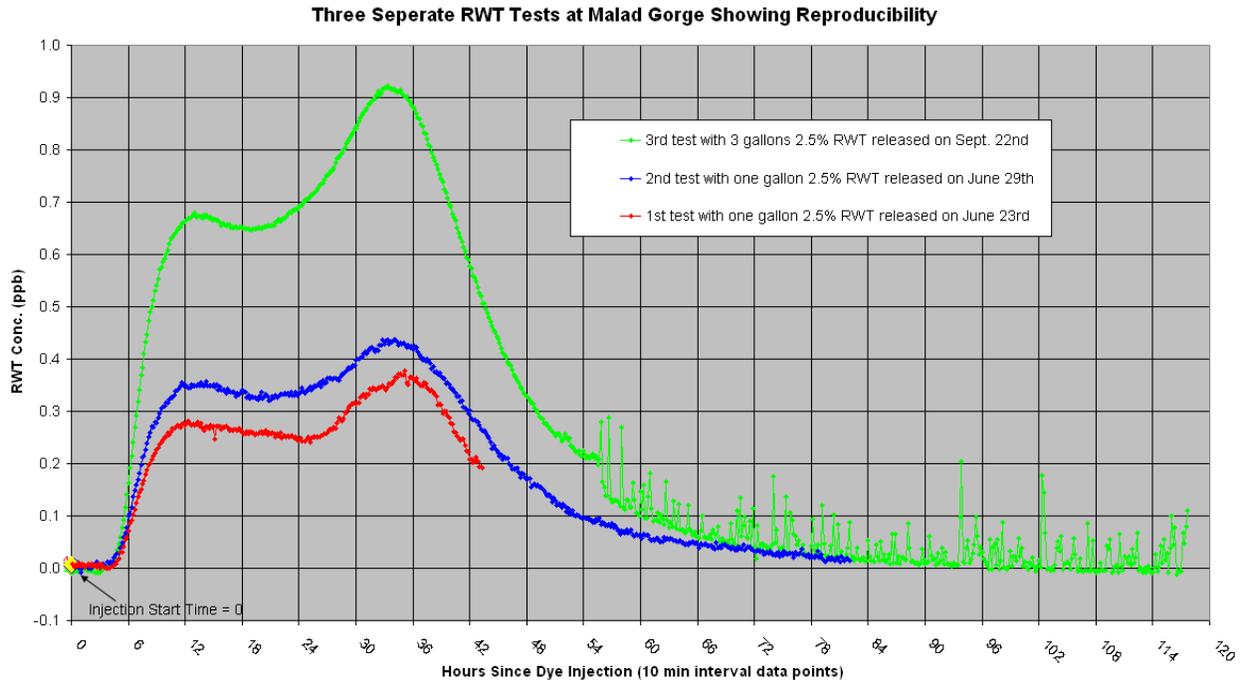
Figure 19. All three RWT tracer test breakthrough curves.
