Idaho Department of Water Resources

Open-File Report

Warm Springs Creek Seepage Survey

By  
Dennis Owsley  
July 2017

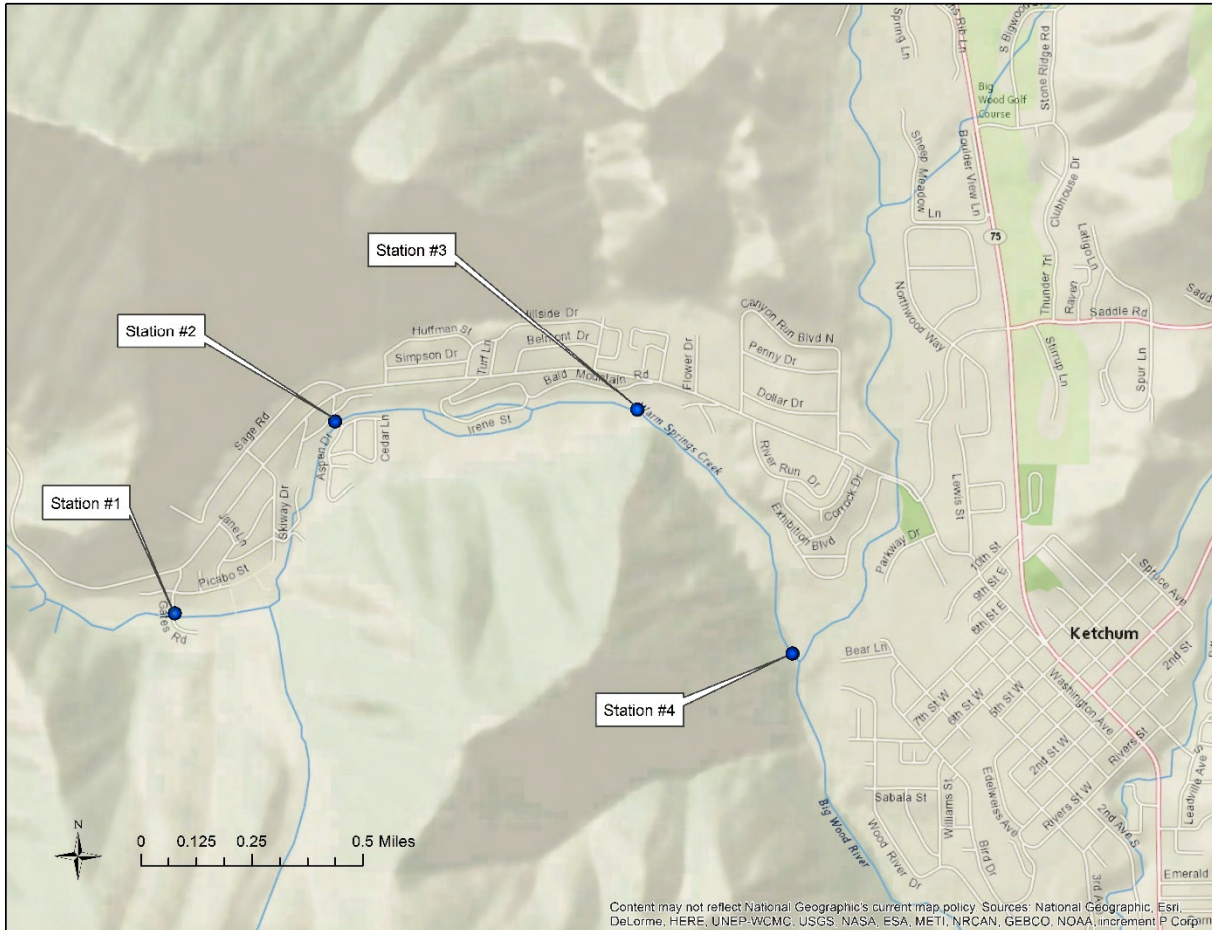
Figure 1. Map showing the location of the seepage survey and measurement stations.

A seepage survey was conducted on the lower 2.2 miles of Warm Springs Creek on July 17, 2017. Warm Springs Creek is a tributary stream to the Big Wood River with a confluence near the town of Ketchum, Idaho (Figure 1). The purpose of the seepage survey was to determine and quantify any gains or losses that occur within this section of the creek.

Station #1 was the furthest upstream measurement location and was measured first. The measurement site was a footbridge approximately 65 yards downstream from the Gates Road bridge across Warm Springs Creek. The site was a good location for measurements and a tag line was strung on the upstream side of the bridge and a measurement was also collected on the downstream side by traversing the bridge. Measured flow rates ranged from 129.8 to 133.9 cubic feet per second (cfs) at this location, with an average of the three measurements at 131.3 cfs (Table 1).

Station #2 was located on Aspen Drive, where the road crosses Warm Springs Creek, approximately 0.7 miles downstream from Station #1. Suitable measurement sections were not available from the bridge access, requiring the ADCP boats to be operated by tethering them across the channel approximately 10 yards upstream of the bridge. Measured flows at this site ranged from 130 to 132 cfs with an average of 130.8 cfs.

Station #3 was located at the USGS gage site on Warm Springs Creek approximately 0.7 miles downstream of Station #2. The USGS gage (Site No. 13137000) is located on the upstream side of an access bridge along the Bald Mountain Road. Measurements were taken directly adjacent to the gage equipment using taglines and tethered boats. Measured flows ranged from 132.1 to 136 cfs, with an average of 133.8. Flows at this station were the highest flows measured by each of the measurement crews throughout the day. At the time of the measurements, the USGS gage was reporting a flow of 69 cfs, indicating the reported flows from the USGS gage were incorrect.

Station #4 was at the mouth of Warm Springs Creek and the Big Wood River. Due to access to the site, only one measurement crew traversed across the Big Wood River to measure Warm Springs Creek. A good measurement site was located approximately 100 yards upstream of the mouth of the creek. The measurement site was approximately 0.8 miles downstream of Station #3. The measured flow at this location was 132.5 cfs.

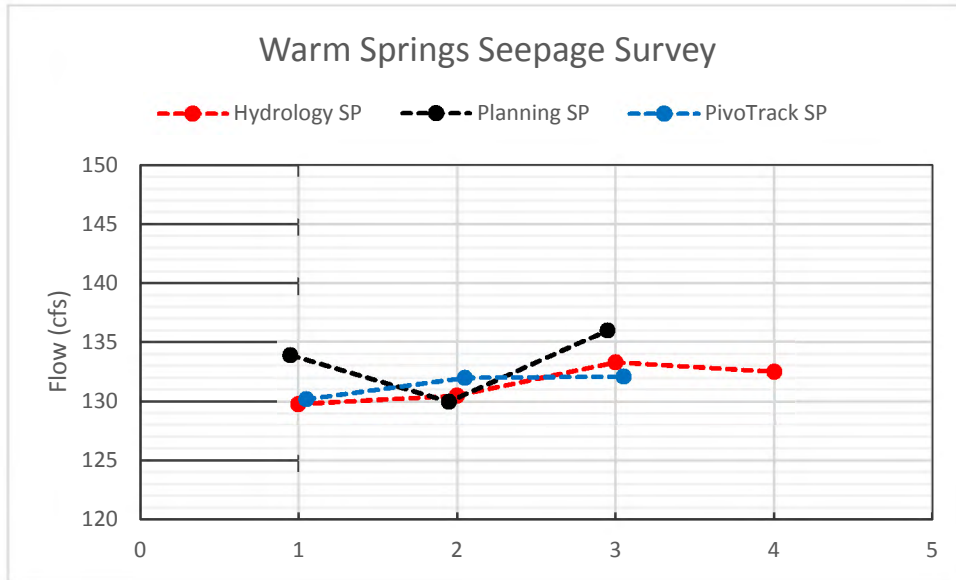
Figure 2. Graphic representation of measured flows.

Based on a review of the flows collected in the lower 2.2 miles of Warm Springs Creek, flows were similar at all four of the measurement stations (Figure 2). Therefore, a definitive net gain or loss could not be determined as the measured flows were within the estimated uncertainty of each of the measurements (Figure 3). A repeat of this seepage survey near the end of the irrigation season would be beneficial to observe any differences in flow conditions.

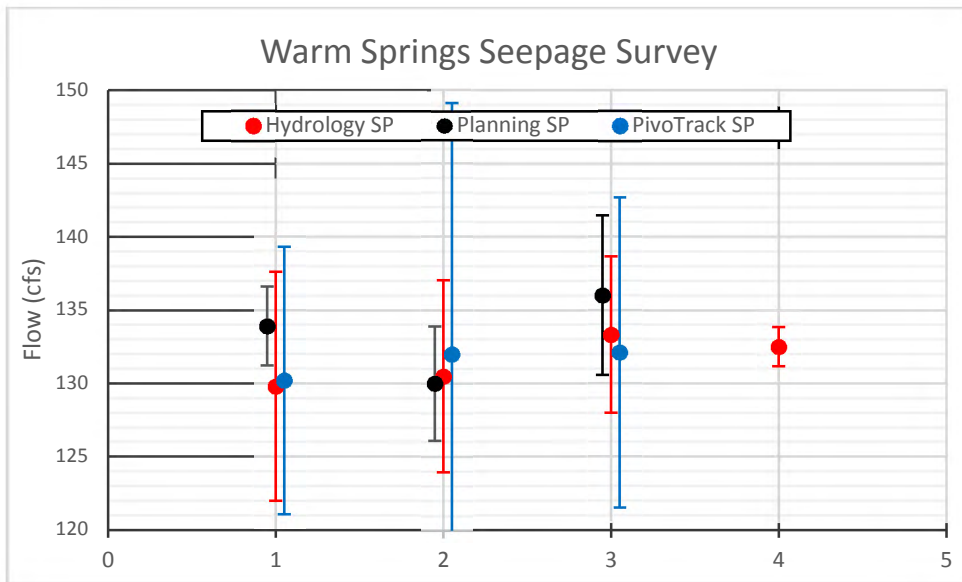
Figure 3. Graph of measured flows showing errors associated with each measurement.
