# Camas Creek Seepage Survey

by Alex Moody

*This report summarizes the results of a seepage survey conducted on Camas Creek, which flows into the Big Wood River at Magic Reservoir. Camas Creek originates within the boundary of the Big Wood Groundwater Management Area. The survey occurred on November 1<sup>st</sup>, 2017 and included six measurements of Camas Creek and its tributaries.*

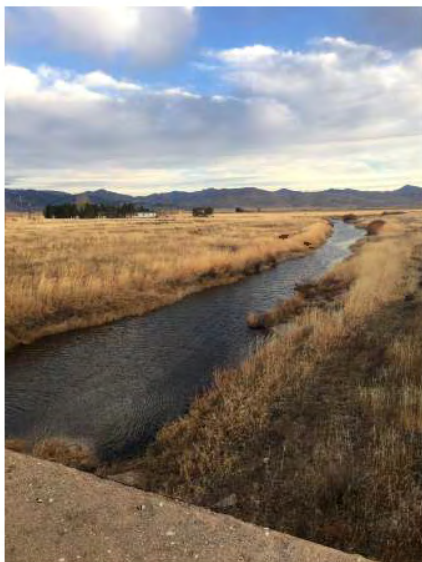
Figure 3: Impounded Camas Creek

**CC2:** Camas Creek 2 was selected by moving downstream of the initial CC1 site, which was giving negative velocity readings and seemed to be impounded at an unknown point downstream (fig. 3). Access to the site is via Lincoln Avenue-700 E off of Highway 20. Crossing over the bridge leads to a gate at which point the road to the north leads to the stream. The measurement was taken on the upstream side of the road (fig. 4).

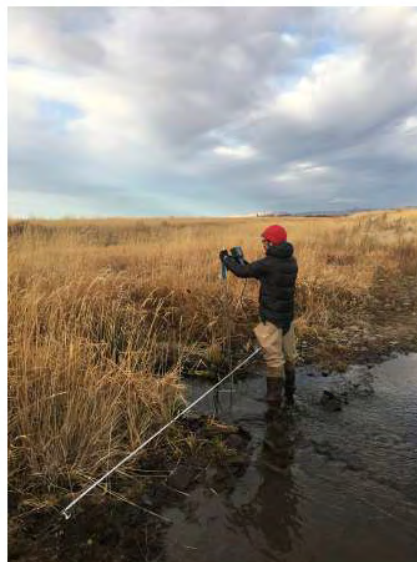
Figure 4: Flow over the road at CC2

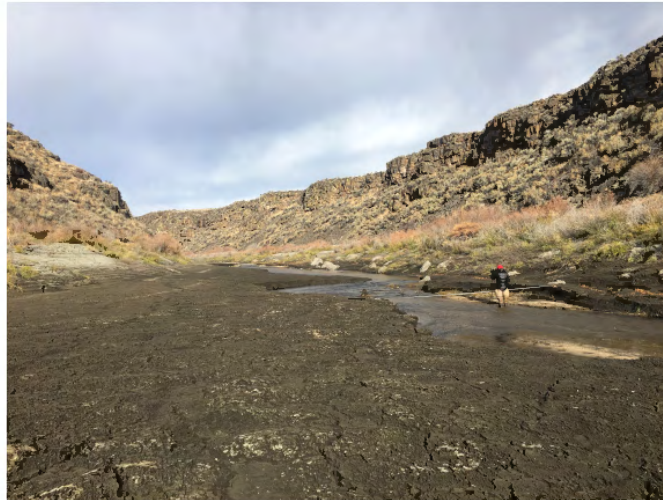
Figure 5: Camas Creek incised into the surrounding basalt near the beginning of Magic Reservoir's slackwater

**CC4:** The most downstream Camas measurement was reached by following Macon Flat road southeast from CC3 and turning north onto the track following the powerlines. There is a gully that can be descended to a point in the stream approximately 400 yards upstream of the beginning of the slackwater from Magic Reservoir. Pelagic sediment from the previous reservoir levels filled much of the canyon, though the creek was in a suitable bed of sand and cobble with uniform flow. See figure 5

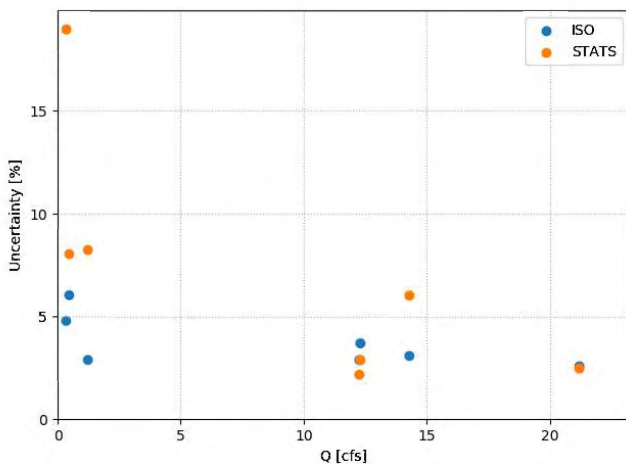
Figure 6: Discharge vs. uncertainty as estimated by the SonTek Flow Tracker

Our uncertainties arise from measurement uncertainty and the method of tributary inspection. Measurement uncertainty decreases with the magnitude of streamflow (fig. 6), though the absolute uncertainties in the tributary flows are relatively small compared to the overall flow of Camas Creek as it enters the reservoir. Tributaries were inspected at their intersection with US Highway 20. If no water was present, no further inspection upstream was made. Elk, Deer, and Soldier Creeks were flowing during the spring survey of Young [1978], though many had infiltrated into the unconfined aquifer prior to their reaching the highway. We cannot be certain if these streams were flowing upstream during the present survey, though we assume any runoff had already infiltrated into the underlying aquifer.

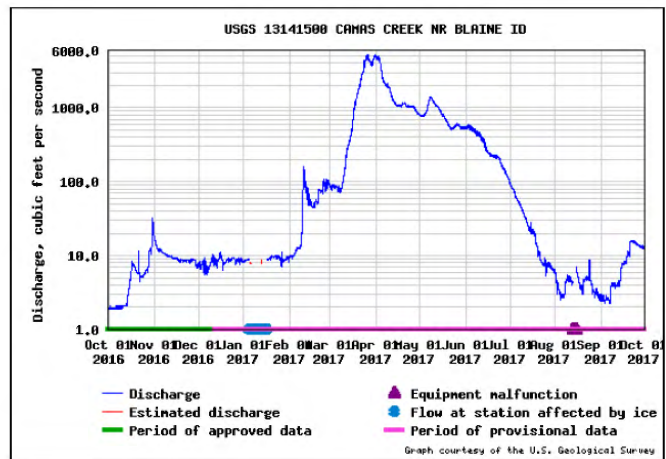
Figure 7: Hydrograph of Camas Creek during water year 2017

Camas Creek streamflow is dominated by runoff events such as spring snow melt (fig 7) and daily discharges can vary over three orders of magnitude in a given water year. All known seepage surveys have been conducted during low-flow conditions with the discharge being no more than 24 cfs at Magic Reservoir. Future seepage surveys during the climbing or receding limbs of the hydrograph in high-flow years would provide insight into baseflow under varying conditions, improve the understanding of the aquifer, and may provide important information for managers at Magic Reservoir and water users in the Camas Prairie.
