IWRB Recharge Water Quality Monitoring

Paul Thomas

April 24, 2019

IWRB ESPA Water Quality Monitoring

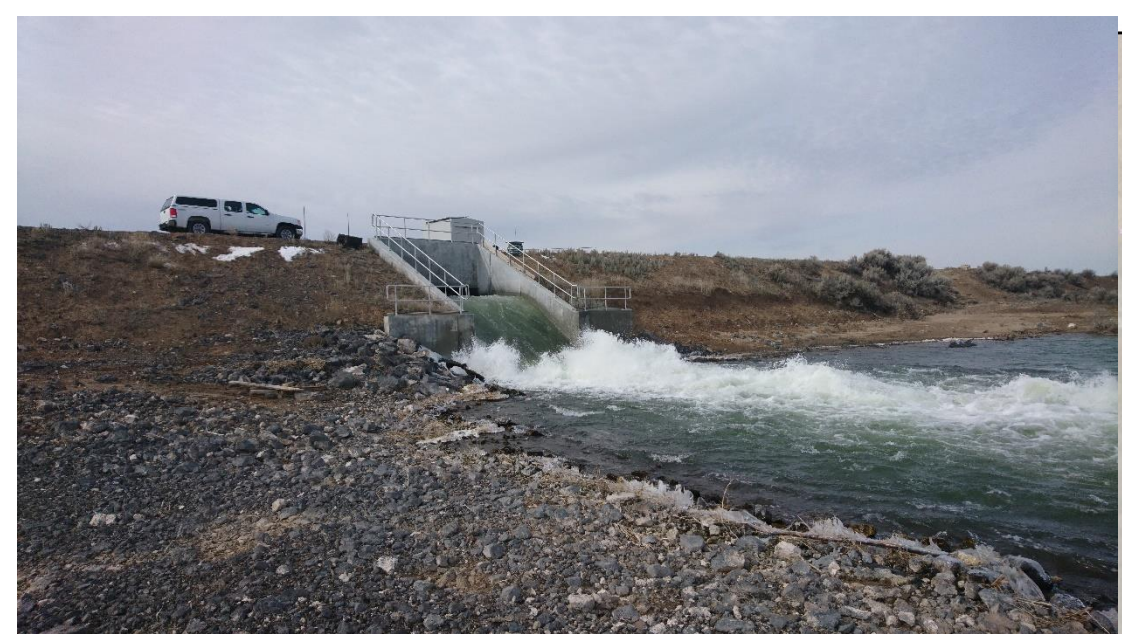
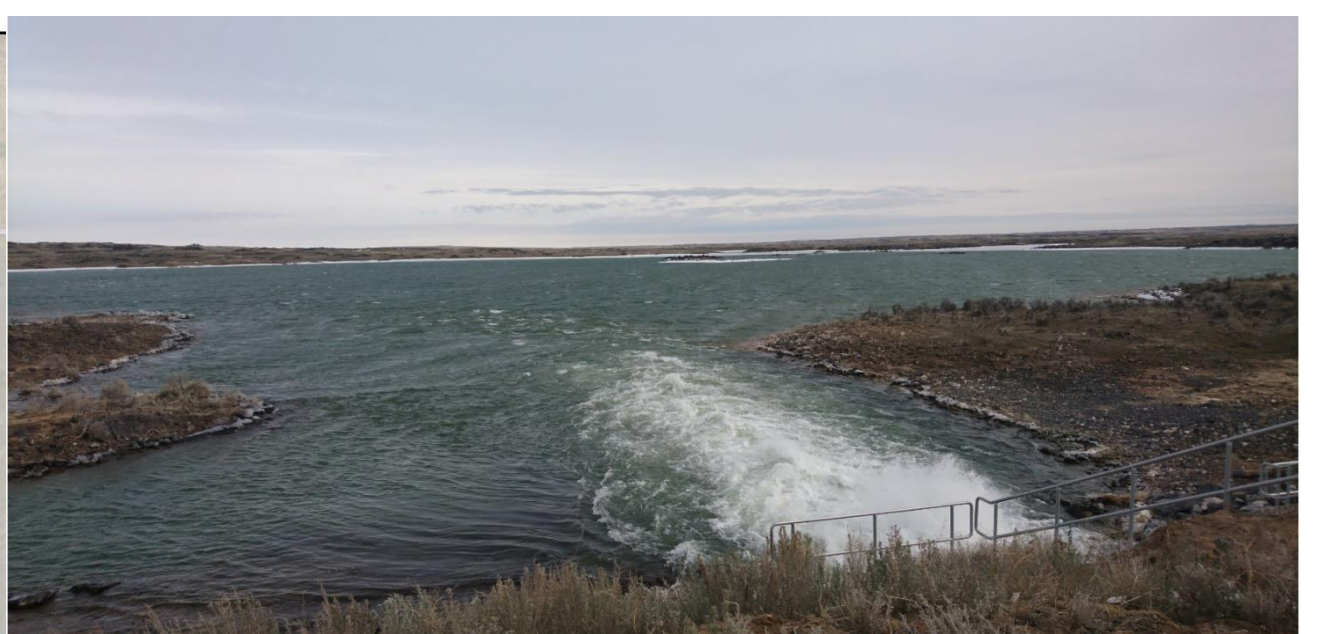
Groundwater Quality Monitoring at Mile Post 31

- Full scale activity started during the 2014-2015 recharge season
- 51 sampling events since start of full scale operations

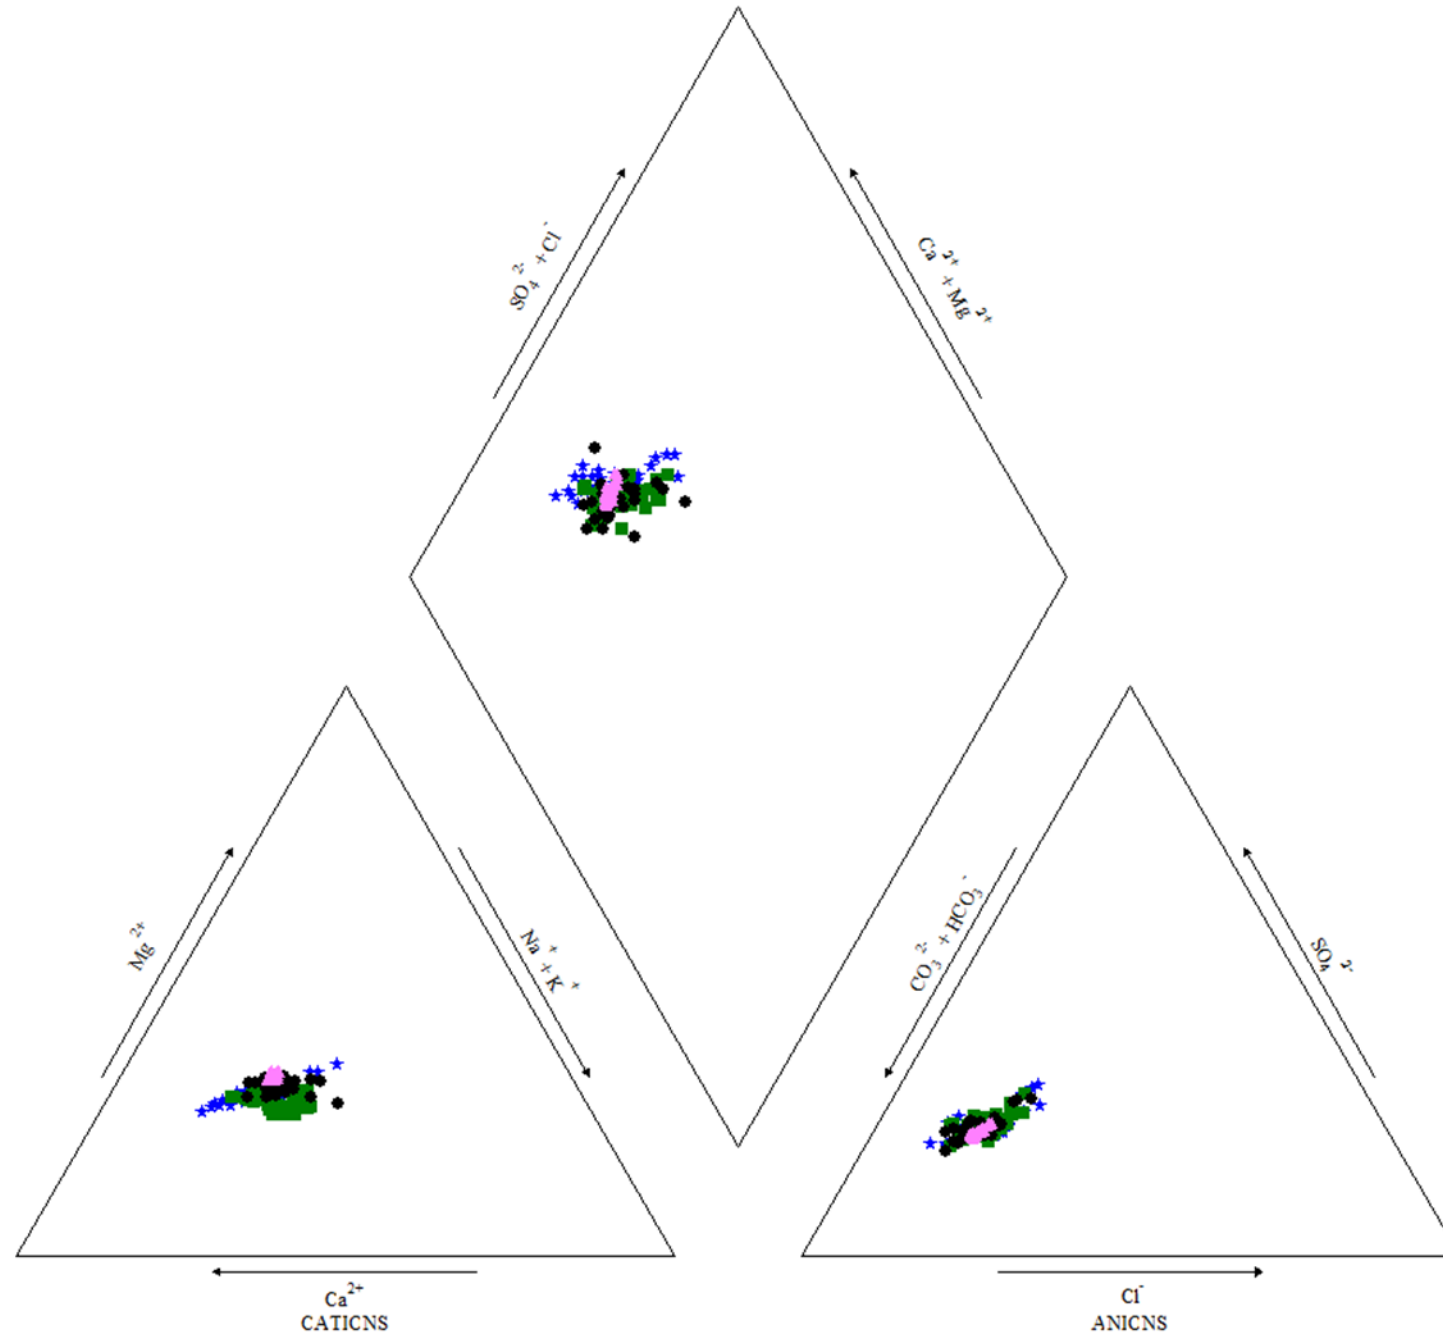
MP31 Water

Surface Water

East Well

Central Well

West Well

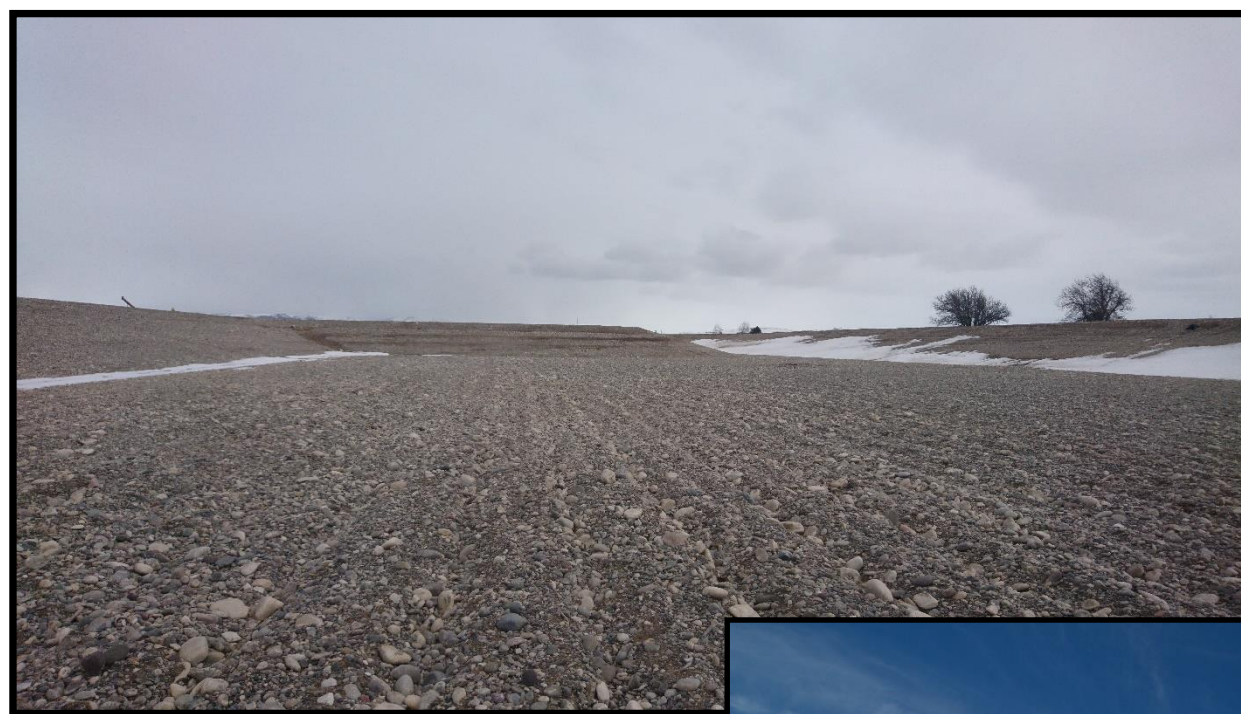
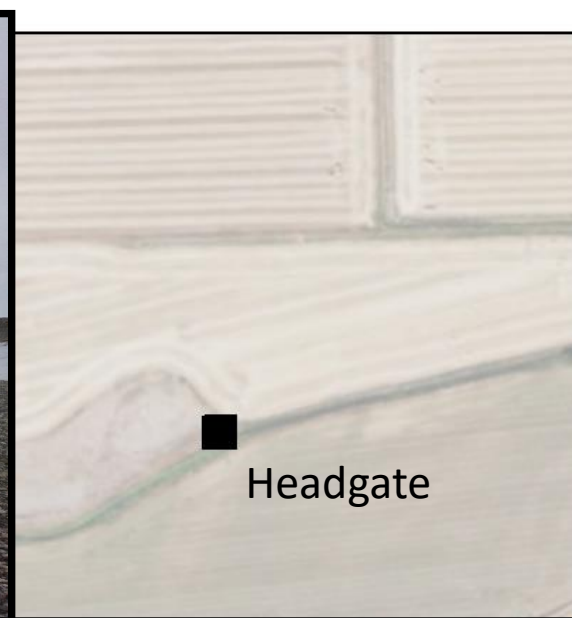
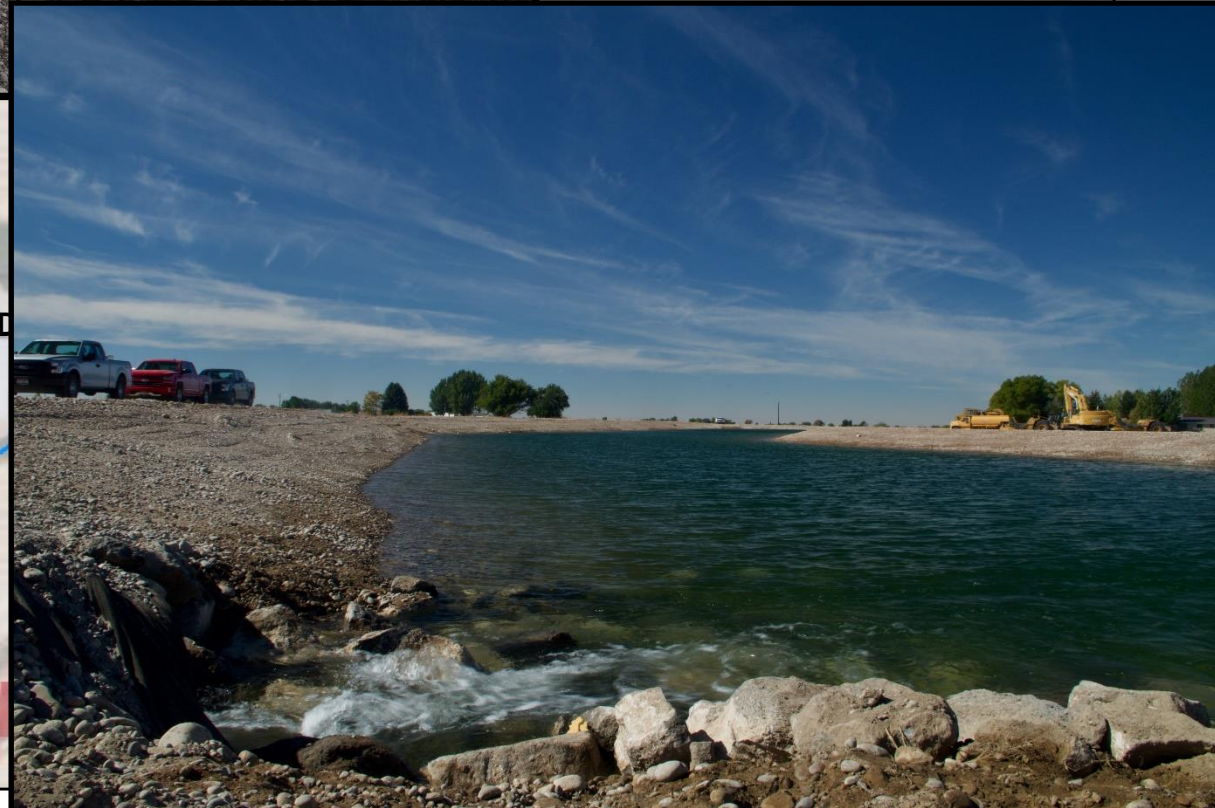
- **Jones Site**

- Basin is ~5 acres
- Site takes 20 cfs
- Old gravel pit

- Dedicated monitor well constructed to mimic domestic design with additional perforations

- Weekly bacteria sampling during recharge

- 3 proximal domestic wells sampling along with MW

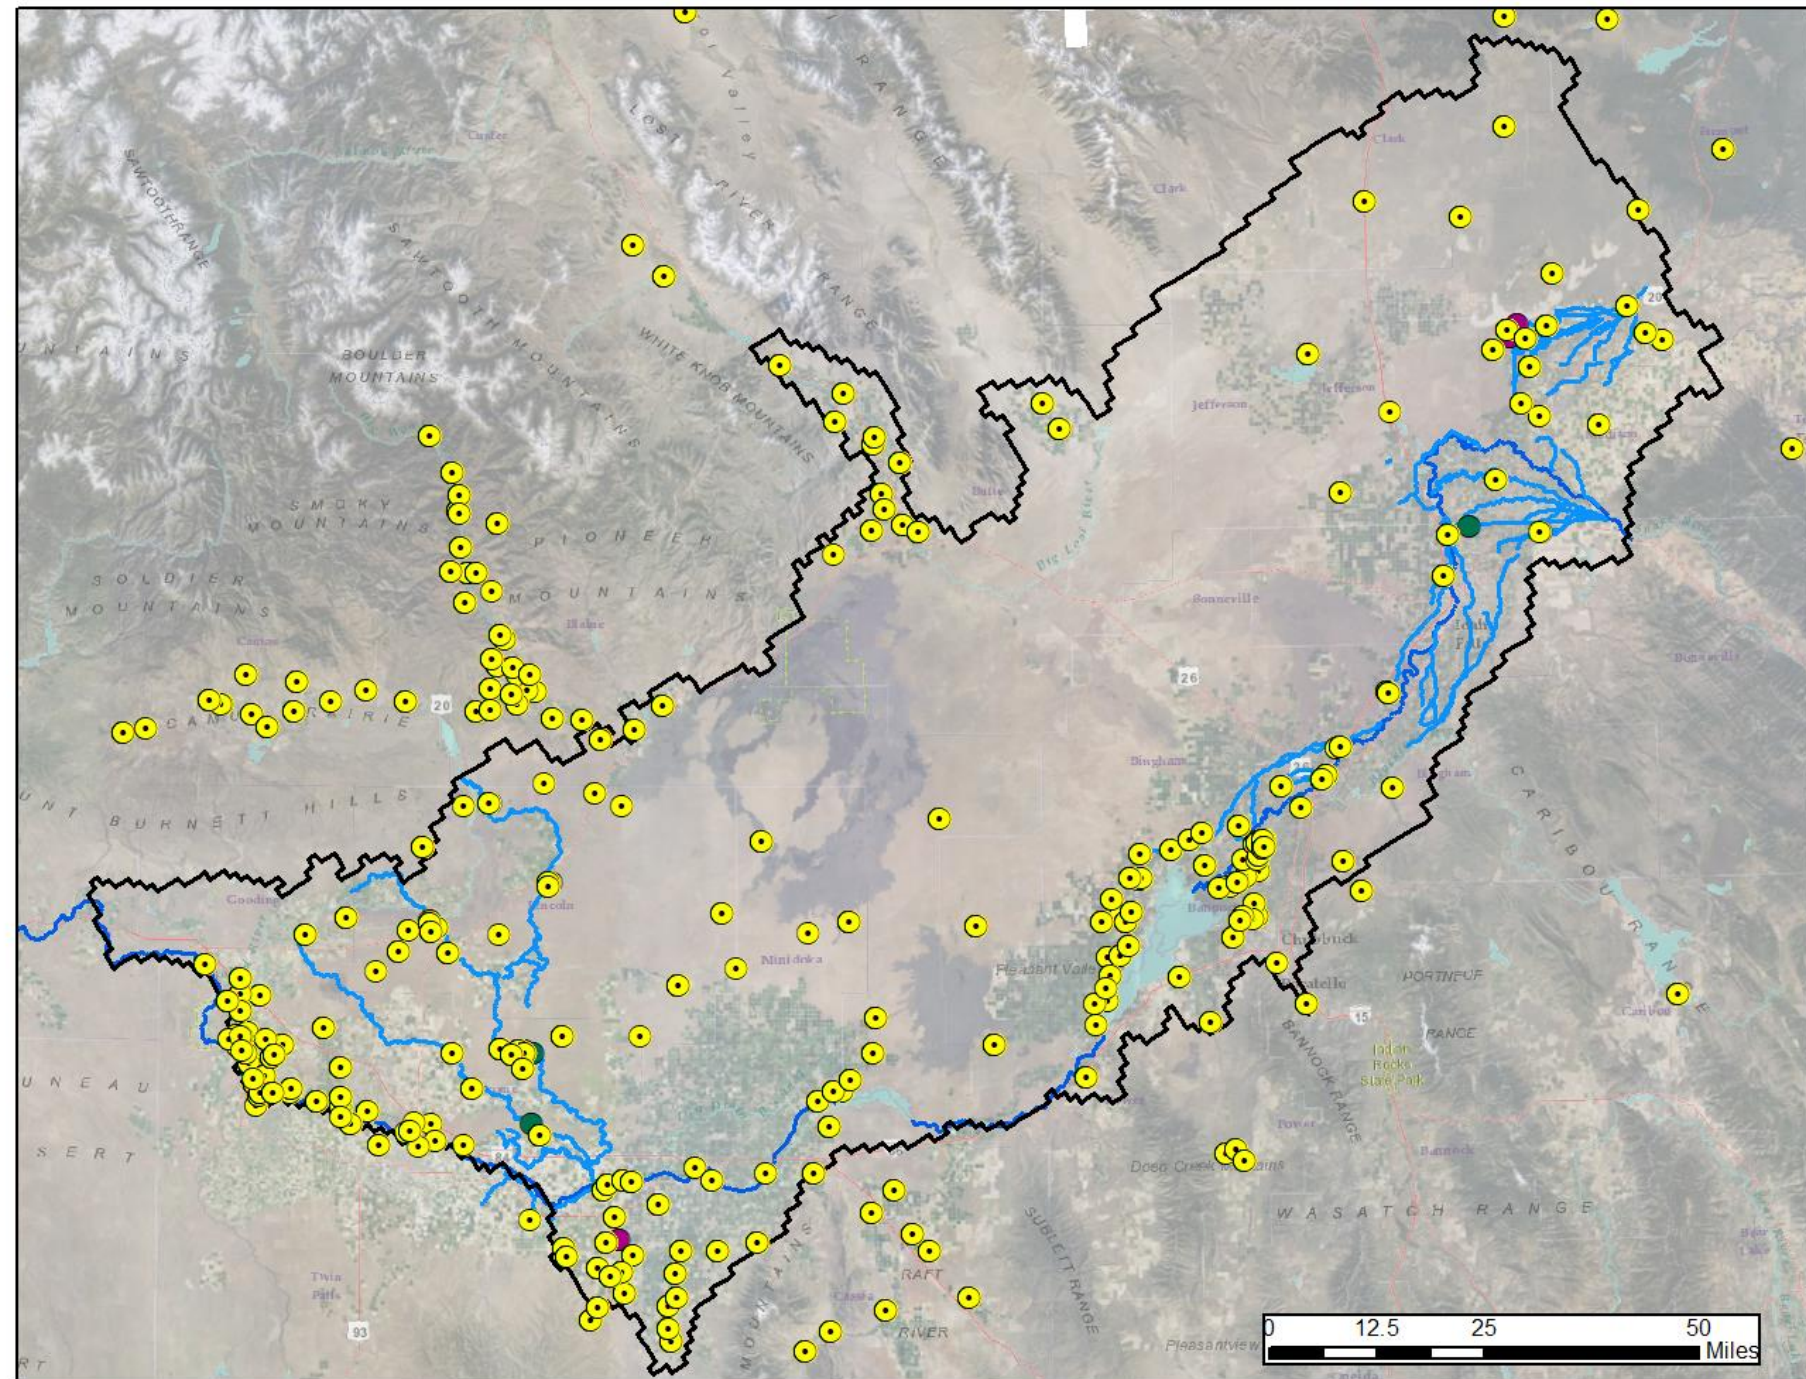
Continuous Groundwater Monitoring in the ESPA

- Pressure transducers used to record depth to water
 - Hourly reporting
- Approx. 230 located within the ESPA
- Plan to add 10-15 more in the South Fork, Egin Bench, and Mud Lake areas.
- Gather data to assist in answering the question, “Where does recharge water flow?”
