Modernizing Idaho's Water Infrastructure

An Ongoing Story Series on the Idaho Water Resource Board's Aging Infrastructure Grant Program **ISSUE NO. 19**

Last Chance Canal Company Main Flume Resurfacing Project

Last Chance Main Flume Resurfacing and Rehabilitation Project (cont.)

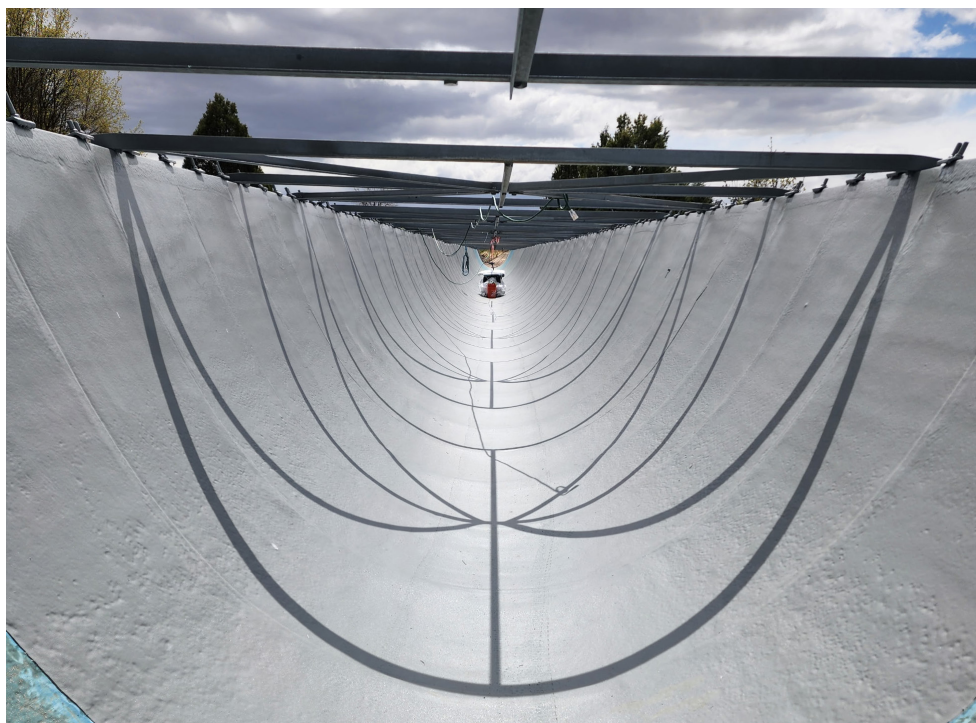
Last Chance Main Flume old liner was replaced with a fresh coating of "Aqualastic" after contractors did extensive repairs and grinding to prepare the surface for the new liner material (photo courtesy Mark Mathews, Last Chance Canal Co.).

Once the flume has been prepared, a new liner material, called "Aqualastic" was sprayed onto the flume at an 80- to 100-millimeter thickness. The new liner is a different color than the blue-shaded old liner so that wear spots in the future may be identified.

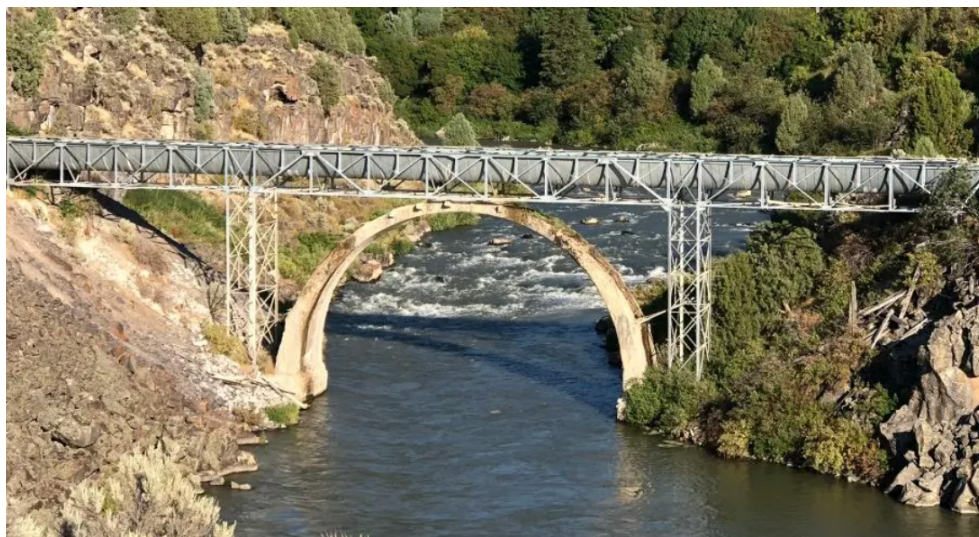
Above: Last Chance Main Flume (courtesy Bear River Heritage Area). Below, construction crew grinds down the surface of the flume and repairs cracks in preparation for new liner coating (courtesy Last Chance Canal).
