Assessment of Lands Served Burley Irrigation District December, 2008

Appendix 1 2006 Irrigated Land Classification for the Eastern Snake Plain Aquifer

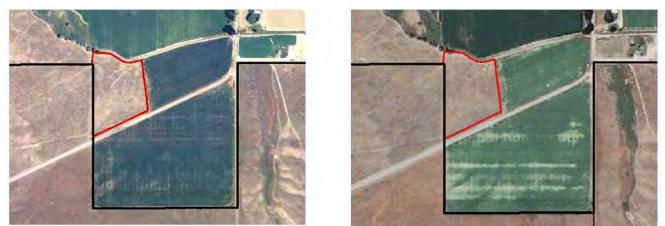
2006 Figure 2. NAIP images of rejected Area #1. Rangeland in T10SR21E S25 NESE that is not irrigated.

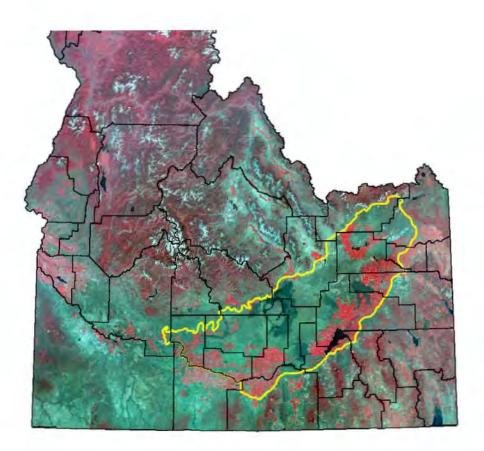
Figure 1. The boundary of the Eastern Snake Plain Aquifer, in yellow.

IDWR is revising its Eastern Snake Plain Aquifer (ESPA) groundwater model. As part of that revision, the Geospatial Technology Section was asked to generate a new digital classification of the irrigated land within the boundary of the ESPA model. Water from irrigated land is a source of significant recharge to the aquifer, and is one of the factors that determine the accuracy of the model's predictions. The new classification would replace the old classification which is circa 1992. The area of the Eastern Snake Plain is illustrated in Figure 1.

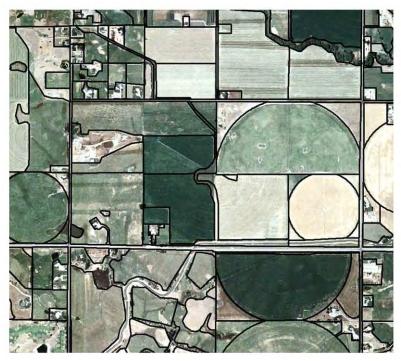
Figure 2. Common Land Unit (CLU) polygons in black superimposed on National Agricultural Inventory Program (NAIP) image data.

In conjunction with the image data, IDWR analysts used Common Land Unit (CLU) polygons of individual fields that were digitized from a combination of 2004 and 2006 NAIP imagery by the Farm Services Administration (FSA). Although FSA will allow access to CLU polygons, they deny all requests for access to the associated attribute data, including the land-cover codes. IDWR, therefore, used the unattributed CLU polygons. The CLU polygons were used because they constitute an existing, recent, highly-detailed, vector dataset that IDWR could attribute as irrigated or non-irrigated relatively easily. Figure 2 shows CLU polygons superimposed on NAIP image data.

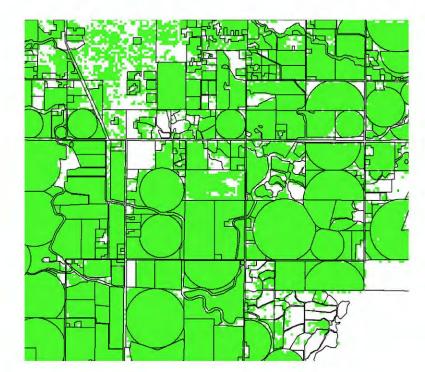
Figure 4. The initial Landsat-based classification output from Step 1 of the classifier with CLU polygons superimposed. Irrigated land is green

The second step in the classification was to overly CLU polygons on the Landsat classification, as illustrated by Figure 4. A simple decision rule was applied that made a polygon irrigated if at least 75% of the area of the polygon was classified by Landsat as "irrigated". The result of the decision rule on Figure 4 is illustrated by Figure 5.

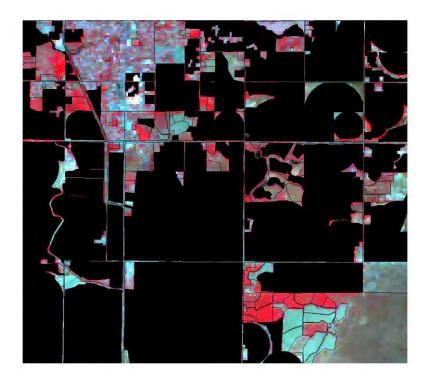
Figure 6. Irrigated polygons masked to black and superimposed on Landsat data from May 19, 2006.

Figure 6 shows masked irrigated polygons on a Landsat image. What is not masked is classified as non-irrigated. Clearly, there are some irrigated fields being classified as non-irrigated. Those misclassifications were corrected by simple editing, and the process was repeated for each date of Landsat data available, and for the NAIP (Figure 7).

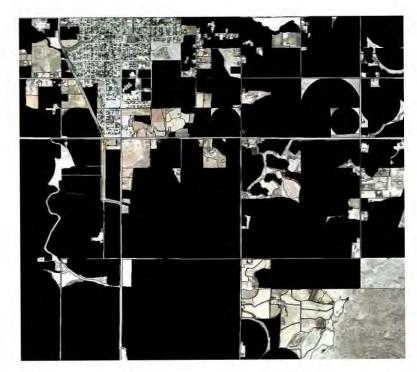
Figure 7. Irrigated polygons masked to black and superimposed on 2006 NAIP image data.

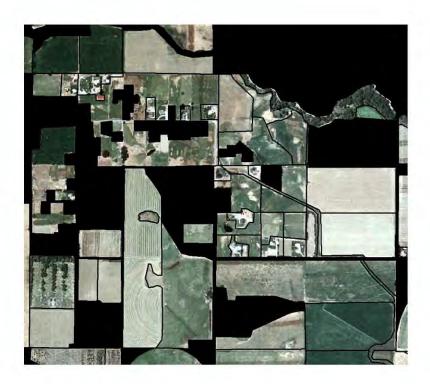
Figure 9 . Non-Irrigated mask on NAIP. Arrows point to some residential land classified as irrigated. Those polygons are changed during editing.

The entire classification could have been done using just Step 3, but it would have taken longer and been more tedious. The first two steps were designed to classify quickly those fields that the computer could readily identify as irrigated. The third step was designed to use a human interpreter to make subtle decisions that were beyond the meager intelligence of the software, and to correct any classification errors made by the software. Figure 9 shows an example of one kind of those errors. Steps 1 and 2 resulted in small polygons of residential land being classified as irrigated. In Step3, those polygons were changed from irrigated to a third class not used in the first 2 steps: residential.
