PROGRESS REPORT ON  
DRAINAGE INVESTIGATIONS

EMMETT VALLEY  
GEM COUNTY, IDAHO

George B. Bradshaw  
Drainage Engineer

Boise, Idaho  
June, 1953

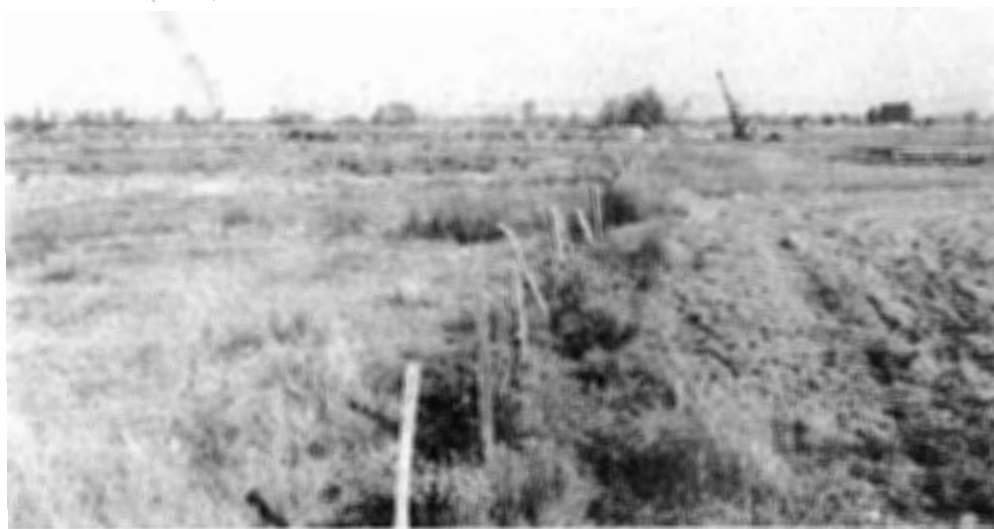
Figure 9. Looking north from center of farm. Soils belong to the Letha and Emerson series and are primarily fine sandy loams.

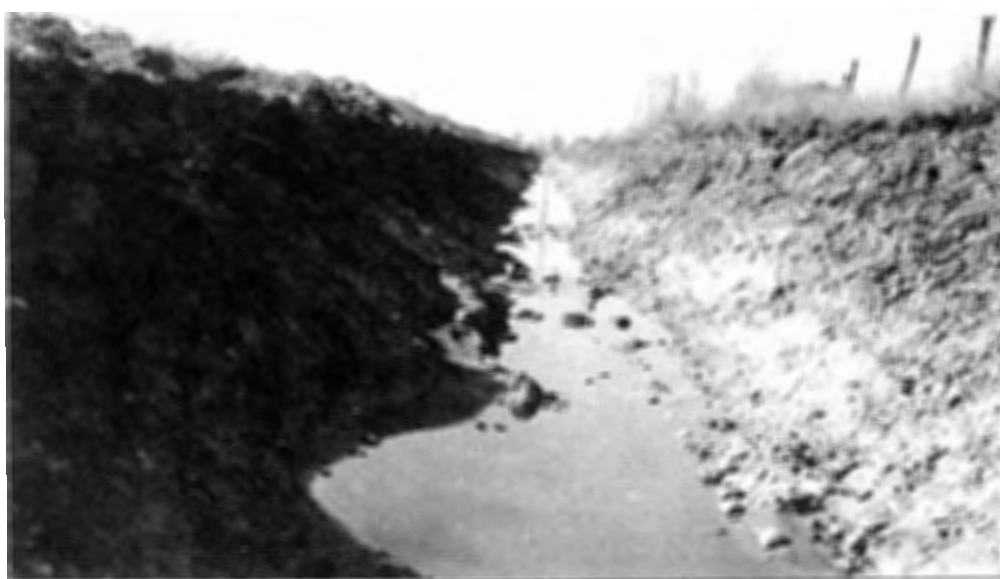
Figure 10. Looking west along open drain, from the north east corner of the farm. Drainable strata of sand and gravel is visible below a two foot soil cap.

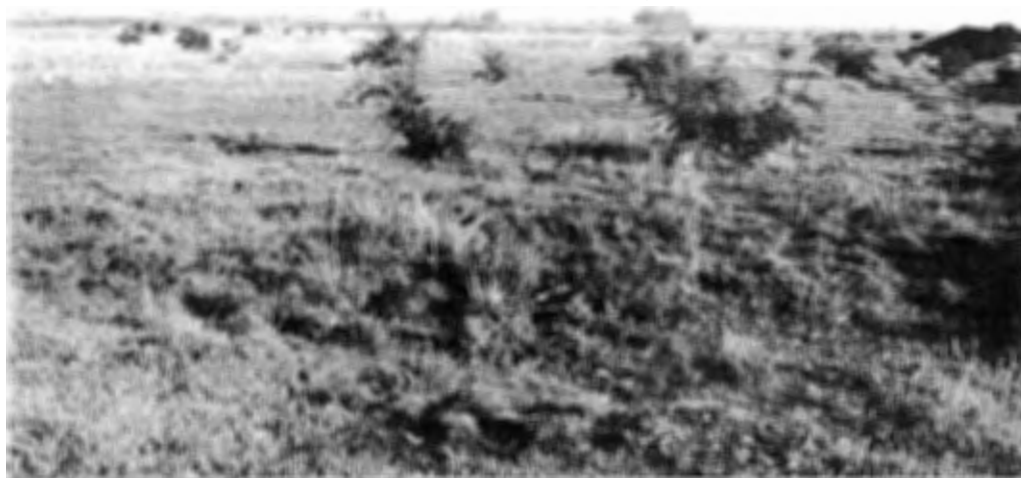
Figure 13. Looking north west from center of new drain. The soils belong to the Muck series. Wild rose bushes in foreground.

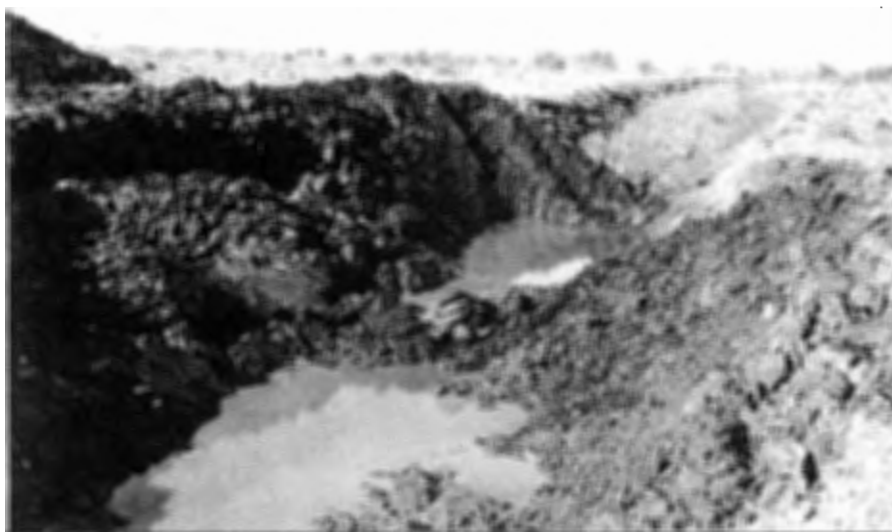
Figure 14. Looking north along partially constructed drain. Caving and sloughing tendency of drain bank is shown.

7. The maintenance cost on the drain will be very high in comparison with the more stable soils. Cleaning to remove the sloughing and heaving muck soil may be required yearly for several years.

8. If additional open drainage work is done on the Muck soils, it should be done with a light dragline and jarring kept at a minimum.

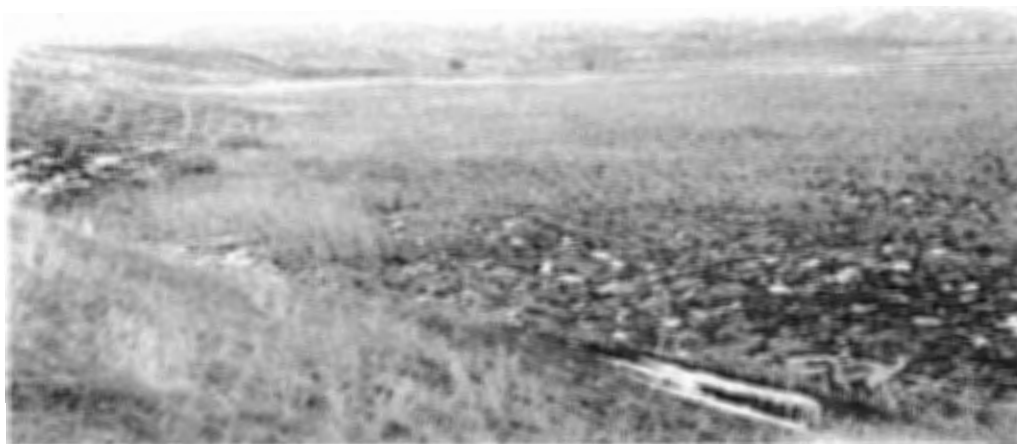
Figure 17. Looking north along proposed route of interceptor drain. The soils belong to the Snow series and are primarily clay loam.

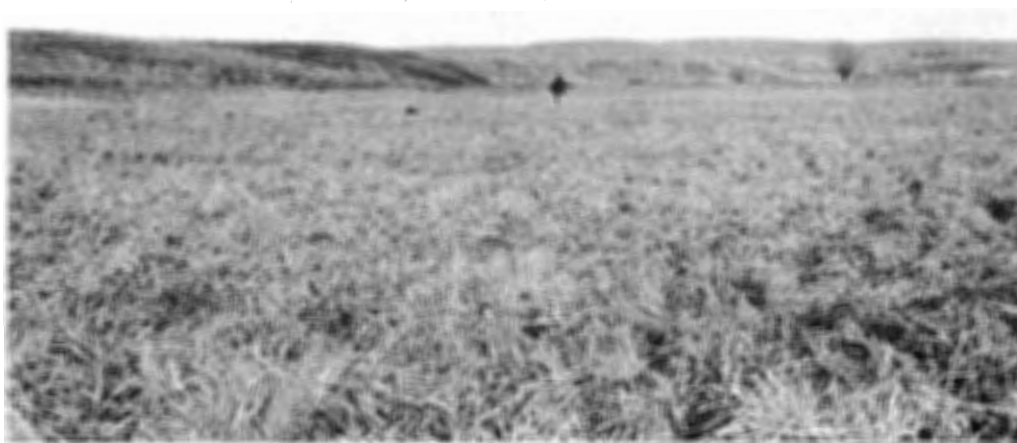
Figure 18. Looking north west over the bog section. During the summer months seepage water accumulates and stands 2 or 3 inches deep on the surface.

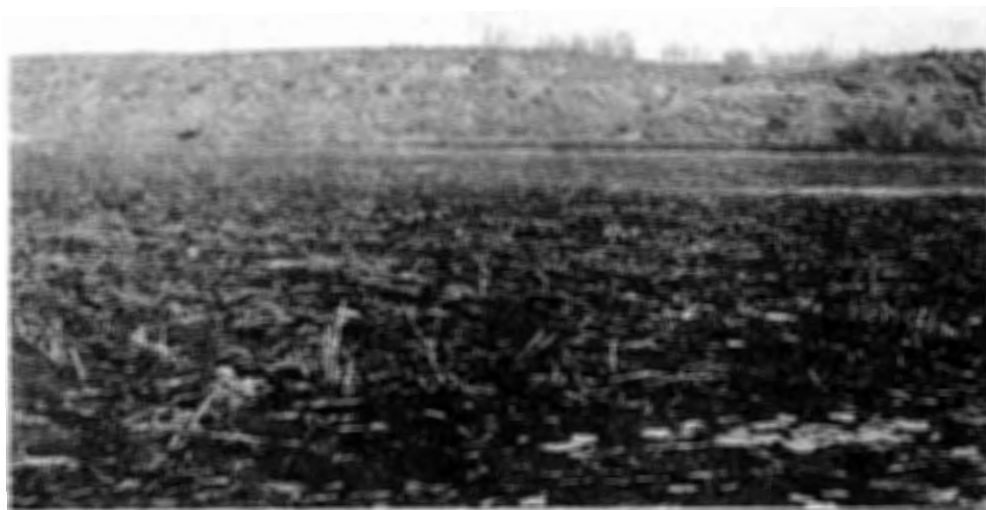
**Figure 21. Looking north towards the Emmett Bench escarpment.. The soils belong to the Snow series and are primarily loam and clay loam.**

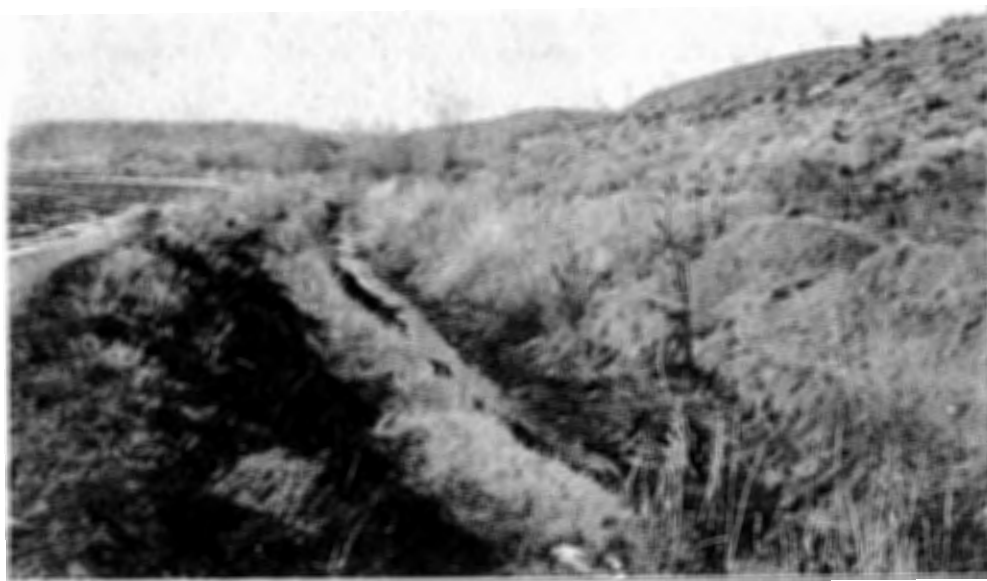
**Figure 22. Looking west along the interception drain. The drain is located at the break in grade and soil change to intercept seepage water from the bench.**

summer and fall when the water table problem is most acute. This watercress condition reduces the effective depth of the drain at the time it is needed the most.

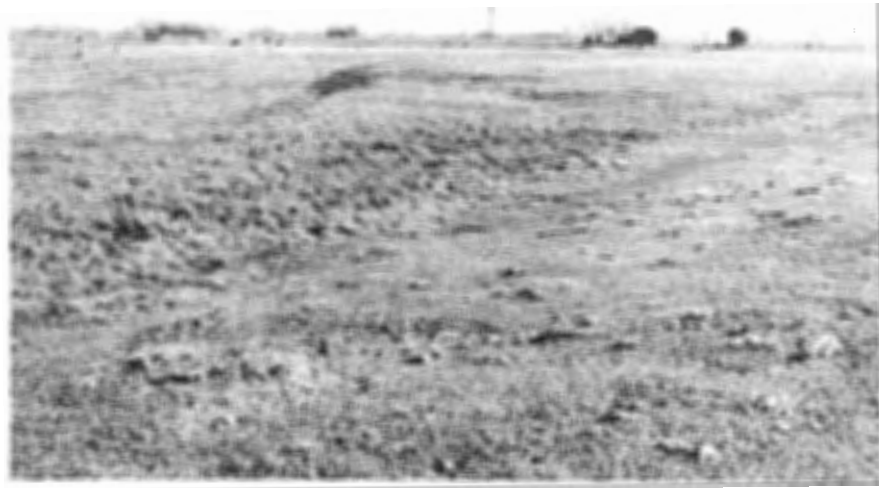
Figure 25. Looking north east along proposed route of tile drain. The area is slightly to strongly alkaline.

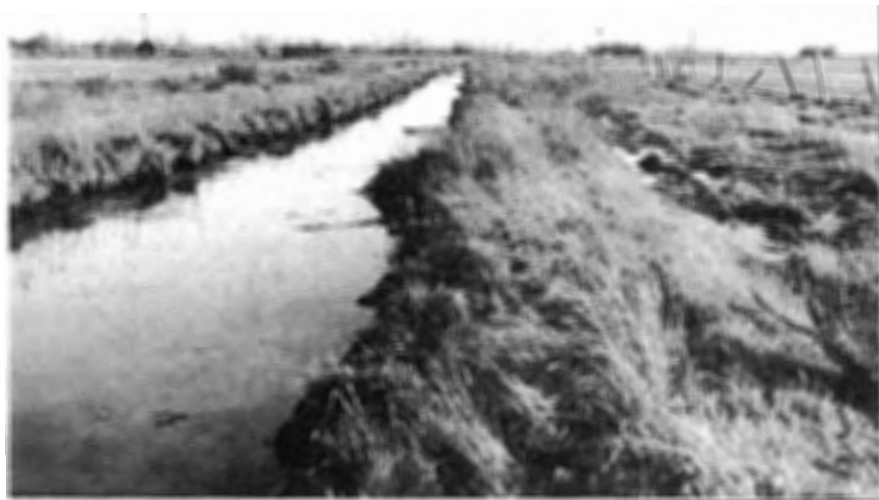
Figure 26. Looking east along shallow ditch at the north side of the farm. The ditch is 1 1/2 feet deep and approximately 12 feet wide.

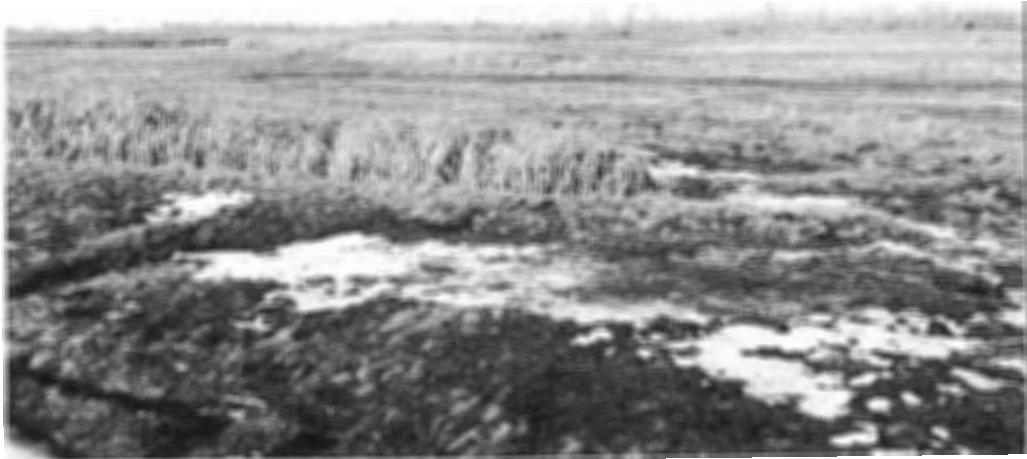
Figure 29. Looking north west from center of farm. Sloughs are to be cleaned, deepened and used for drainage channels.

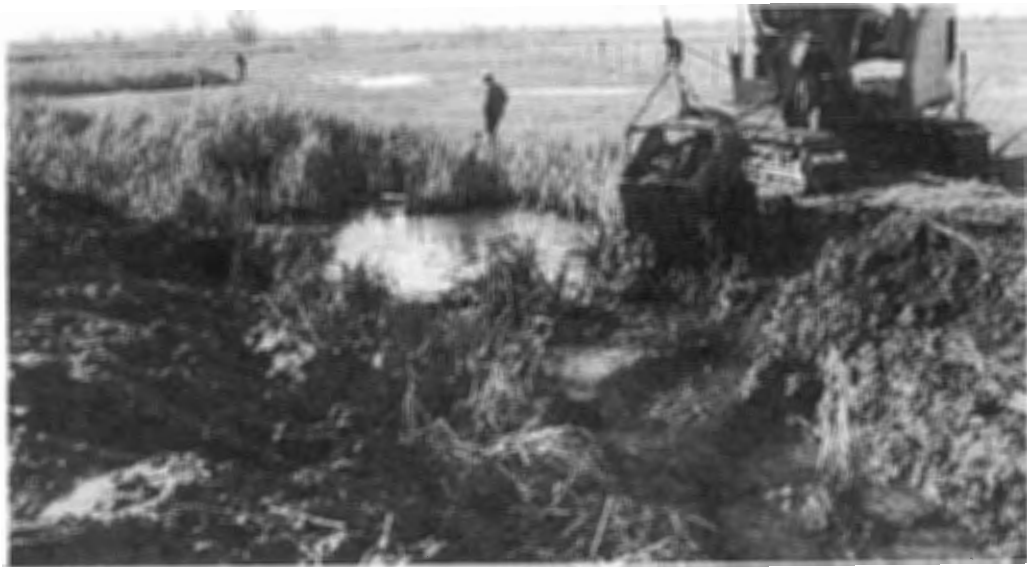
Figure 30. Looking west from south center of farm. Slough is being cleaned and deepened and will be used as an interceptor drain.

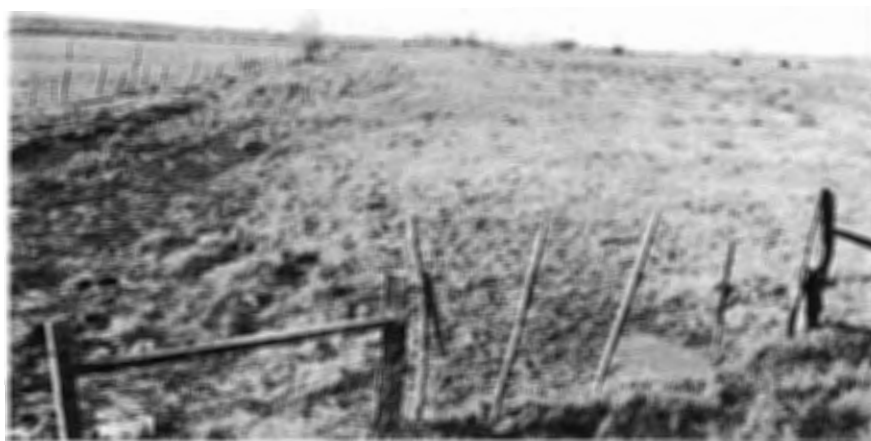
Figure 33. Looking west along proposed drain route from the north south road disecting the farm. Land on right side of the fence is strongly alkaline.

The slough in figure 33 will be eventually cleaned out, deepened and used as a drain to help reclaim the land shown, and to drain a standing swamp at the extreme east end of the ranch.

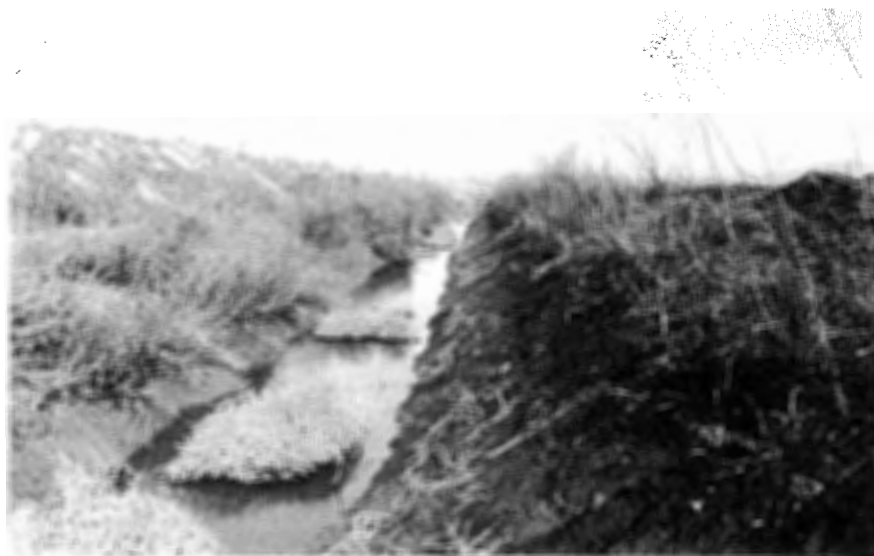
Figure 34. Looking north along section of drain that was installed during 1952. This section of drain is in slowly permeable soil.

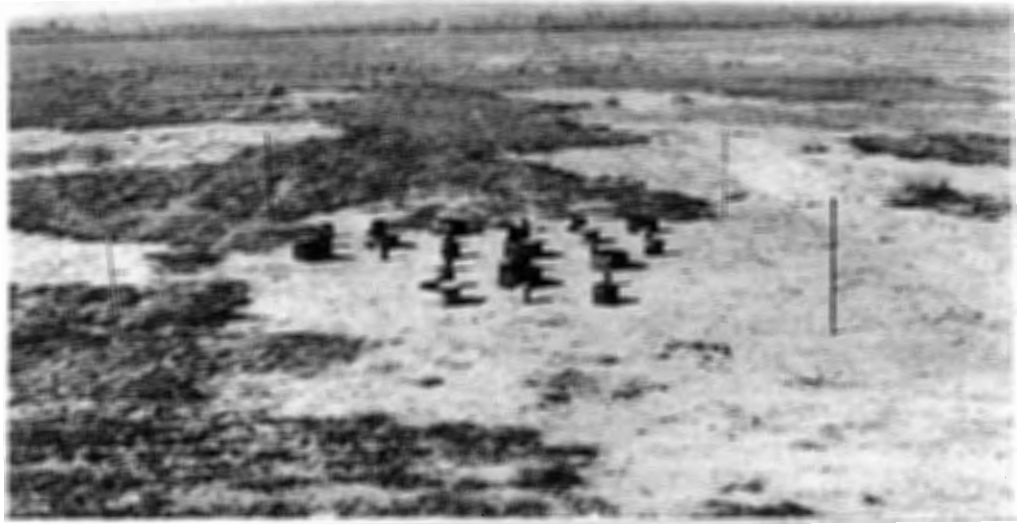
Figure 37. Looking north over the Ranch "I" alkali reclamation plot. The soils are silty clay to 10 feet and strongly alkaline in the top two feet.

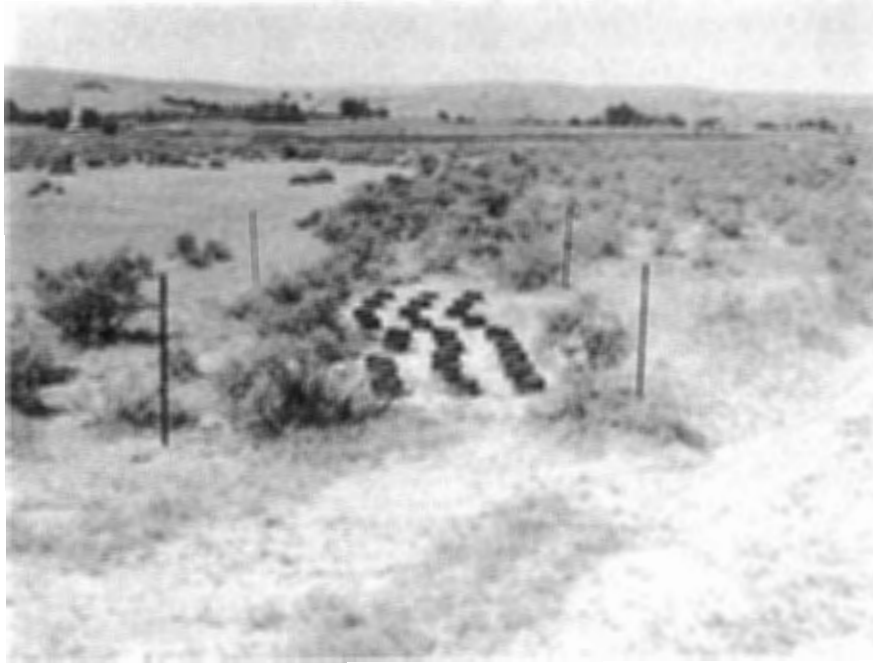
Figure 43. Looking west over the Ranch "H", Greasewood, alkali reclamation plot. The soils are rapidly permeable to the gravel strata and moderately alkaline to a depth of four feet.

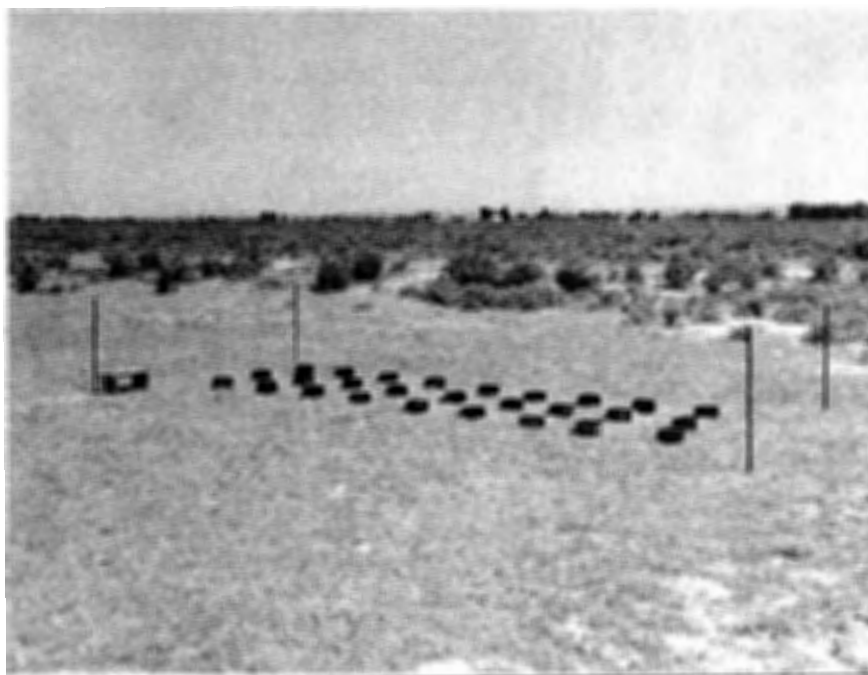
Figure 46 Looking north over the Ranch "H", Salt Grass, alkali reclamation plot. The soils are moderately to rapidly permeable and alkaline to a depth of six feet.
