PROGRESS REPORT ON
DRAINAGE INVESTIGATIONS

EMMETT VALLEY
GEM COUNTY, IDAHO

George B. Bradshaw
Drainage Engineer

Boise, Idaho
May 1954

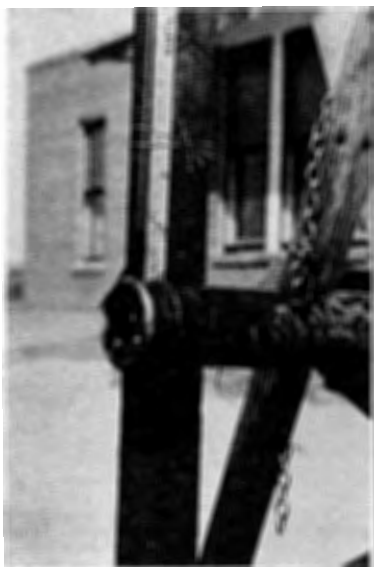
Figure 18 Orifice and manometer tube used to measure the discharge from an artesian aquifer.

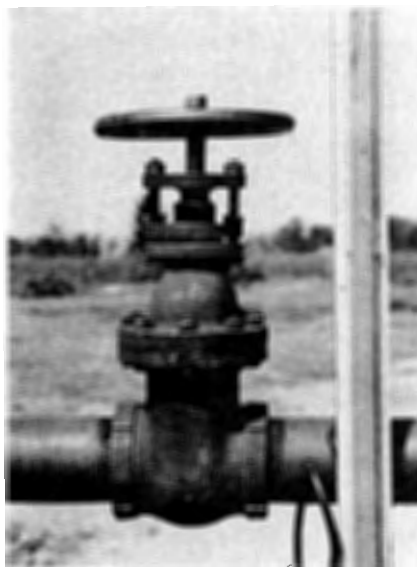
Figure 19 Four inch gate control valve used to maintain a constant head on the discharge orifice.
