Wood River Valley Hydrograph Update

Presented to the WRV MTAC 19 April 2023
By Alex Moody

IDAHO DEPARTMENT OF
WATER RESOURCES

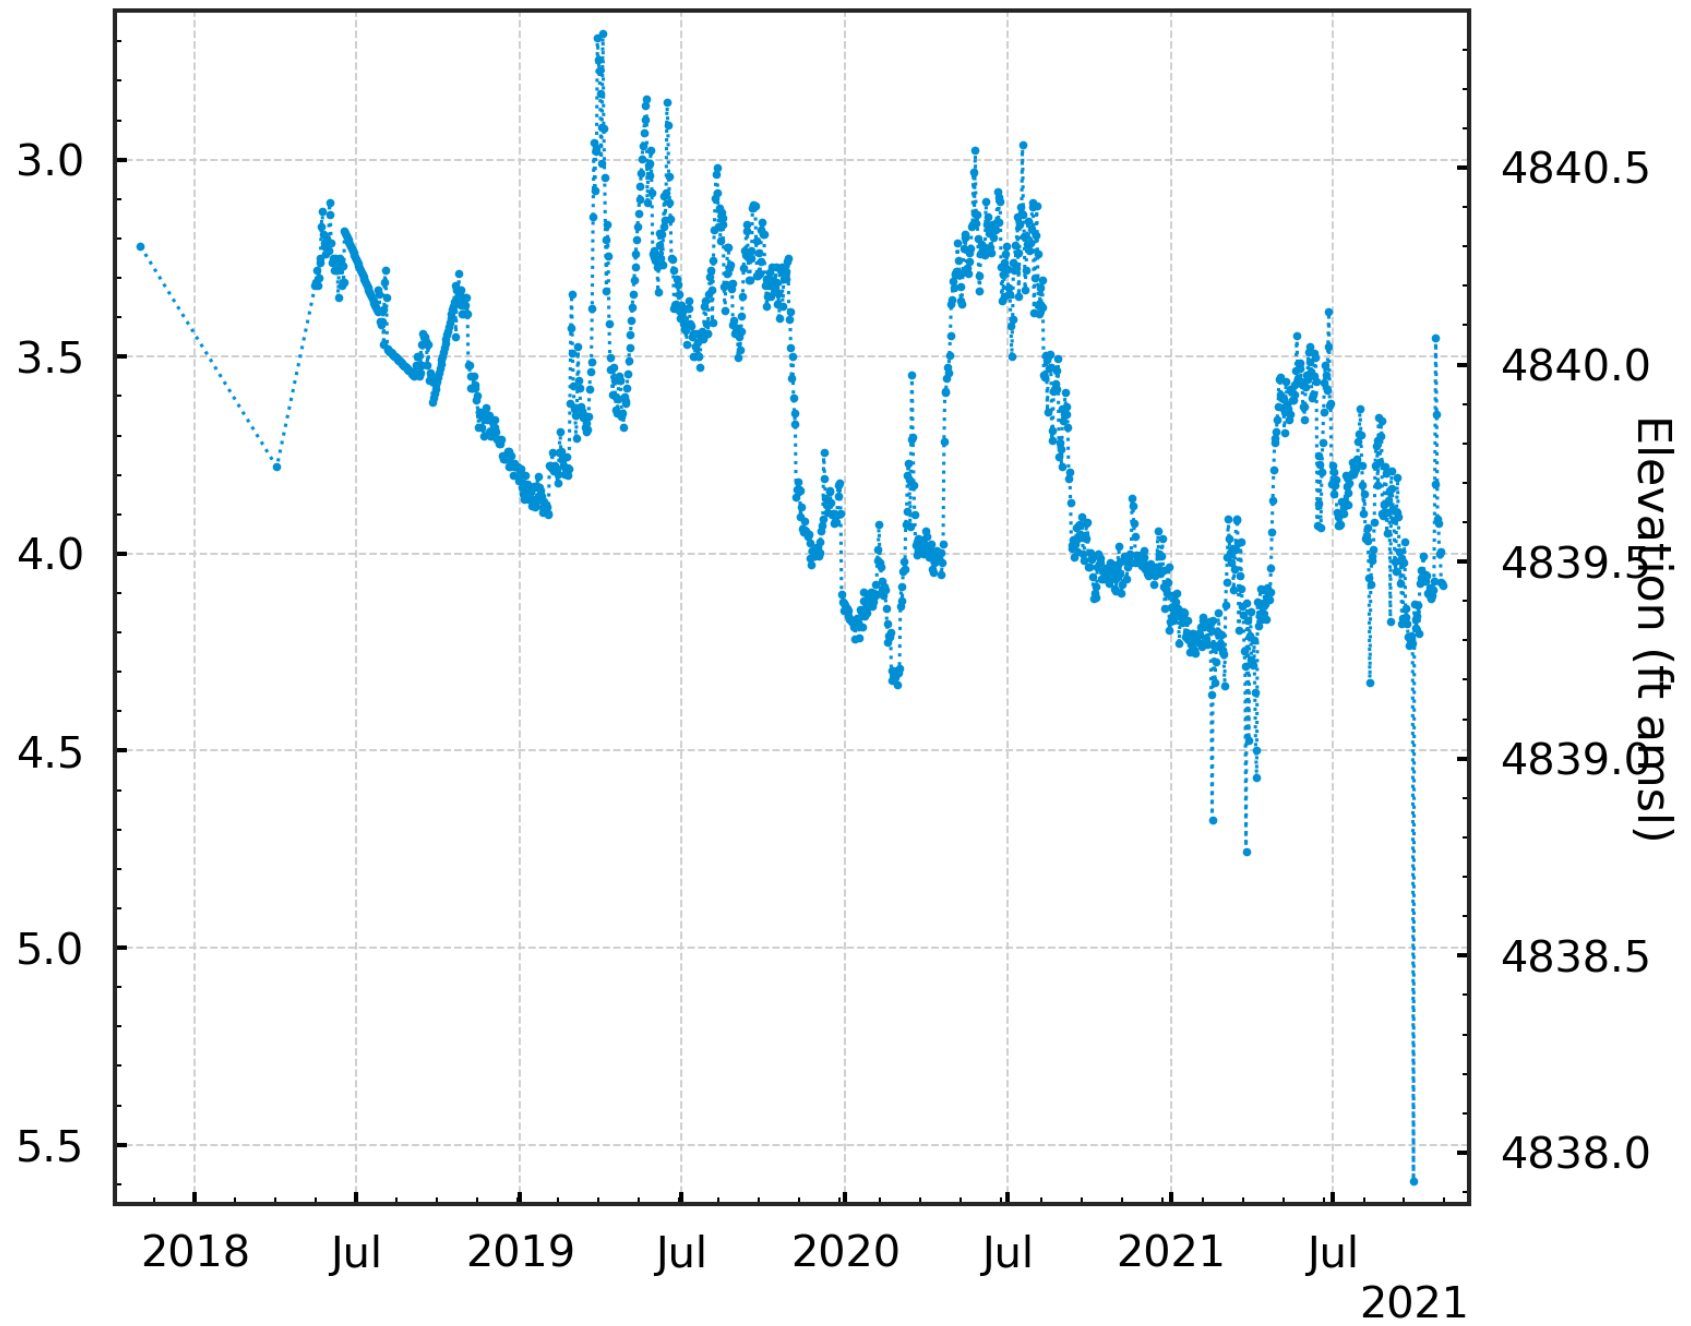
01S 18E 22BBD1 Heartrock Ranch Stock

Depth to water (ft)
