A series of seepage surveys were conducted on the lower six miles of Trail Creek during the fall of 2017, 2018, and 2019. Trail Creek is a tributary stream to the Big Wood River with a confluence near the town of Ketchum, Idaho (Figure 1). The purpose of the seepage surveys was to determine and attempt to quantify streamflow gains or losses that occur within this section of the creek in support of the Big Wood Ground Water Flow Model that was recently developed in the Big Wood River basin.

Figure 1. Map of Trail Creek

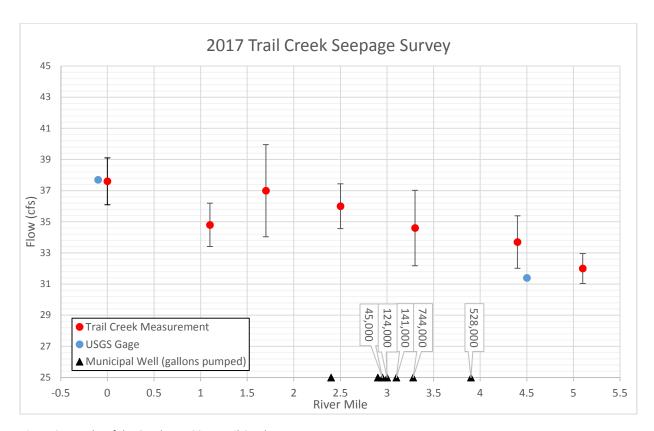
Figure 2. Results of the October 4, 2017 Trail Creek seepage survey.

Flow rates during the 2017 seepage run were approximately 35 cubic feet per second (cfs), the highest of the three seepage runs. The higher flows of the first run resulted in a noticeable amount of leaf material and debris suspended in the water column, and yielded slightly higher than the average uncertainty in the individual flow measurements. However, measurements collected near the USGS gage stations indicated results close to the reported USGS values (Figure 2).

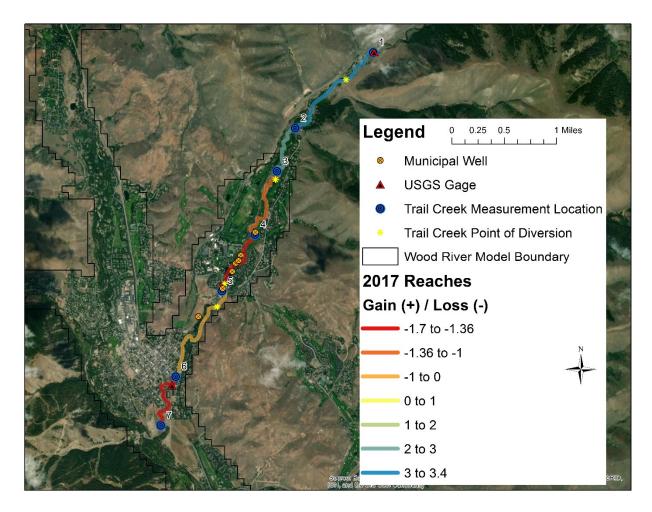
Figure 3. Map of October 4, 2017 seepage results.

Overall, the measurements from the 2017 seepage run indicate that Trail Creek is a losing reach within the model boundary from measurement location 3 to 7 (Figure 3). Upstream of the model boundary, measured Trail Creek flows indicate this reach was gaining during the seepage run. However, due to the uncertainty in the measurements with respect to the magnitude of the flow changes, gains or loses cannot be quantified with confidence.

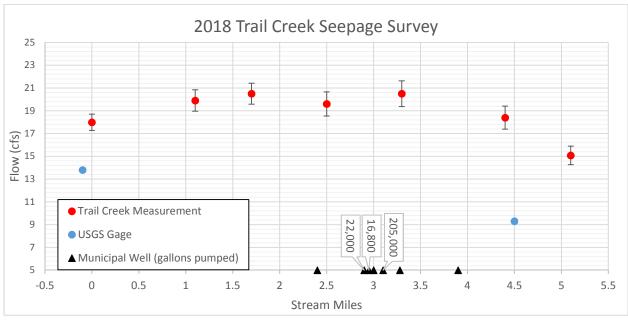
Figure 4. Results of the November 7, 2018 Trail Creek seepage survey.

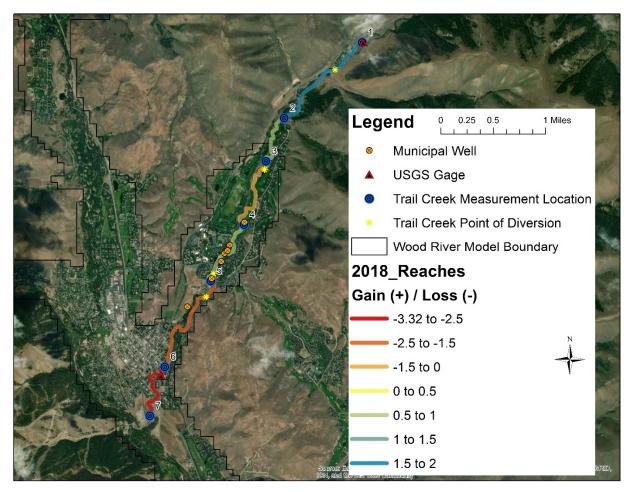
Figure 5. Map of November 7, 2018 seepage results.

Overall, the measurements from the 2018 seepage run indicate that Trail Creek is a losing reach within the model boundary between measurement locations 5 to 7 (Figure 5). Upstream of these measurements, Trail Creek appears to been gaining during the seepage run. Due to the uncertainty in the measurements with respect to the magnitude of the flow changes, gains or loses cannot be quantified with confidence above measurement location 5.

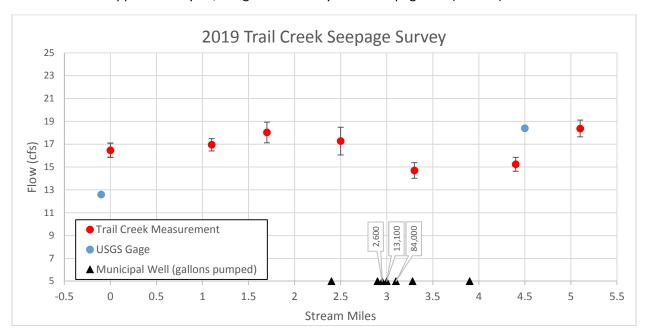
Figure 6. Results of the November 22, 2019 Trail Creek seepage survey.

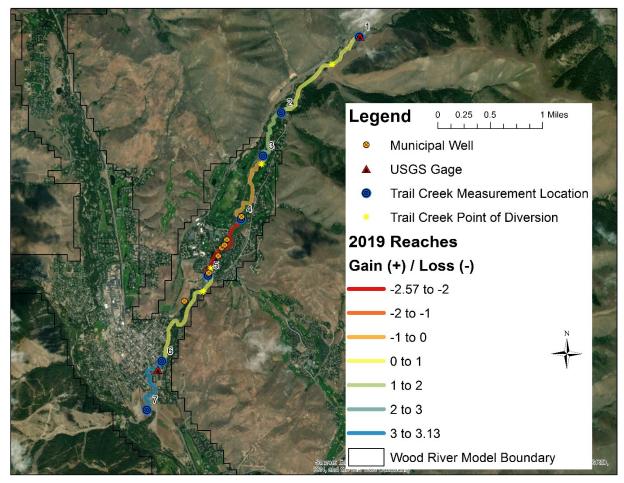
Figure 7. Map of November 22, 2019 seepage results.

Overall, the measurements from the 2019 seepage run indicated that Trail Creek is a losing reach within the model boundary between measurement locations 3 and 5, and gaining within the model boundary between measurement locations 5 and 7 (Figure 7). Upstream of the model boundary, Trail Creek appears to have been gaining during the seepage run. Due to the uncertainty in the measurements with respect to the magnitude of the flow changes, gains or loses cannot be quantified with confidence.

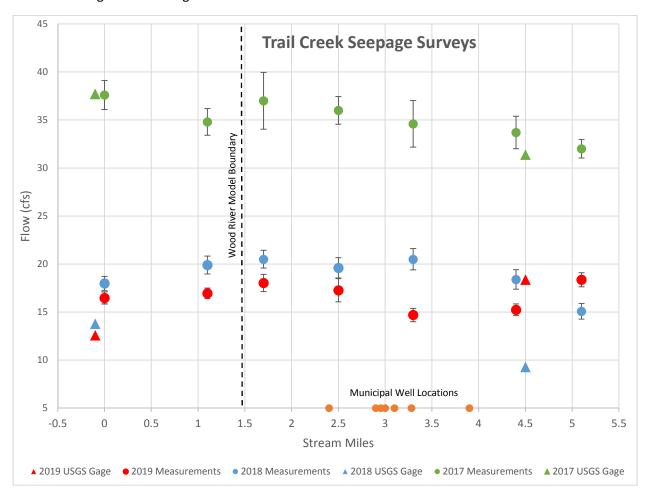
Figure 8. Results of 2017, 2018, and 2019 seepage surveys.

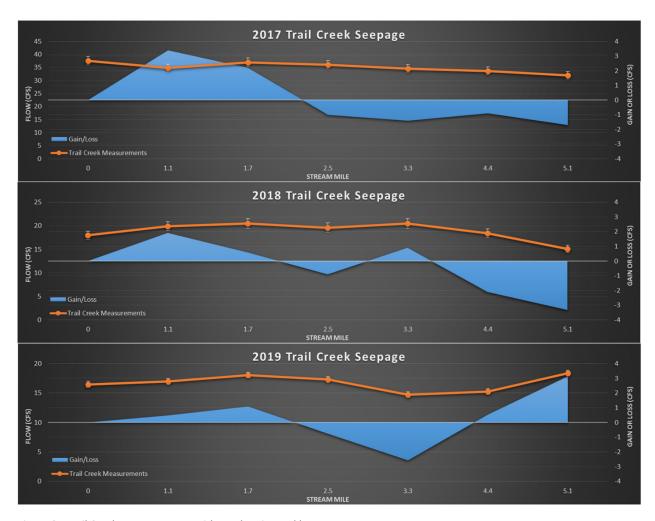
Figure 9. Trail Creek measurements with reach gains and losses.

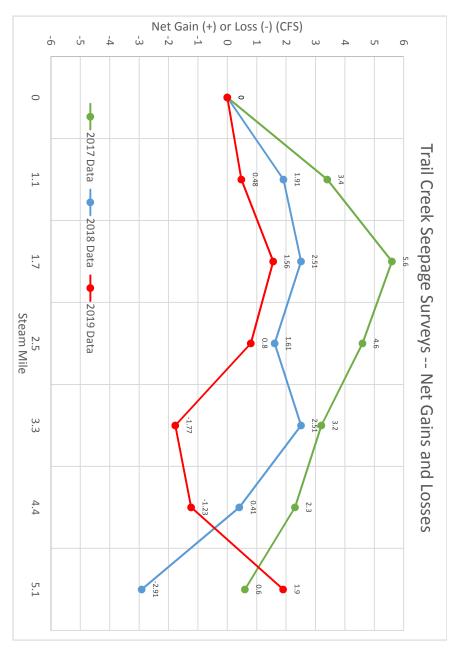
Figure 10. Net gains and losses of the three seepage surveys.

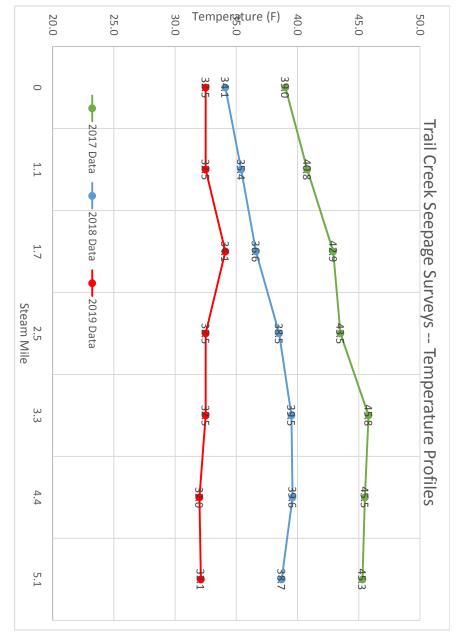
Figure 11. Temperature surveys of Trail Creek.

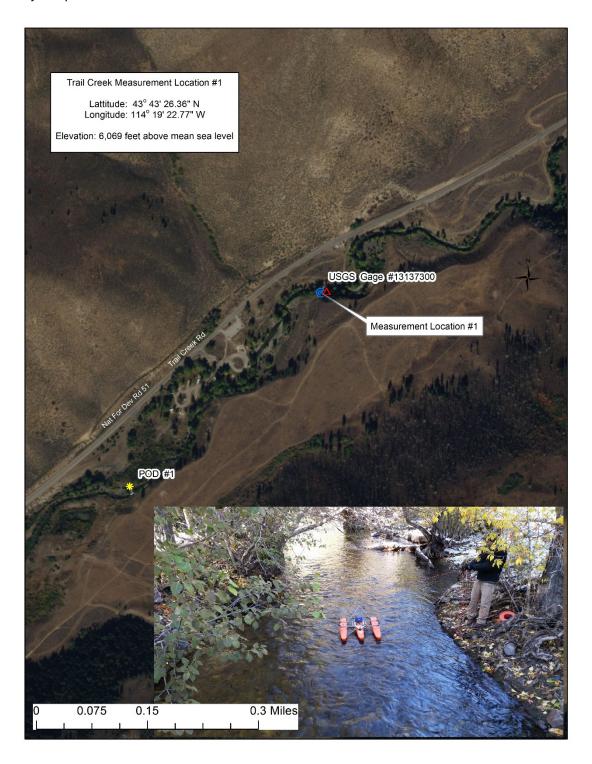
Figure 12. Map of Measurement Location #1

<u>Measurement Location #1</u>: Farthest upstream measurement site located at a footbridge across Trail Creek at the National Forest Service Boundary Creek Campground. USGS Stream Gage #13137300 was located just upstream.

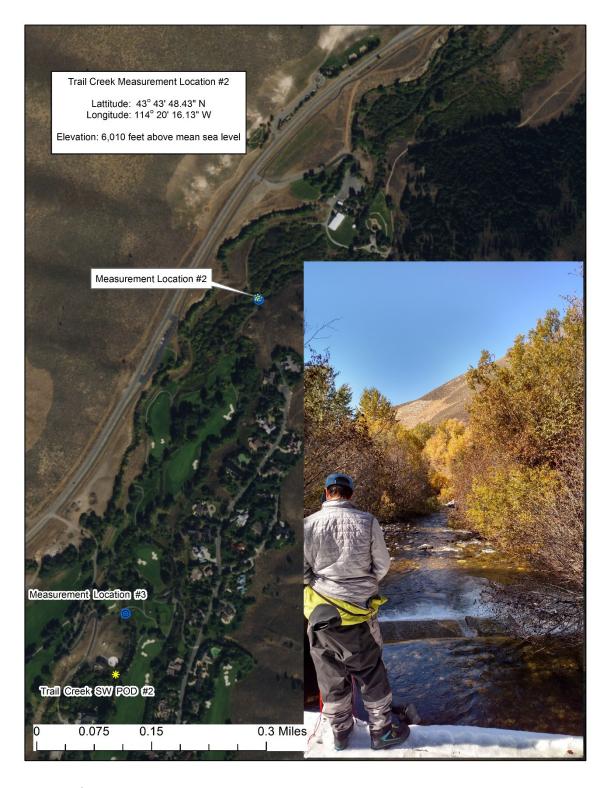
Figure 13. Map of Measurement Location #2

<u>Measurement Location #2</u>: Near the golf course restaurant at the northern end of the golf course property. A bridge across Trail Creek was selected as the measurement site.

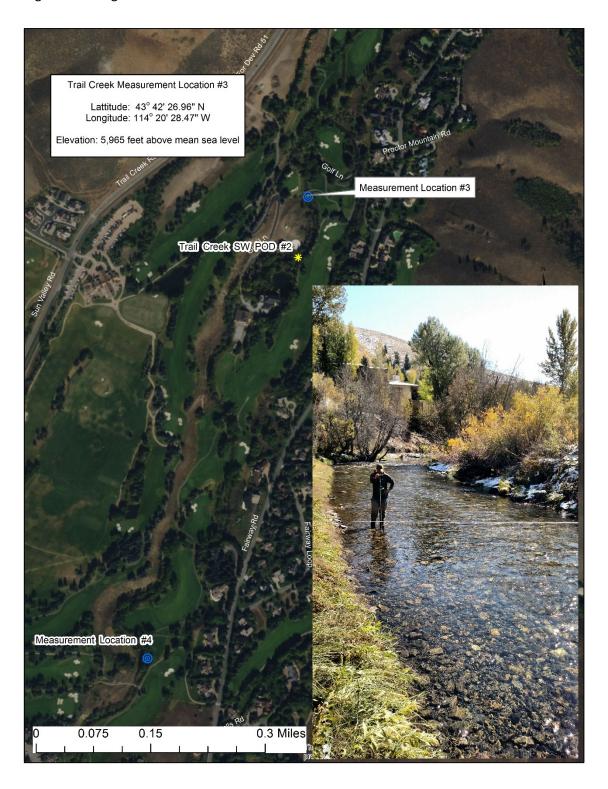
Figure 14. Map of Measurement Location #3.

<u>Measurement Location #3:</u> Located on the Sun Valley Golf Course and accessed off of Golf Lane approximately 0.5 miles downstream from Location #2. The measurement site was just downstream from a golf cart bridge across Trail Creek.

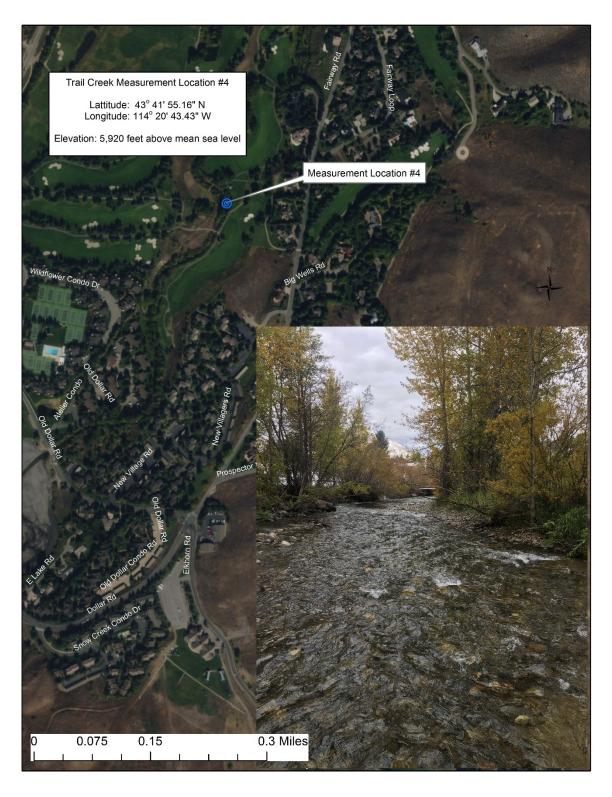
Figure 15. Map of Measurement Location #4.

<u>Measurement Location #4</u>: Located on the Sun Valley Golf Course with access via a golf cart bridge that crosses Trail Creek.

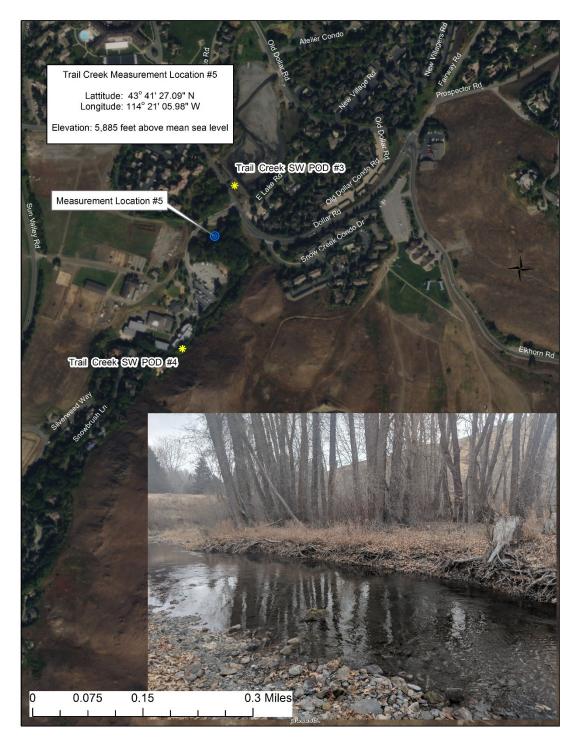
Figure 16. Map of Measurement Location #5.

<u>Measurement Location #5</u>: Downstream of the dam south of Sun Valley, approximately 0.6 miles downstream from Location #4.

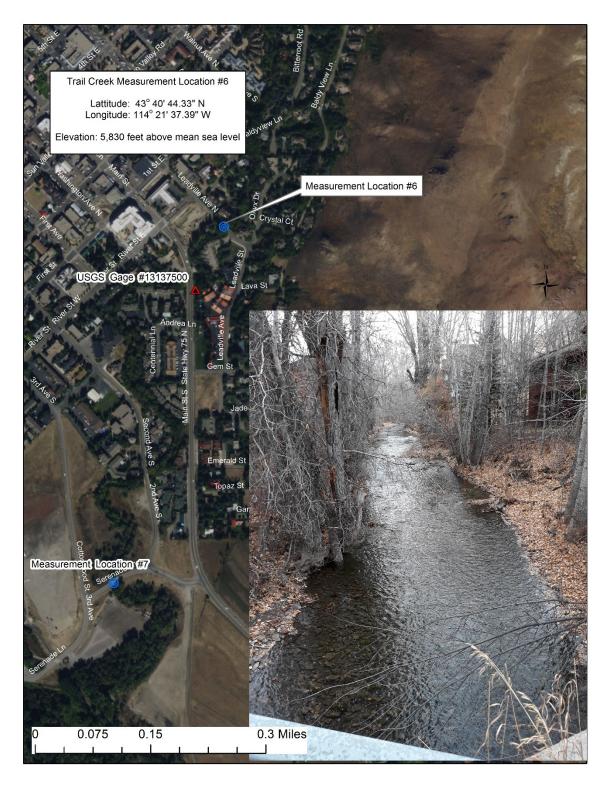
Figure 17. Map of Measurement Location #6.

<u>Measurement Location #6</u>: Located in the residential portion of the town of Ketchum, accessed at the bridge over Trail Creek on Leadville Road. This location was approximately 1 mile downstream from Measurement Location #5.

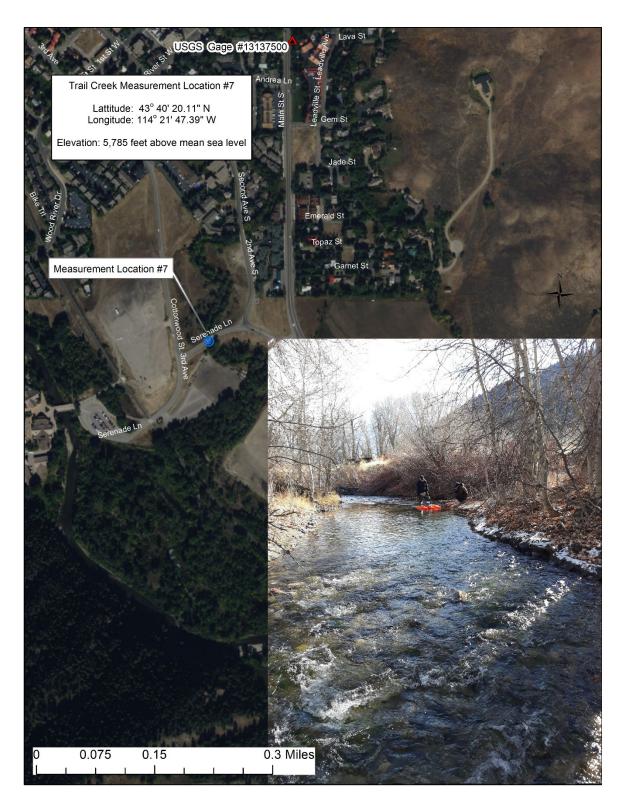
Figure 18. Map of Measurement Location #7.

<u>Measurement Location #7</u>: Near the mouth of Trail Creek and the Big Wood River, just downstream of the Serenade Lane Bridge that crosses Trail Creek.

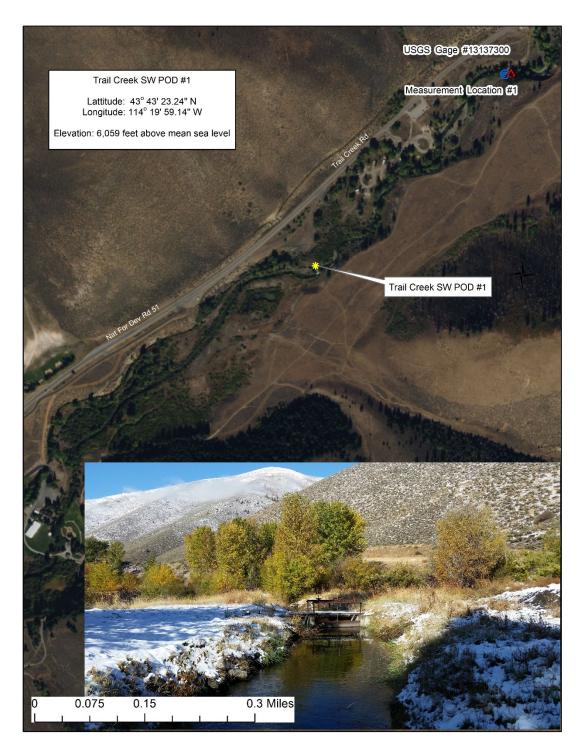
Figure 19. Map of POD #1

<u>POD #1 Location</u>: Approximately 0.5 miles downstream from the Boundary Creek Campground measurement location, a surface water diversion for the Sun Valley Golf Course was located (POD #1). This diversion was active and the flow rate near the head gate off of Trail Creek was measured at 6.2 cfs, measured using a Flow Tracker.
