Evidence supporting

Depleting the Deer Creek Aquifer

*A Rapid
Decline*

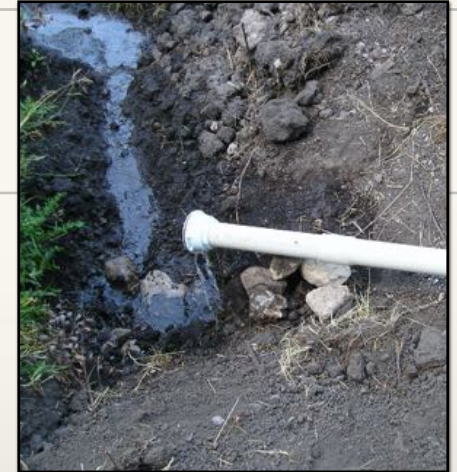
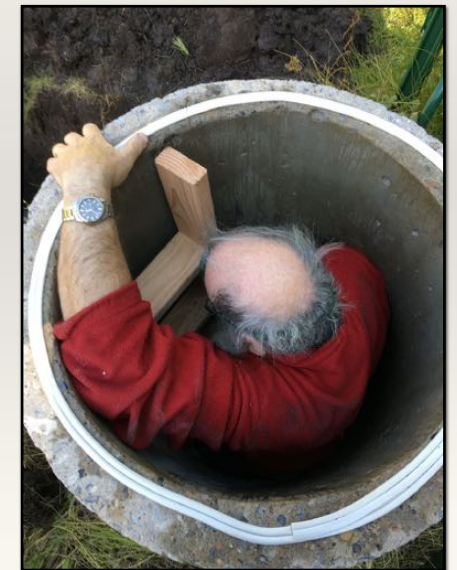
Is Spring Development at Fault?

- ❖ Development (more detail in supplemental slides)
 - ❖ Designed and constructed with professional engineering input.
 - ❖ Passed inspections by county, Dept of Health.
 - ❖ Granted water right by Idaho Dept. Of Water Resources (IDWR).
- ❖ System worked flawlessly 2006-2016.
- ❖ Maintenance & inspection (more detail in supplemental slides)
 - ❖ Little that can go wrong, gravity fed.
 - ❖ Summer 2019 in-depth inspection — everything as built.
- ❖ **Conclusion:** Due diligence for design & implementation.
Proper inspection, licensing, maintenance & operation.

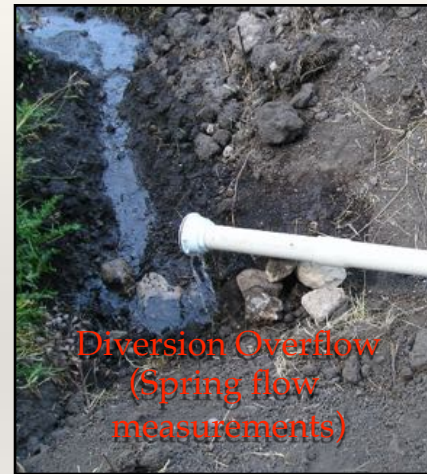
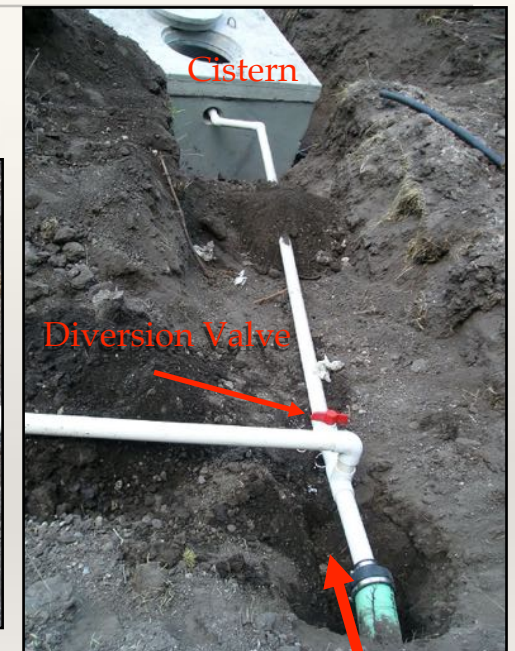
Flow from Spring Pool

Was the Lot 182 Spring Improperly Developed?

- ❖ Gravity fed from spring pool to cistern. Cistern (used to) overflow to Deer Creek. Pump up to cabin from cistern.
- ❖ Diversion of spring flow possible for inspection and measuring
- ❖ Development followed advice of John Beer, a licensed Civil Engineer with 50+ years experience in municipal and private water systems.
 - ❖ Development done by Gale Allred, DBA Eagle Excavating 2006.
 - ❖ Spring plumbing approved by Bannock County Plumbing Inspector Chris Critzer.
 - ❖ Spring development inspected and approved by S.E.I. Health Department.
 - ❖ The Idaho Department of Water Resources (IDWR) inspected the developed spring and **issued a water right**.
 - ❖ Since 2005 the Lot 182 spring has operated 24/7, 52 weeks a year. Met domestic needs until after 2016.
- ❖ **Conclusion:** Due diligence for design & implementation. Proper inspections/licensing performed.
