# Validation Study

Priest Lake Thoroughfare and Breakwater Replacement Study near Priest River, Idaho

for Bonner County Public Works

January 20, 2010

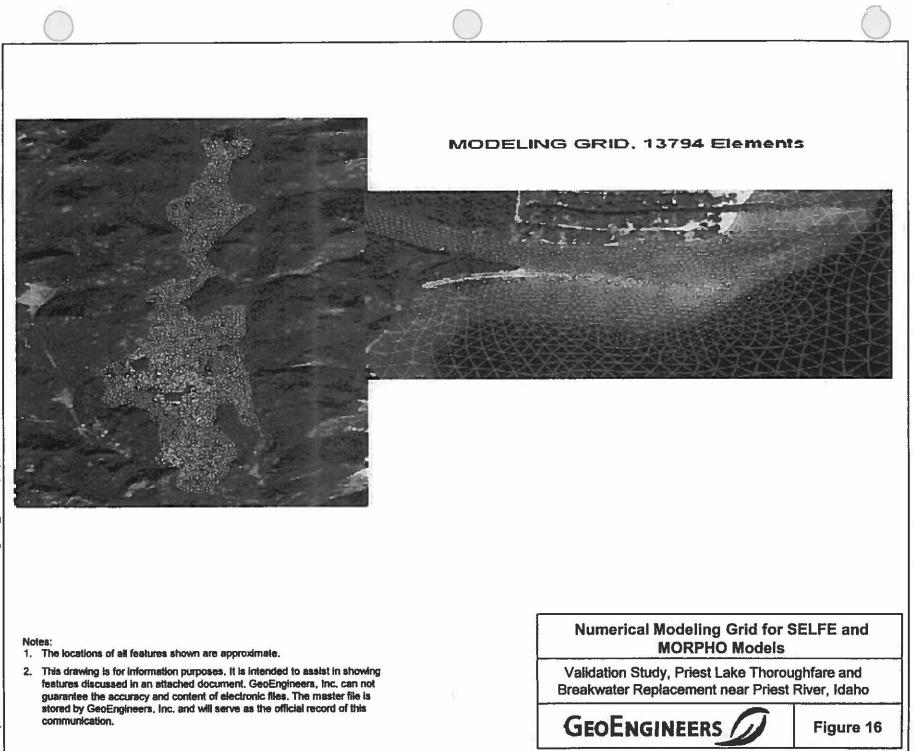
The modeling grid consisted of approximately 13,800 elements. In the vicinity of the project area, the modeling grid was refined to account for variable bathymetry and the porous Breakwater. The modeling was conducted for a compressed 1-year period. Variable, 10-year-averaged daily lake water surface elevations and 1994 daily measured Thoroughfare flow discharges were input to the model. Suspended sediment concentration in the Thoroughfare was input as a constant load. An example of the SELFE modeling results, with a snapshot of current velocities over the modeling domain, is shown in Velocity Model Results Example, Figure 17.

Figure 17 shows a plan-view of depth-averaged velocities over the modeling domain in color format. The color red corresponds to higher velocities, and blue corresponds to low or no velocities. The figure shows that flow with high velocities from the Thoroughfare dissipates along the channel and Breakwater. A significant amount of flow transmits through the porous Breakwater. In other words, the energy of the flow dissipates along the Breakwater. At the end of the Breakwater, flow velocities (and kinetic energy) are reduced dramatically, which results in deposition of suspended sediment and a reduction of flushing capacity of the flow. It is likely that the effect of the flow dissipation (and flow energy) has been exacerbated by the scouring of the high ground and undermining of the breakwater. The flushing effect of the Thoroughfare flow was probably historically stronger, allowing the channel to continue to self scour.
