SUMMARY OF HYDROLOGIC CONDITIONS
IN THE
MOUNTAIN HOME AND CINDER CONE BUTTE
AREAS

By
Shane Bendixsen

April, 1994

IDAHO DEPARTMENT OF WATER RESOURCES
BOISE, IDAHO

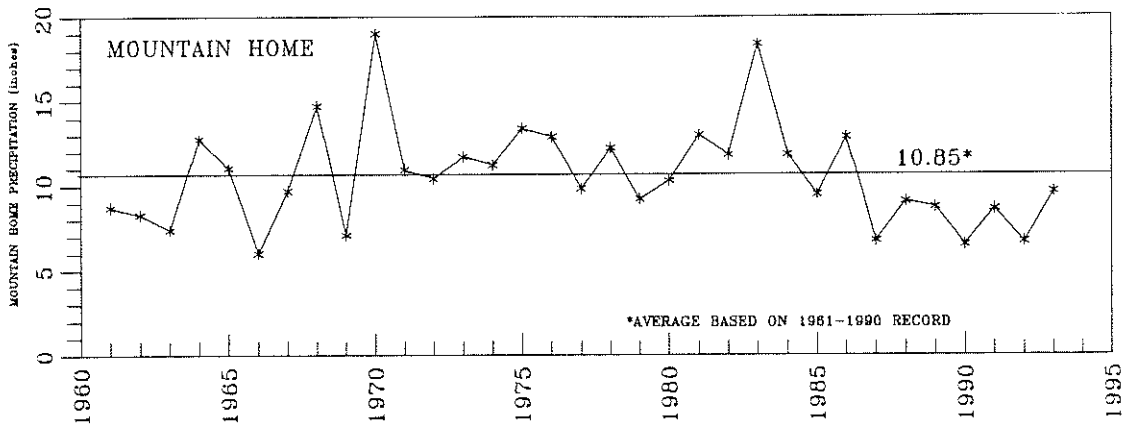
Figure 3. Precipitation and Snow Course Data

Figure 3, "Precipitation and Snow Course Data", presents data for precipitation in Mountain Home and snow at the Camas Creek Divide. As presented, the data for Mountain Home readily shows the recent drought, but no overall trend is seen. When the cumulative departure is taken for the same data though, a steady increase or rise is seen from the mid to late 1960's until approximately 1986 or when the recent drought began. Snow course data at the Camas Creek Divide shows the same trend.

feet over the past 25 to 30 years. The 1987-92 drought did not interrupt the rise. The same general trend is seen in Figure 3, (previously mentioned) for cumulative departure with snow and precipitation data.

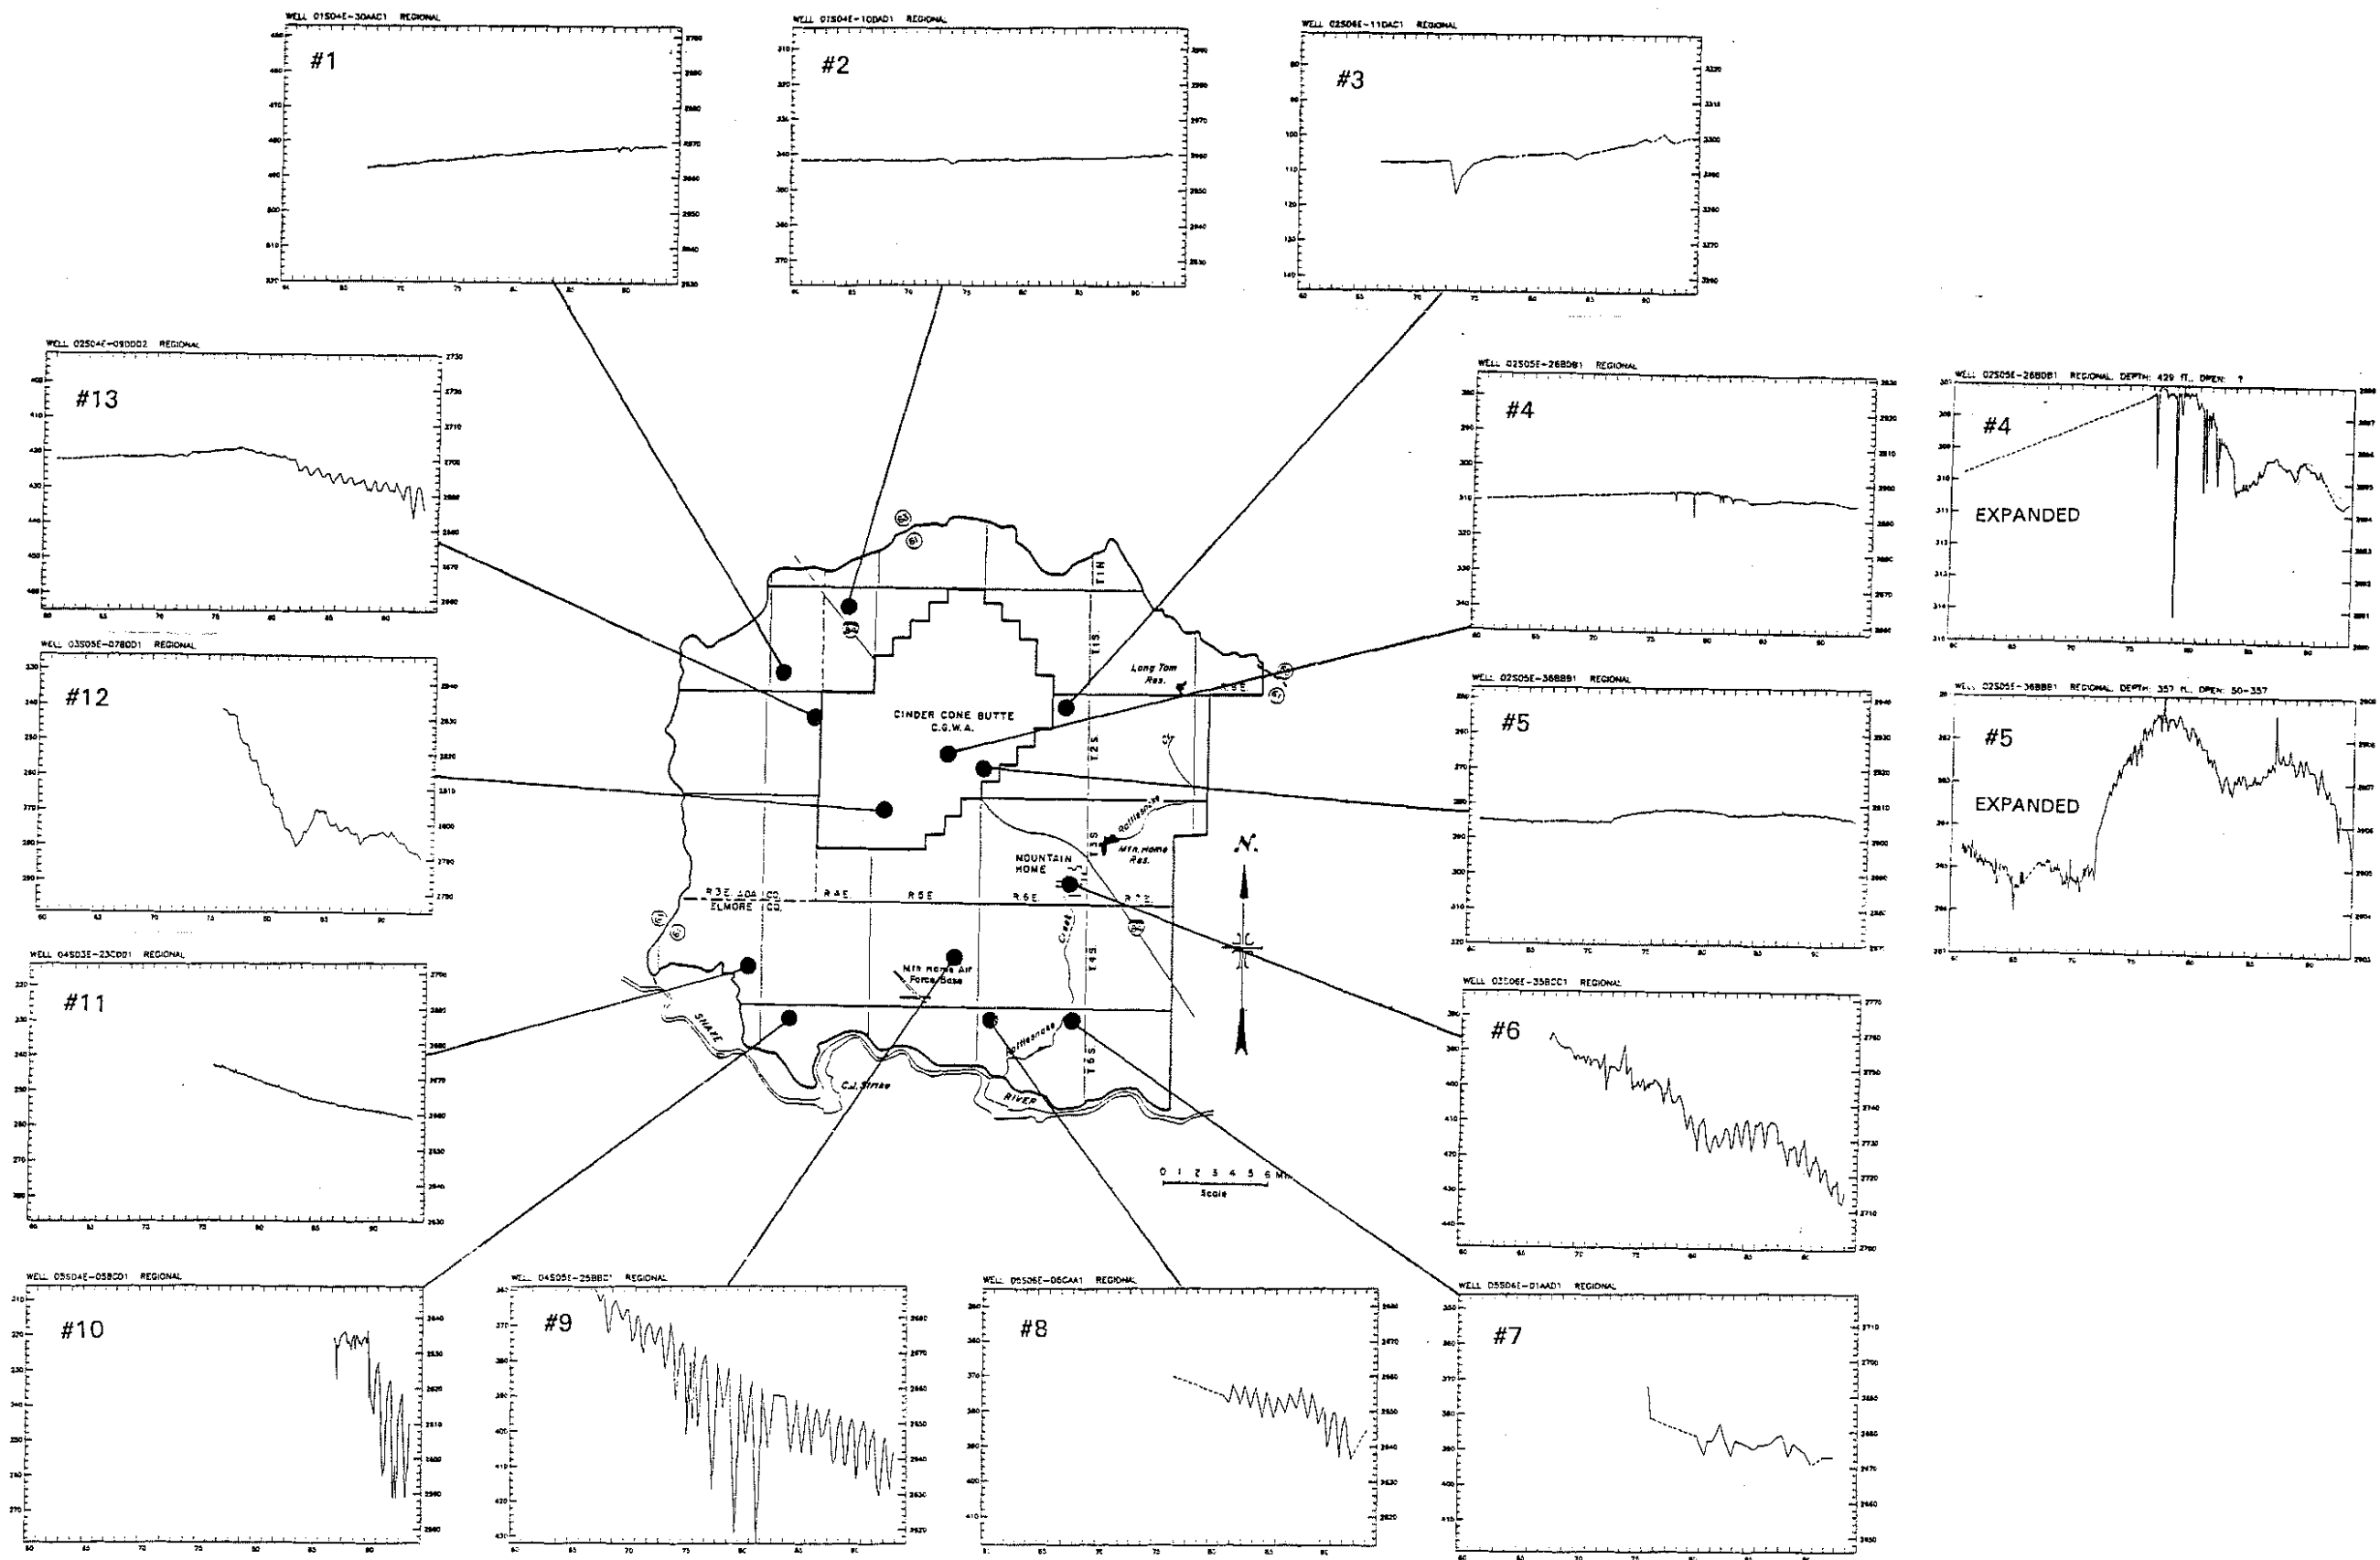
Figure 9. Regional Hydrographs

Figure 9, "Regional Hydrographs" presents hydrographs for 13 wells monitoring the regional system. These wells were chosen as being the most representative. All hydrographs cover the same time period and with the same vertical scale. Hydrographs #4 and #5 are also presented with an additional expanded vertical scale.

In the most northern part of the GWMA hydrographs (labeled #1, #2, and #3) show rising ground water levels of approximately 2 to 8
