SUMMARY OF HYDROLOGIC CONDITIONS
IN THE
MOUNTAIN HOME AND CINDER CONE BUTTE
AREAS

Shane Bendixsen

April, 1994

IDAHO DEPARTMENT OF WATER RESOURCES
BOISE, IDAHO

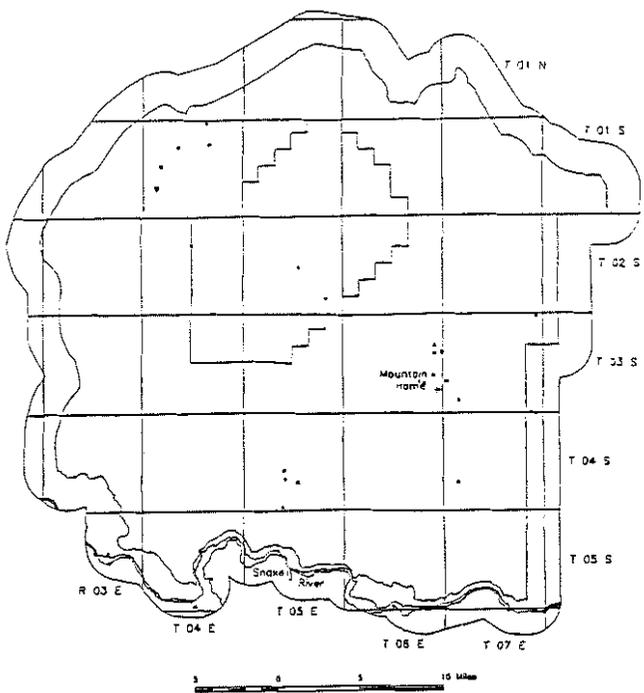
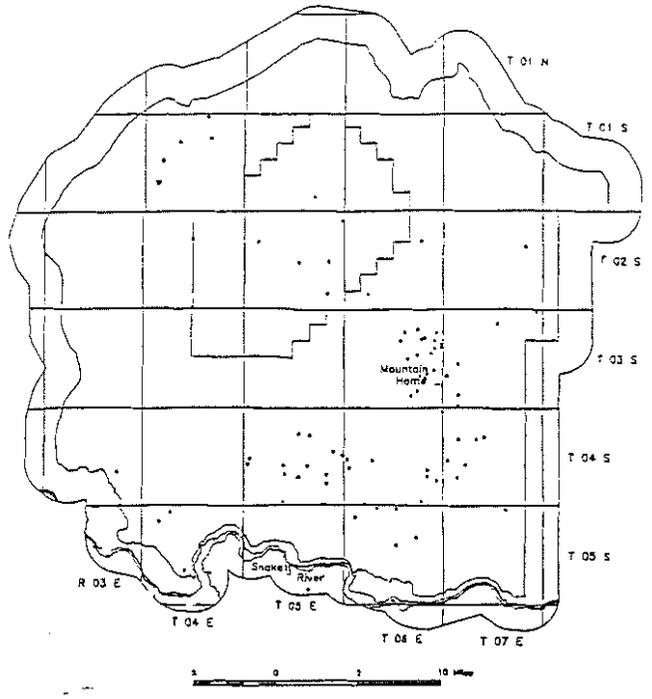
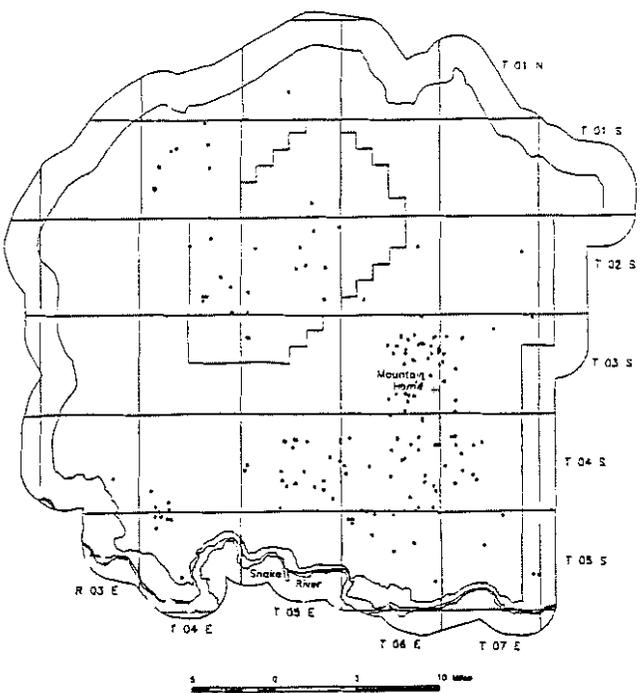
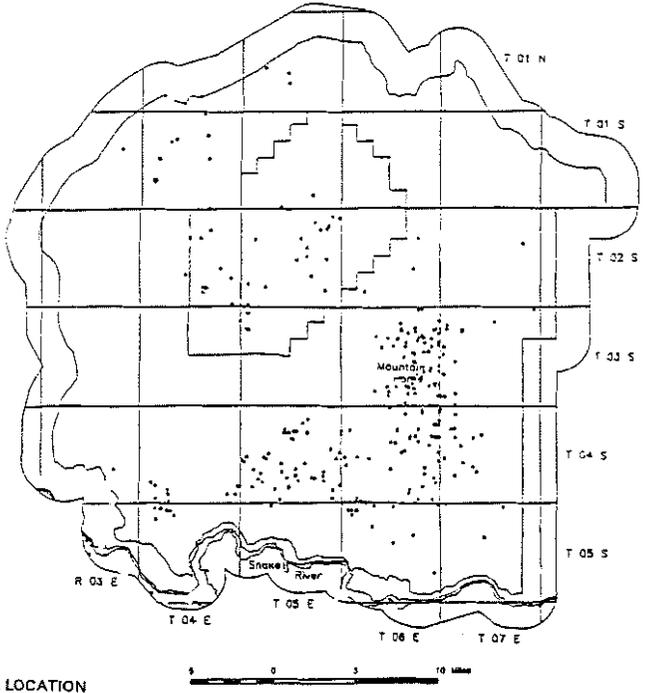
Figure 2. Ground Water Development

1960

1970

1980

1993

SOURCE: IDWR DATA BASE FILE
USGS GROUND WATER SITE INVENTORY FILE

Agriculture and the Air Force Base are the primary industries. Ground water development for agriculture has primarily taken place in the southern and northwestern regions. Development for domestic use is primarily in the area in and surrounding Mountain Home. Figure 2, "Ground Water Development" indicates rates and locations of ground water development by the amount of wells as identified in the USGS and IDWR data bases.

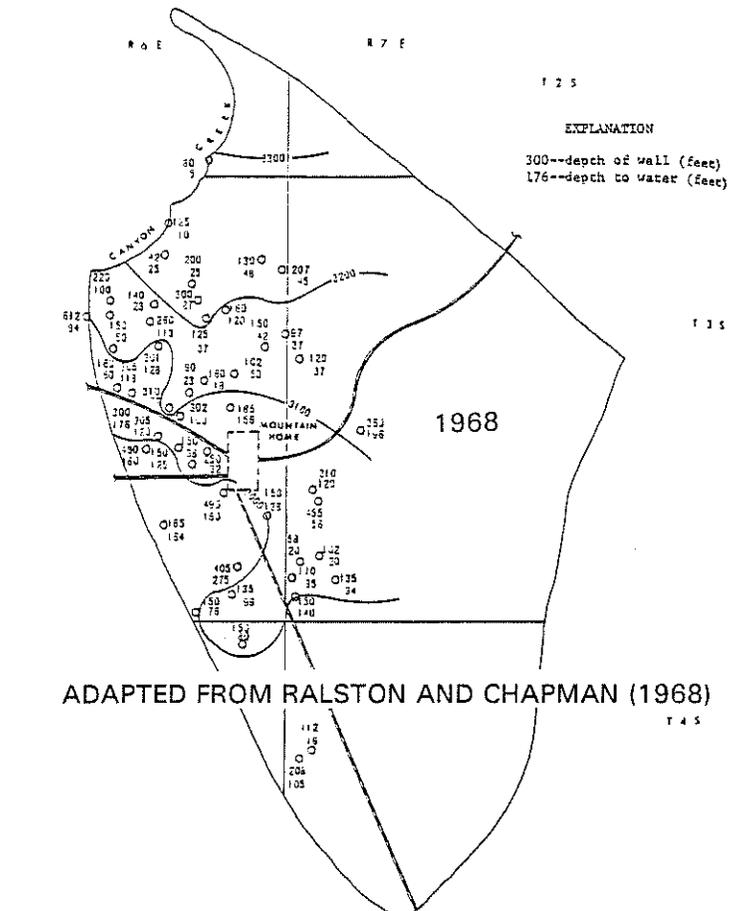
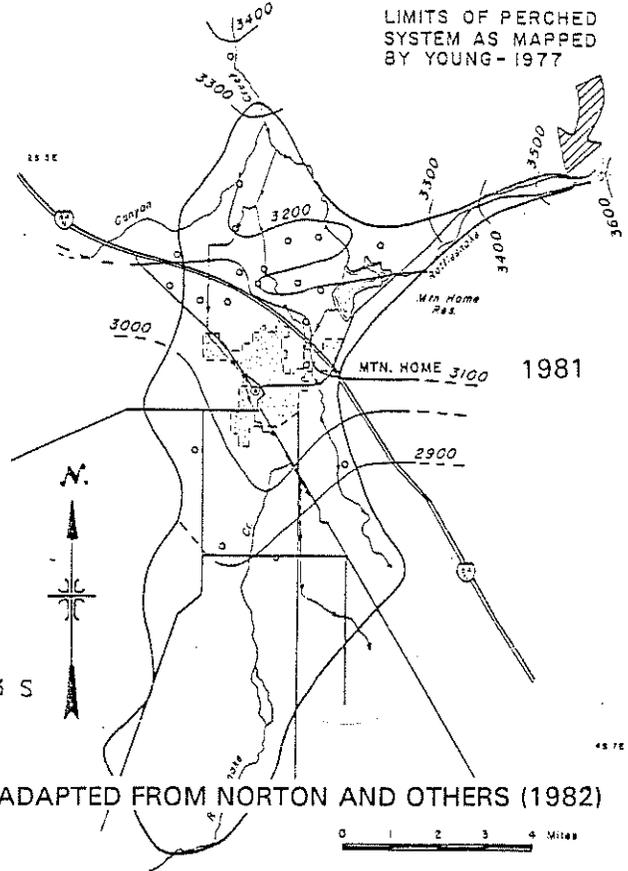
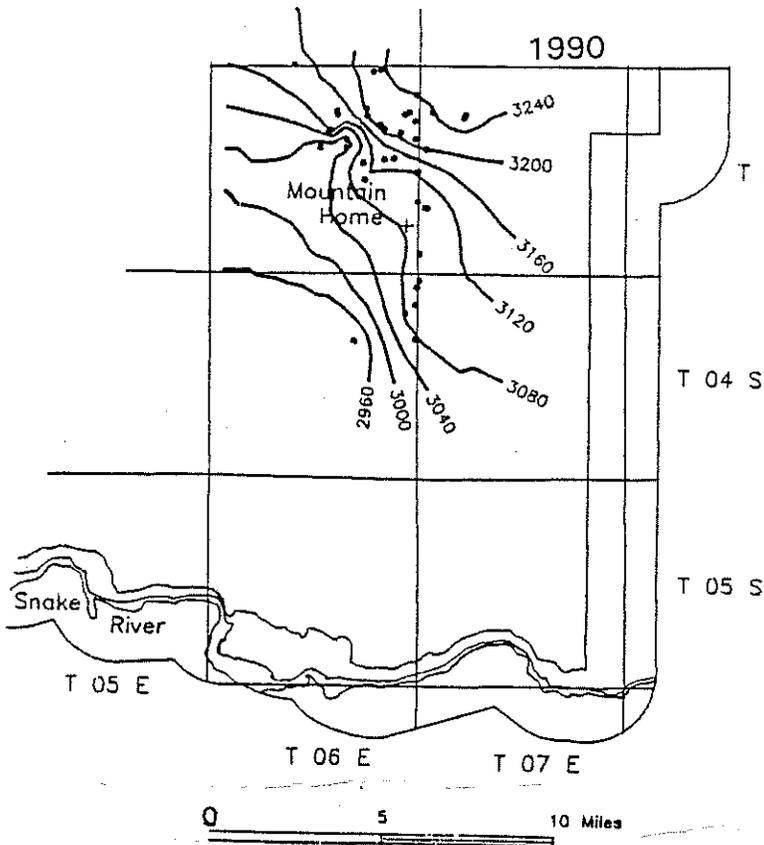
Figure 6. Perched System

ADAPTED FROM RALSTON AND CHAPMAN (1968)

ADAPTED FROM NORTON AND OTHERS (1982)

Figure 6, "Perched System" presents elevation contours for the perched system from data generated in 1968, 1981, and 1990. As presented the contours have not changed to any large degree from 1968 to 1990. The slight deviations seen are most likely related to the different data sets used (ie, not all measurements came from the same wells and some data may reflect pumping levels). Therefore, some deviation between the three data sets would be expected. In any event, no significant change in flow direction or gradient has occurred from 1968 to 1990.
