# ANNUAL SUMMARY OF GROUNDWATER CONDITIONS IN THE SOUTHEAST BOISE GROUNDWATER MANAGEMENT AREA CALENDAR YEAR 2022

Prepared by Gus Womeldorph 5/11/2023

This report describes the groundwater conditions in and around the Southeast Boise Groundwater Management Area (GWMA) based on the groundwater level observation network established in the spring of 2000 under the guidance of the Southeast Boise Groundwater Advisory Committee (Advisory Committee). The network is a cooperative effort among Micron Technology, Inc., Veolia Water Idaho, Inc., and the Idaho Department of Water Resources (IDWR). The cooperators submit water level data to IDWR and/or provide support and access to wells for monitoring. The data is maintained in the IDWR groundwater database. The J.R. Simplot Co., City of Boise, Sunroc Corp., Idaho Transportation Department, Idaho Department of Lands, Boise Gun Club, and other landowners provide access to wells within the monitoring network.

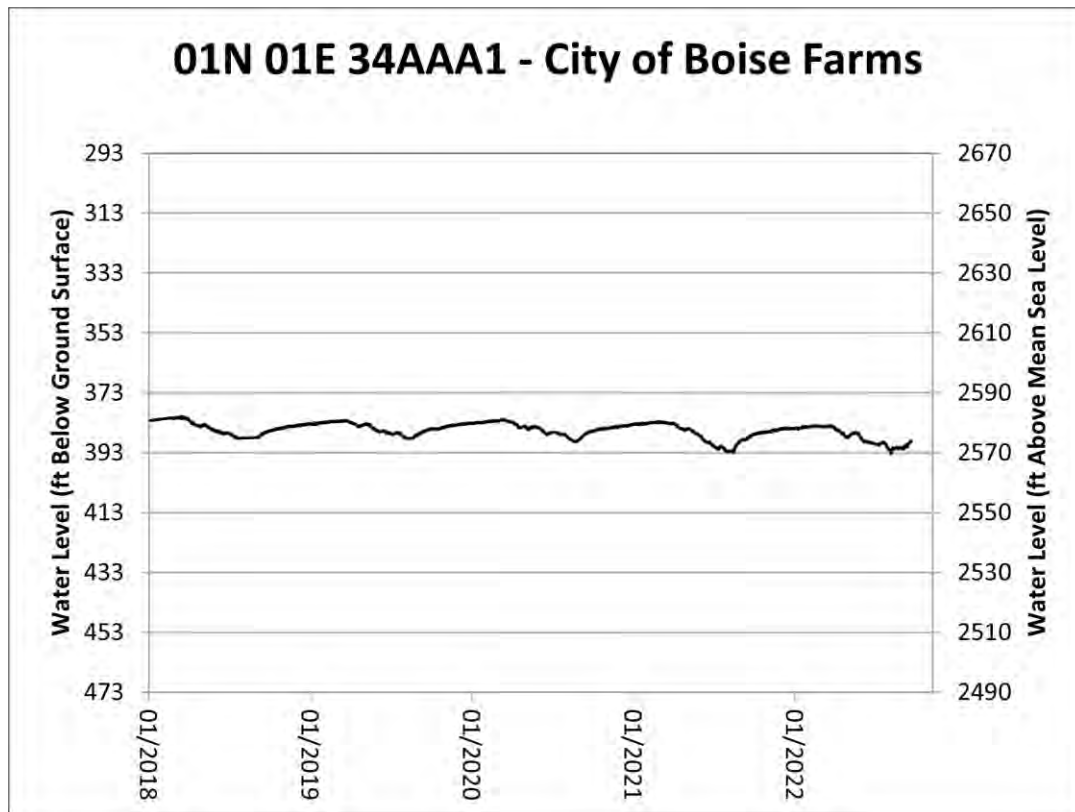
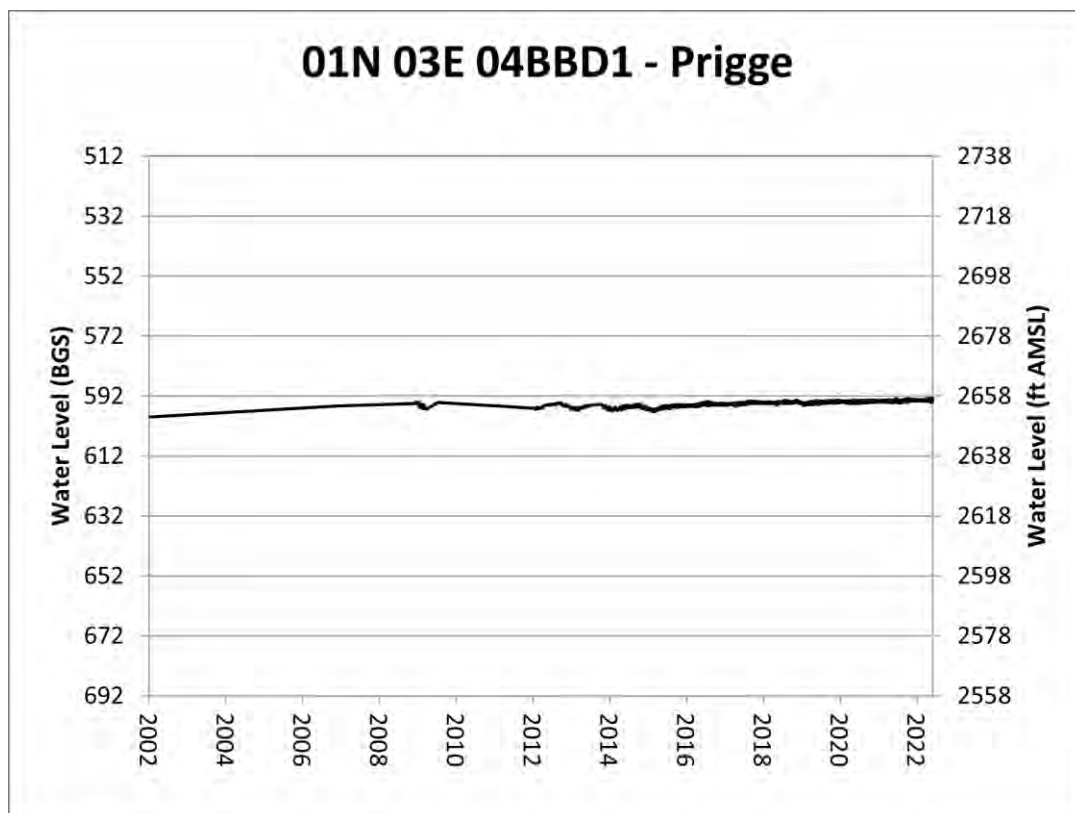
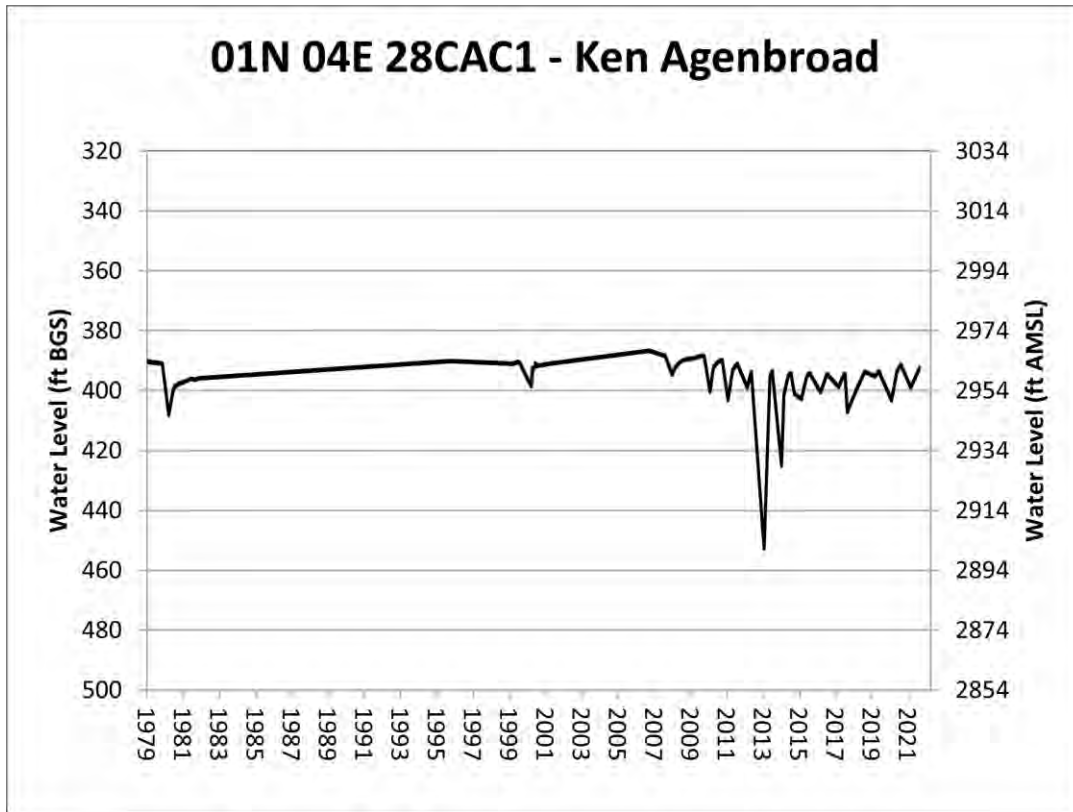
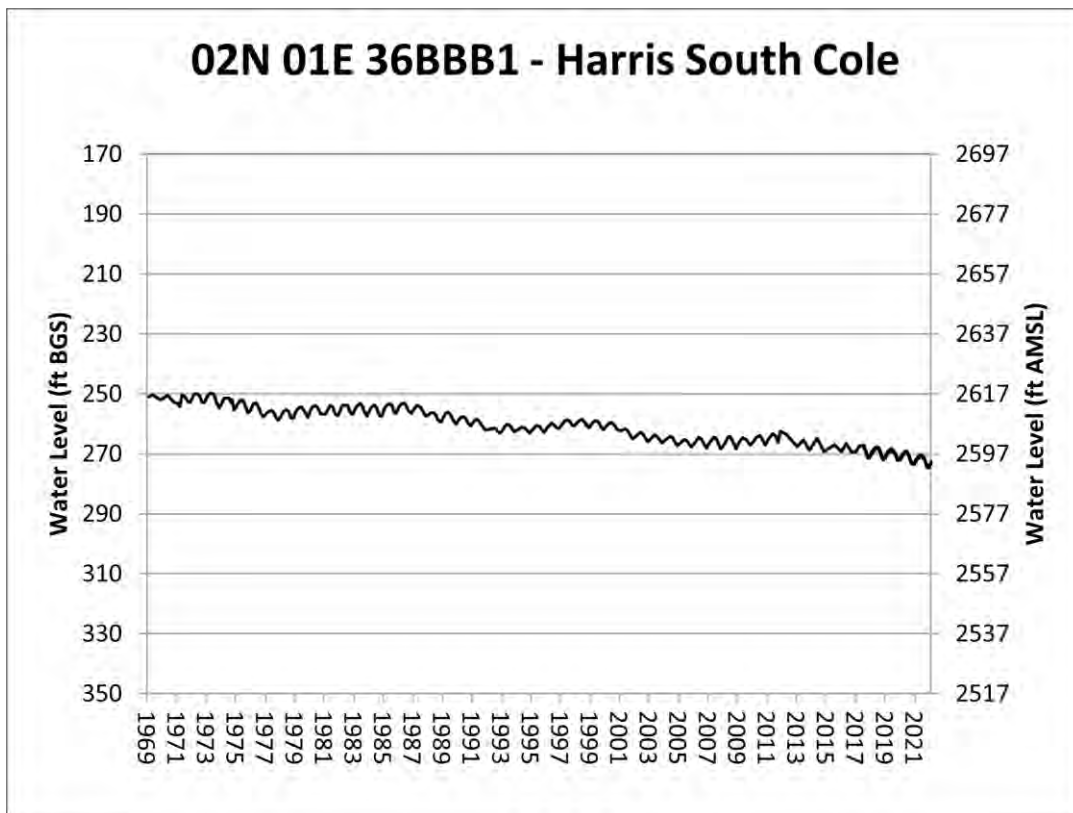
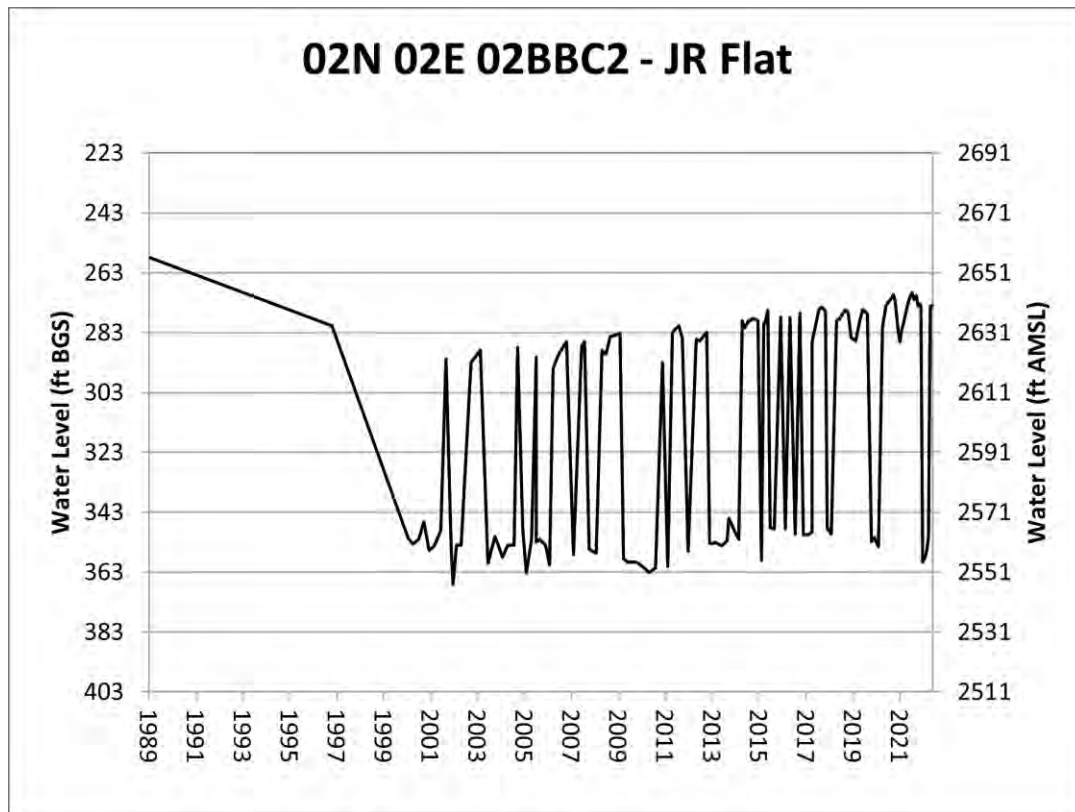
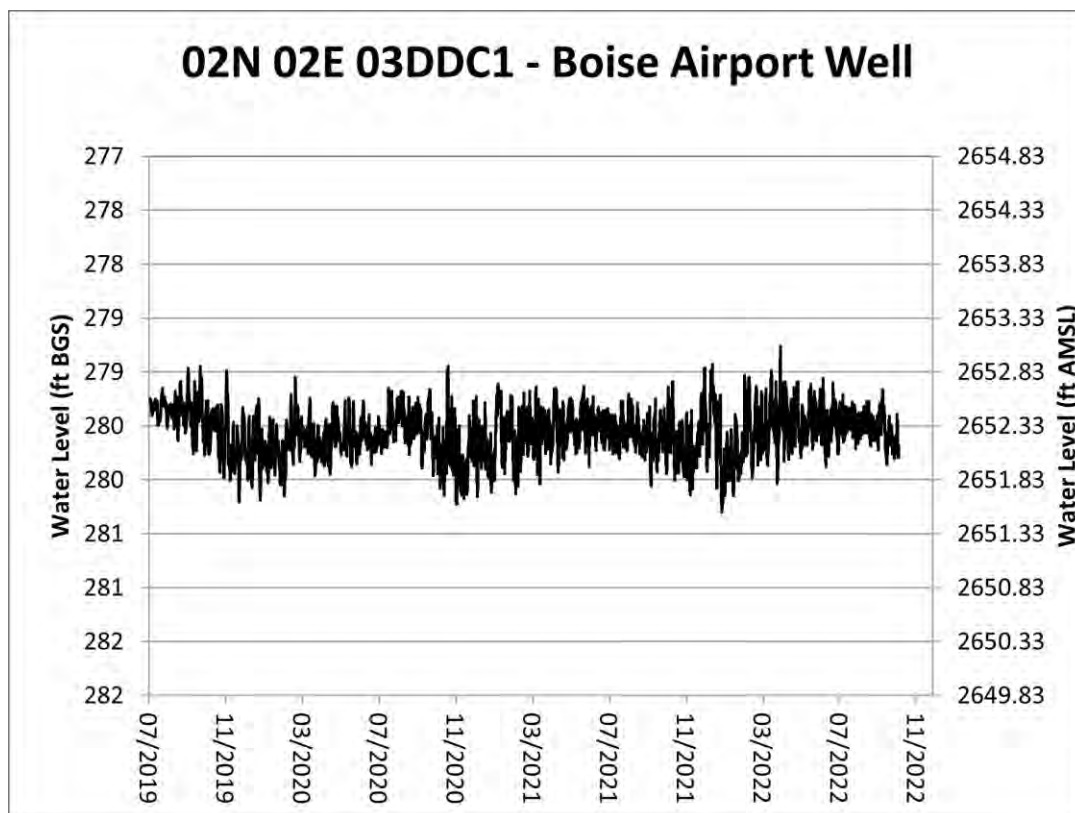
# Hydrographs for Active Monitoring Wells

Groundwater level hydrographs showing the complete period of record through December 31, 2022, for active wells in the monitoring network are shown in **Appendix C**. Groundwater level hydrographs displaying data only for the period from January 1, 1990, to December 31, 2022, for all active monitoring wells are shown in **Appendix D**. All available data has been included in this report. Several wells are subject to significant seasonal trends and/or pumping effects, which can make it difficult to draw meaningful conclusions from the hydrographs. Similarly, nearby pumping and/or management changes may impact apparent water level trends. Periodic data collection in wells lacking continuous measurements from pressure transducers can make it difficult to conclude trends due to the uncertainty regarding the seasonal peaks and troughs of the hydrographs relative to the instantaneous manual measurements. The magnitude of the observed water level changes can also be such that determining trends independent of factors such as systematic and random errors can be challenging. All qualitative and quantitative analyses should recognize the limitations of the data as well as the associated uncertainties. Qualitative trends have been completed for each well in the network, and Mann-Kendall trend analyses have been completed for each well with at least four years of fall measurements.
