Eighteenmile Creek Seepage Study

August 26-28, 2008

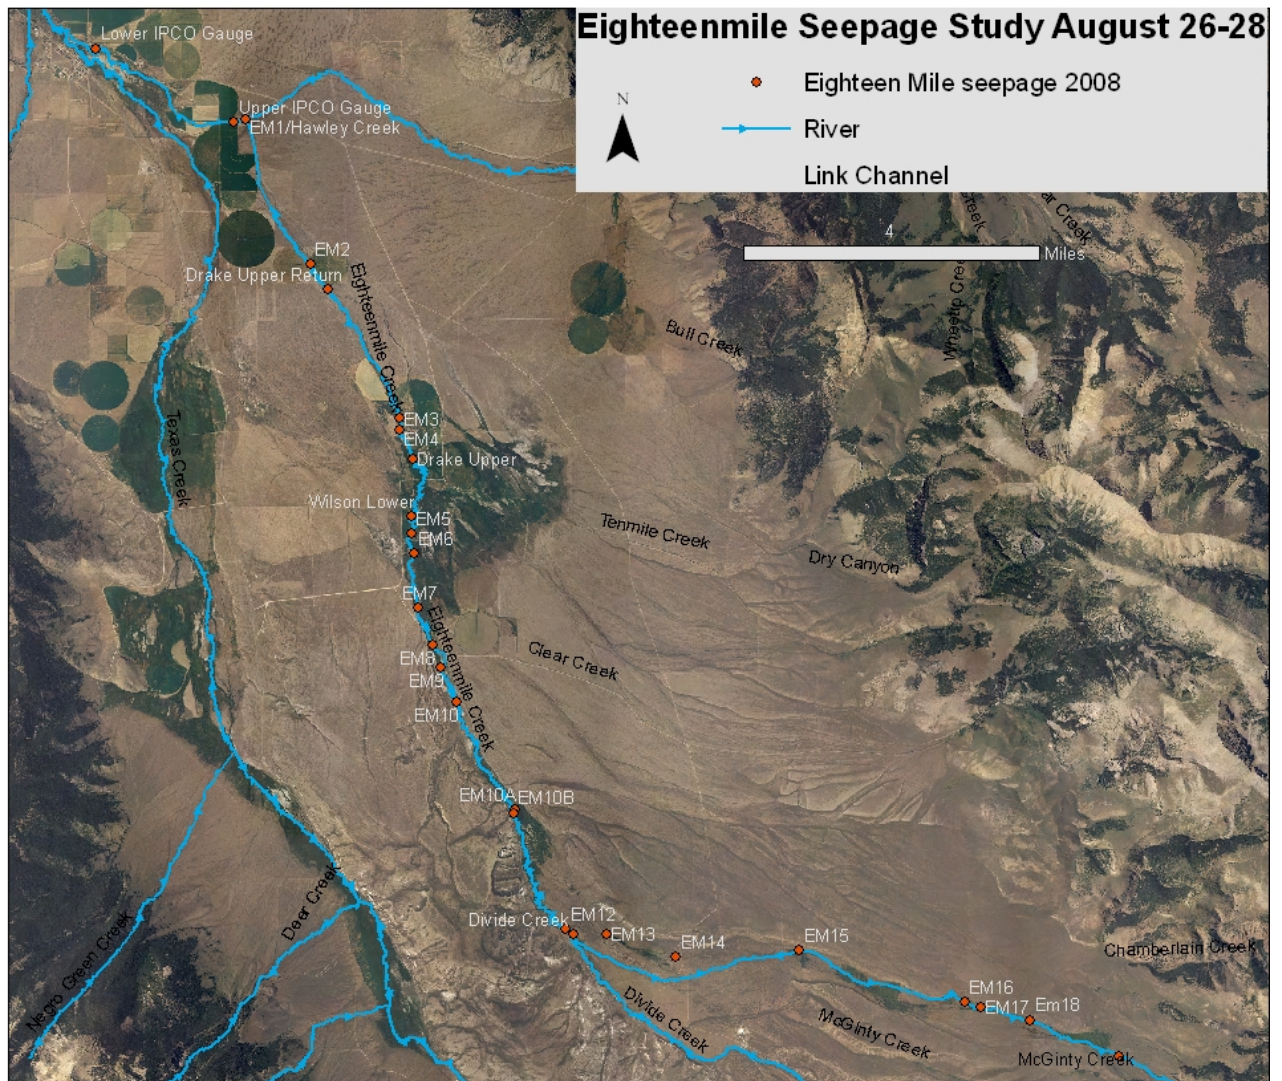
Figure 1. Map of Eighteenmile Creek with important surface water features labeled.

Above all diversions, Eighteenmile Creek flows out of a steep, confined mountain reach into a willow complex on BLM land (Figure 1). The stream flow was measured at 2.2 cfs near the upper most diversion, EM19, which was off. The uppermost four diversions were off during the three day seepage study; these-diversions are probably only used during high flows. Eighteenmile Creek gains 1.3 cfs before the first active diversion EM15 diverts 0.3 cfs. The riparian area along the stream changes in this reach as well with less willows, a smaller channel, and a loss in flow (1.3 cfs from EM16 to EM13).. From EM13 to above EM10A and EM10B the stream gained 3.7 cfs; we did not visit Divide Creek nor did we see the EM12 diversions but were told by the landowner that both were dry. For the upper part of the Eighteenmile Creek we relied on Mr. Whittaker to locate the channel and diversions.
