# Priest Lake Water Management Study

Work Progress Briefing – 9/18/2017

IDAHO WATER RESOURCE BOARD

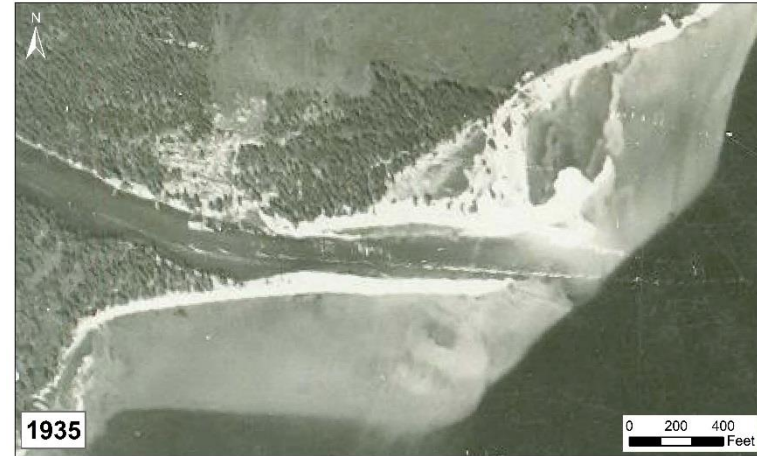
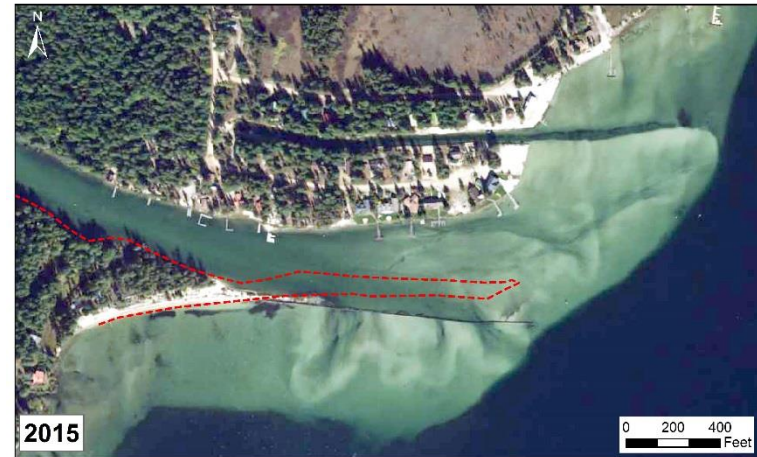
# THOROFARE HISTORY

- Historical aerial imagery suggests that alignment of Breakwater was different in 1935 and Thorofare mouth was narrower
- Widening the Thorofare mouth is likely to have reduced the flow velocities and subsequently sediment transport capacity of Thorofare

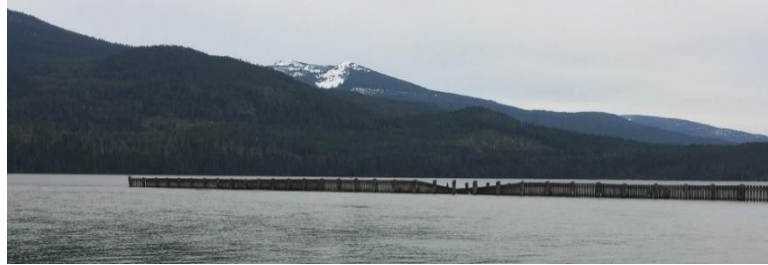
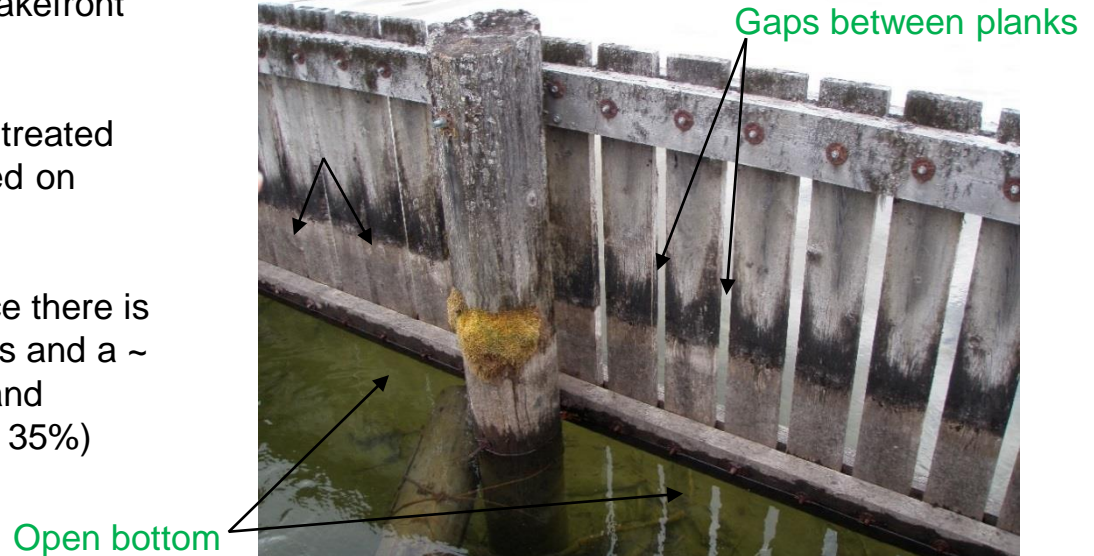
# THOROFARE BREAKWATER

- Original timber pile breakwater (BW) was constructed by USFS to facilitate access to Thorofare in 1933 (IMR 1989)
- Currently, breakwater serves an additional function of providing wave shelter to lakefront properties in Sandpiper's Shore
- Breakwater structure composed of untreated timber piling and plank boards installed on cross-reams
- Breakwater is considered porous since there is a ~ 1-in gap between the plank boards and a ~ 10-in gap between bottom of planks and Thorofare bed (BW porosity ~ 20% to 35%)

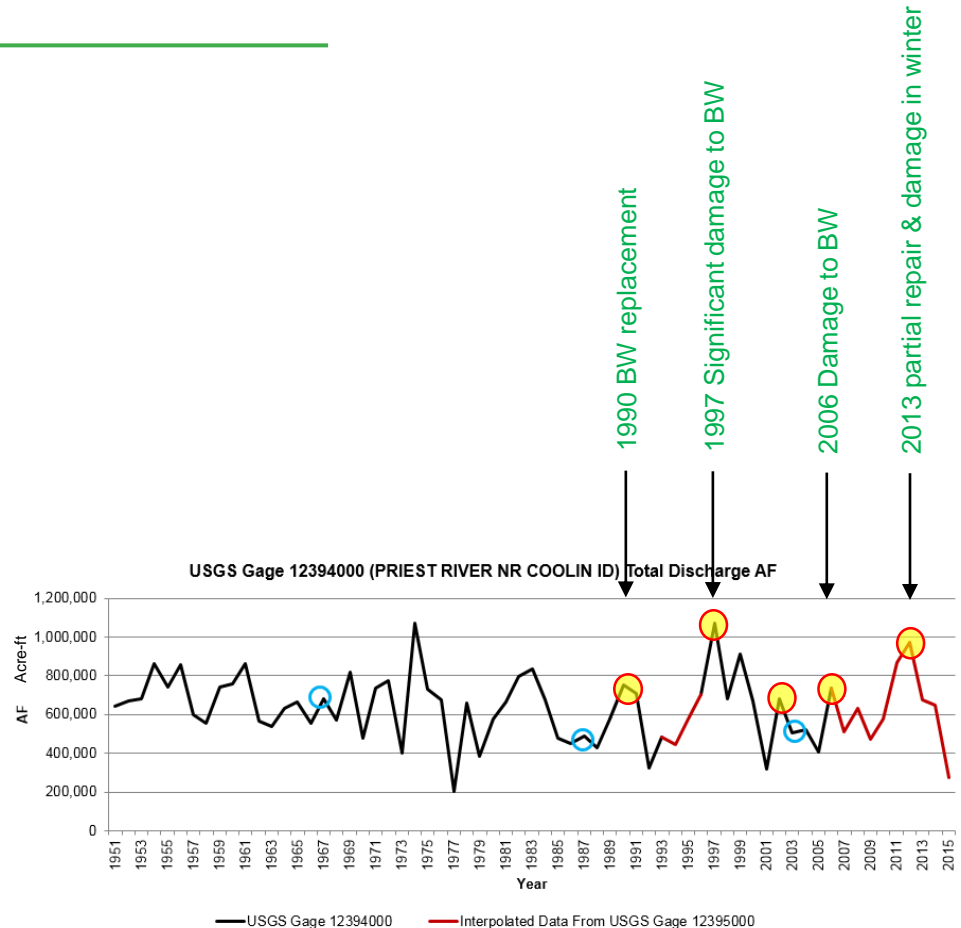
# BREAKWATER HISTORY

- 1920's: Original timber pile breakwater (BW) constructed
- 1980: Easternmost 200 ft of BW was replaced
- 1990: BW replacement by InterMountain Resources
- 1997: Partial repair after damage due to spring runoff
- 2006: Partial repair after damage due to spring runoff
- 2013: Longer plank boards (14' vs. old 8' boards) were installed in solid ground. However, the flow in the subsequent winter scoured the bed underneath the boards. (Source: Copper Bay Construction Co.)

- Damages to breakwater have occurred approximately every 7 to 10 years, resulting in need for (partial) repair
- Non-engineered repairs of breakwater have not withstood strong spring run-offs/ice forcing

- Service life of breakwater ~ 30 to 40 years with periodic repairs
- Portions of Breakwater currently nearing end of service life

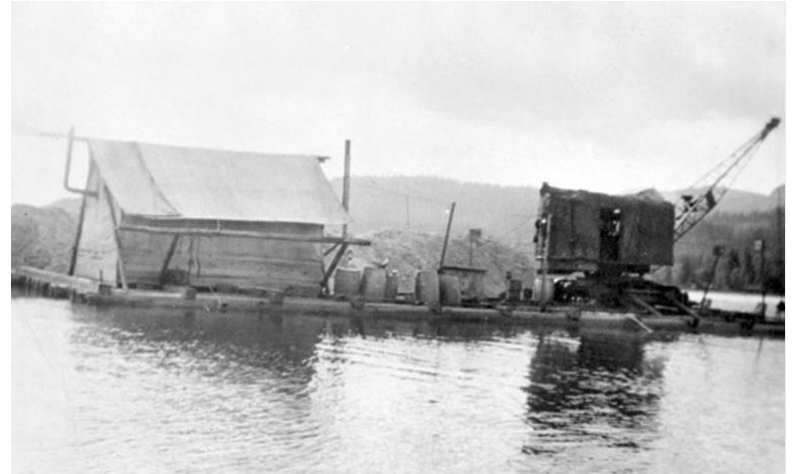
# THOROFARE DREDGE HISTORY

- 1930's: historical photo showing mechanical dredging of Thorofare using a barge
- 1940 – 1990's: anecdotal accounts suggest episodic mechanical dredging
- 1990s – present: no official records of dredging but a few permits exist.

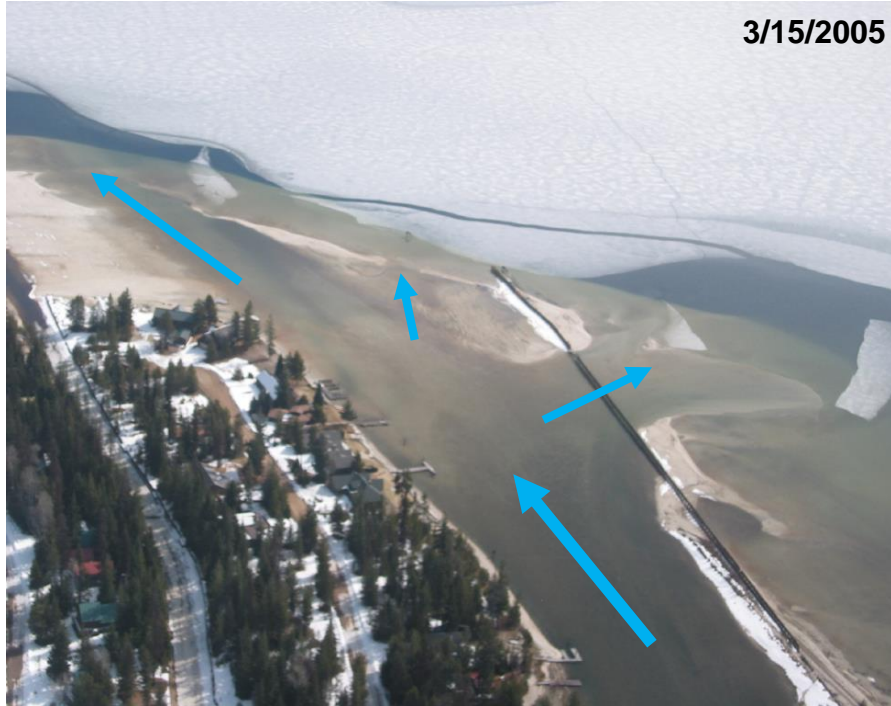
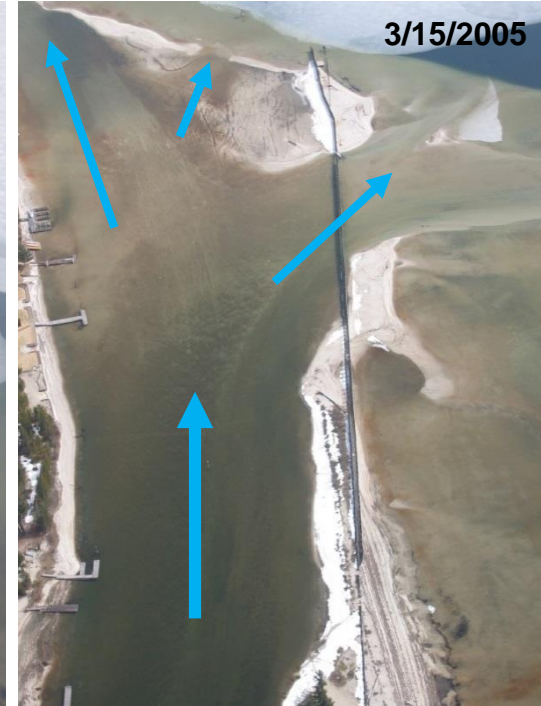
# THOROFARE FLOW SPREADING

- Shallow sand bar at the mouth on 3/15/2005, WL = 0.33' USGS
- Significant flow spreading & flow cutting into the sand bar and underneath the breakwater
- Aerial photo suggests ~40% of flow is going underneath the Breakwater, % to be verified with numerical modeling

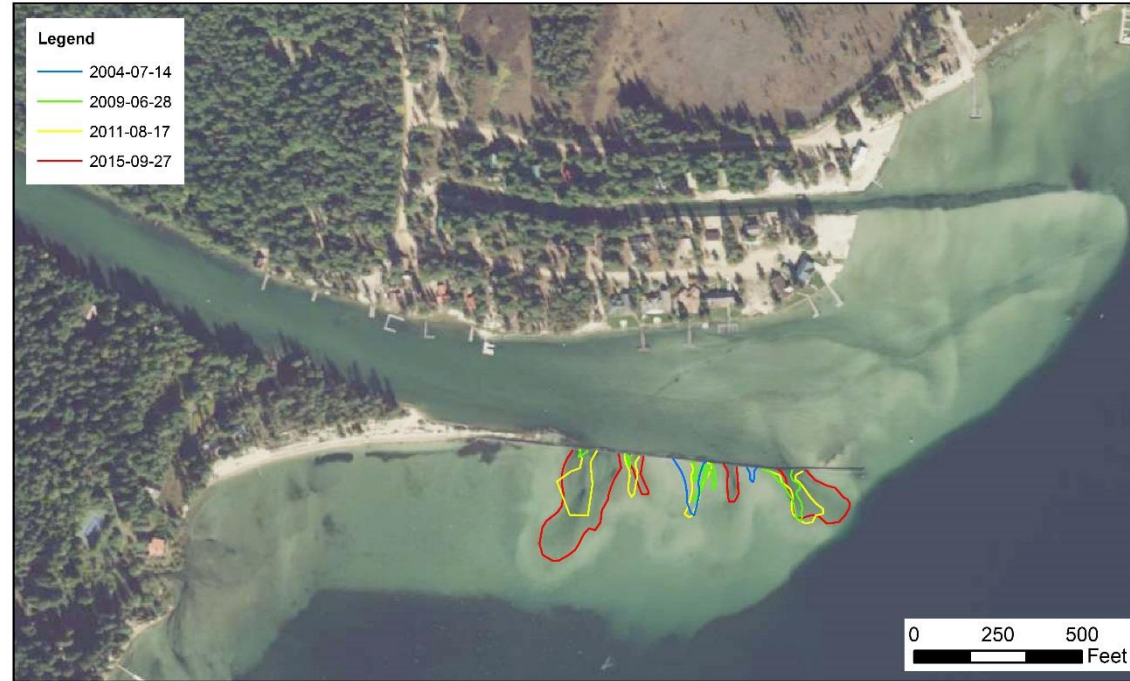
# THOROFARE FLOW SPREADING

- Thorofare flow forms channels underneath the breakwater.
- The channel locations & width vary with time

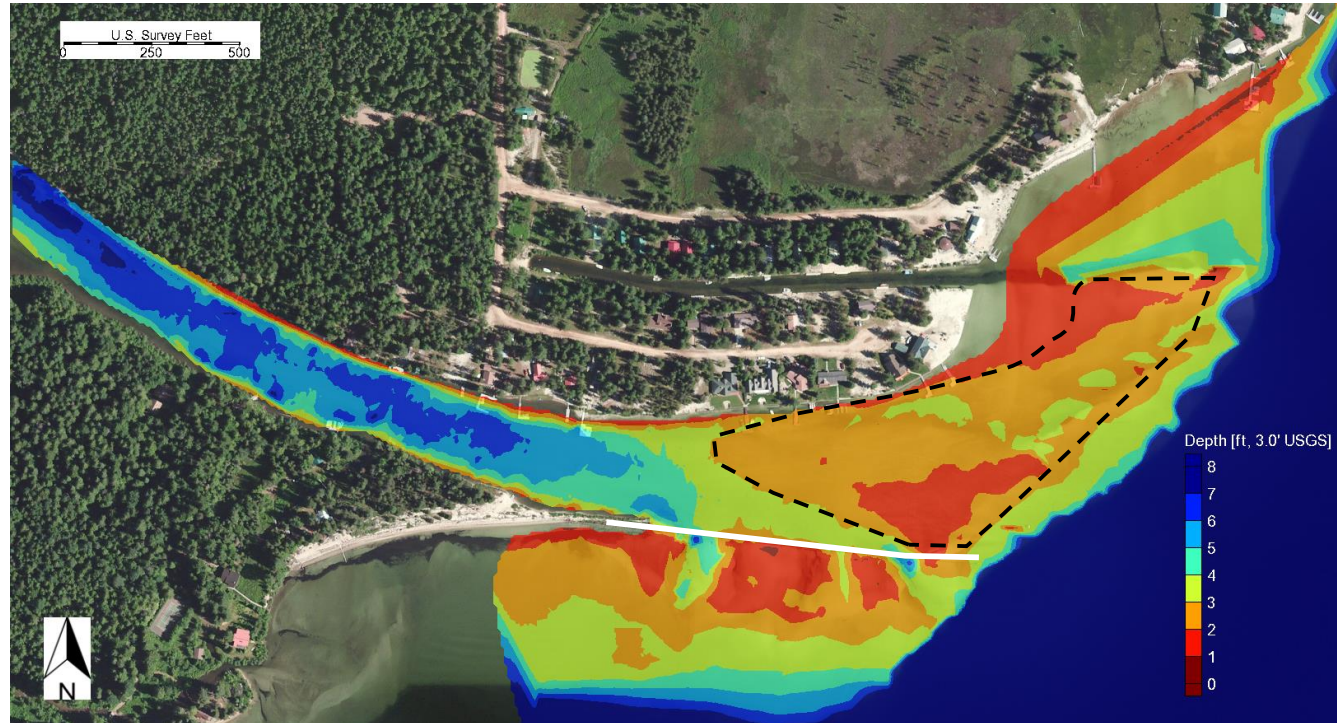
# THOROFARE HYDROGRAPHY

- Only existing historical hydrographic survey of Priest Lake dates back to 1995 (DEQ 1997). Unfortunately, that survey did not cover the Thorofare
- MM completed a hydrographic survey of Thorofare in May 2017
- Color contours here represent available water depth during summer w.r.t. Lake Level at 3.0' USGS gage
- Water depths at the Mouth outlined by black dashed line is mostly shallower than 3 ft, with some areas shallower than 2 ft

- Dredging & improvements to better confine Thorofare flow likely needed to maintain navigable access
- Accurate marking of Thorofare mouth by buoys would be important to help boaters access Thorofare

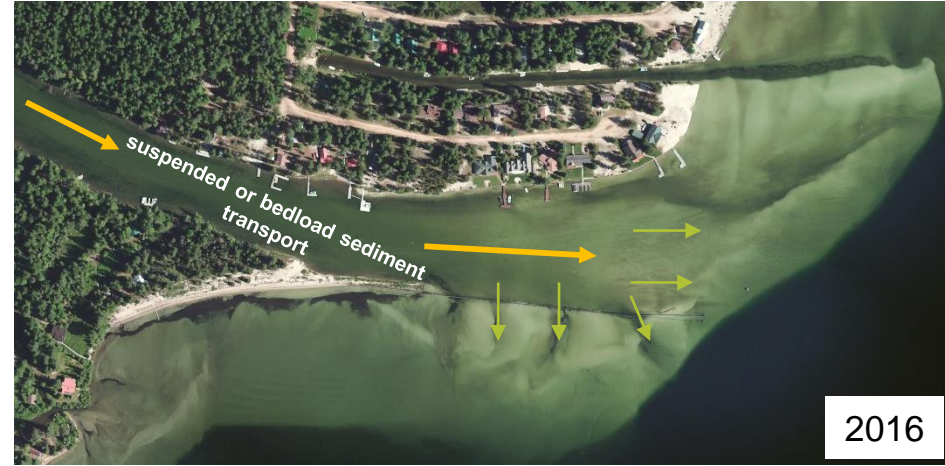
# THOROFARE BED LOAD SEDIMENT TRANSPORT

- Bed load sediment transport is dominant sediment source in the Thorofare.
- Sources come from tributaries and Thorofare bank adjustment.
- Majority of bedload is likely transported during spring runoff high flow and certain winter high flow conditions.
- Flow diversion at the breakwater reduces sediment transport capacity of Thorofare resulting in sediment deposition in the outlet area near the breakwater.

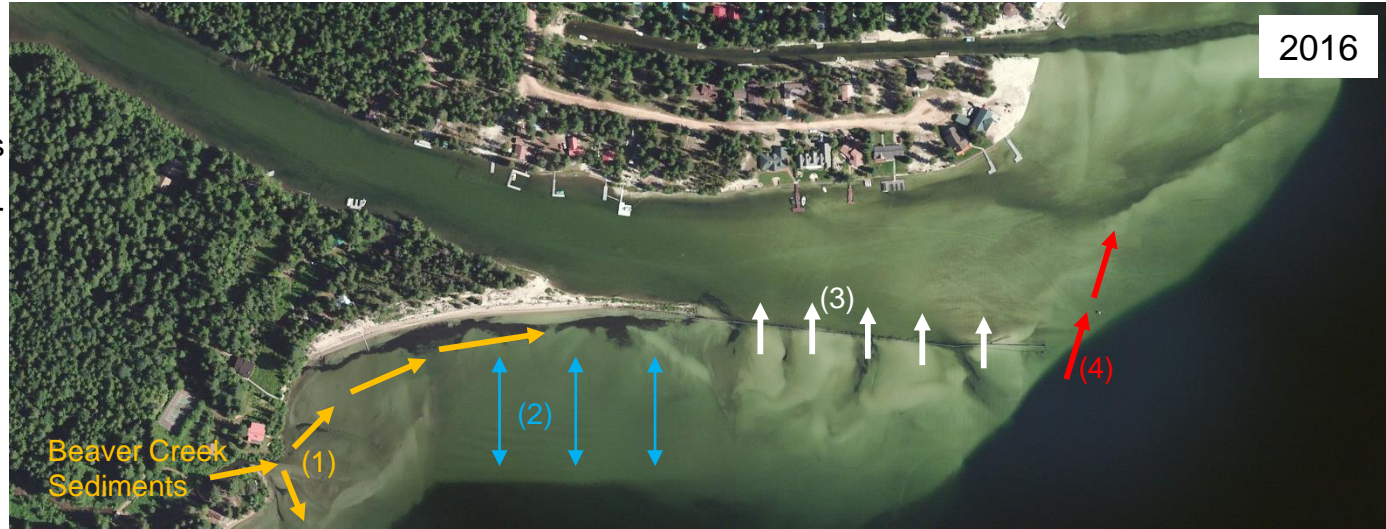
# LAKE SHORELINE - WAVE-DRIVEN SEDIMENT TRANSPORT

Wave-driven sediment sources & transport directions include:

- 1) Beaver Creek brings sediments to its mouth, some of it moves eastward parallel to breakwater due to waves & currents
- 2) Waves move sediments perpendicular to shoreline
- 3) Waves may push some sediments through & underneath the breakwater during summer low flows
- 4) Portion of sediments will move past the breakwater end

Without monitoring sediment input from Beaver Creek & having consecutive surveys of the shoreline, quantification of sedimentation transport in this area is difficult.

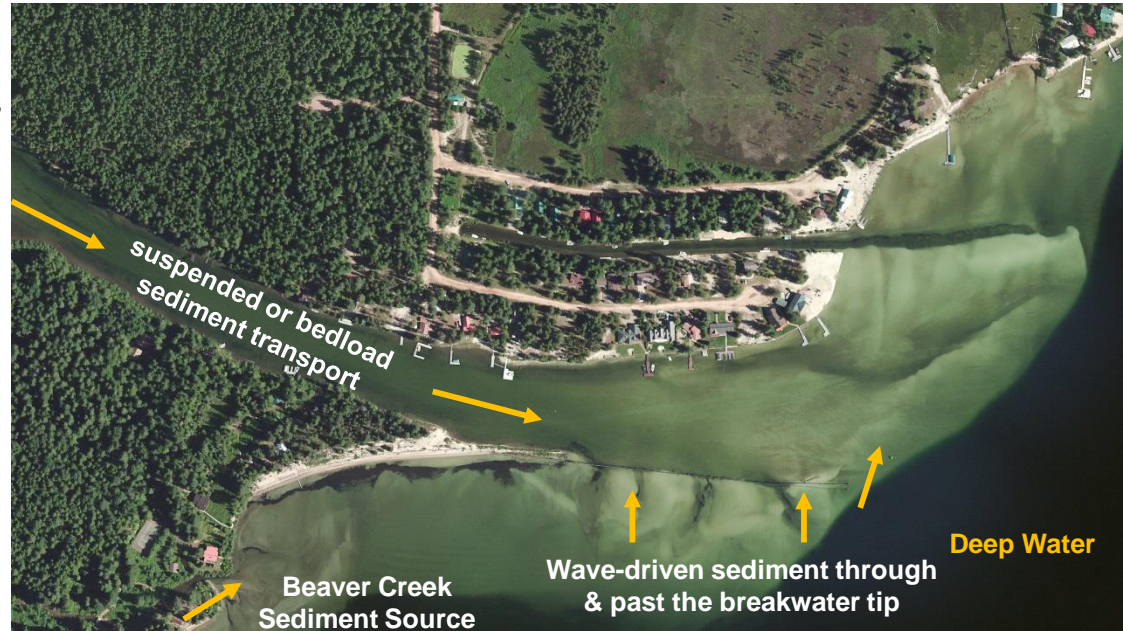
# THOROFARE GEOMORPHOLOGY SUMMARY

- Thorofare mouth has formed a lacustrine delta into Priest Lake.
- Sediment deposition is result of decreased transport capacity as low-gradient Thorofare meets zero-gradient Lake and flow spreading.
- Deposition has been accentuated by three factors at the mouth:
  - 1) Widening of Thorofare channel along Breakwater
  - 2) Reduced Thorofare discharge & velocity as water passes through or under existing timber breakwater
  - 3) Wind-driven sediments get pushed through and around the breakwater eastern end
- Thorofare flow passes through the Breakwater and has episodically scoured the bed underneath the breakwater leading to significant spreading of the flow and reduced sediment transport capacity at the Mouth

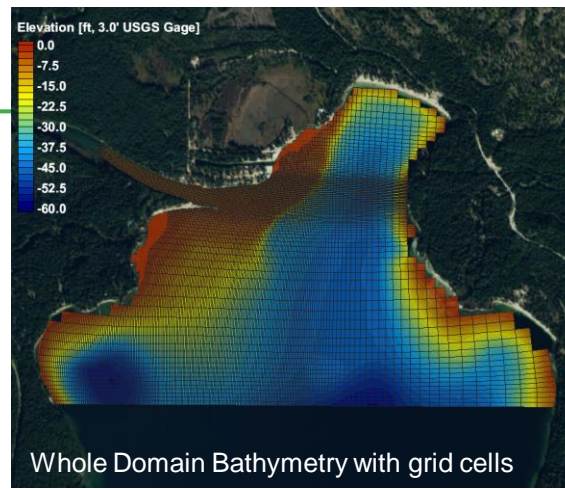
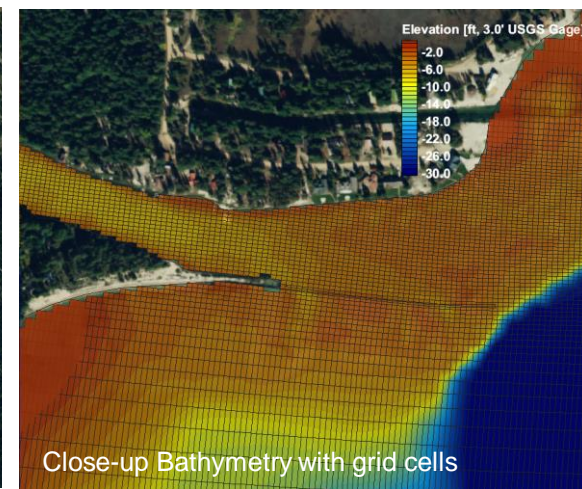
# HYDRAULIC MODELING

- Delft3D-FLOW is a three-dimensional (3-D) hydrodynamic and transport simulation program which calculates non-steady flow and transport phenomena that result from river forcing on a curvilinear, boundary fitted grid.
- Delft3D is widely accepted and used in industry and academia

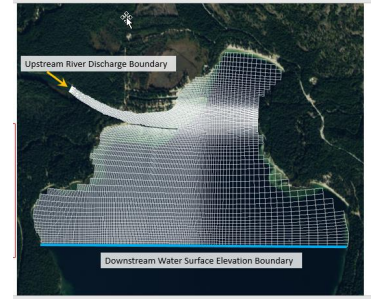
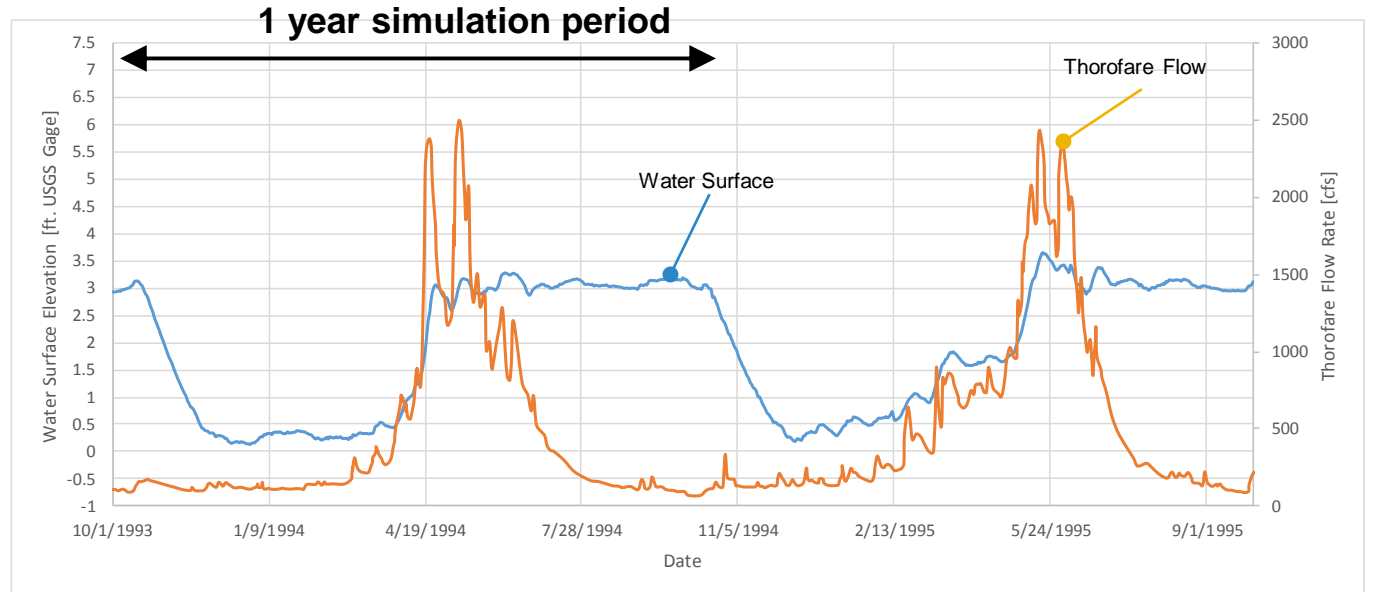
# MODEL INPUT - BOUNDARY CONDITIONS

- Run a 1-year simulation in order to simulate a wide range of hydrodynamic conditions as well as see any sufficient mid to long term sedimentation.
- 1994 water year simulation

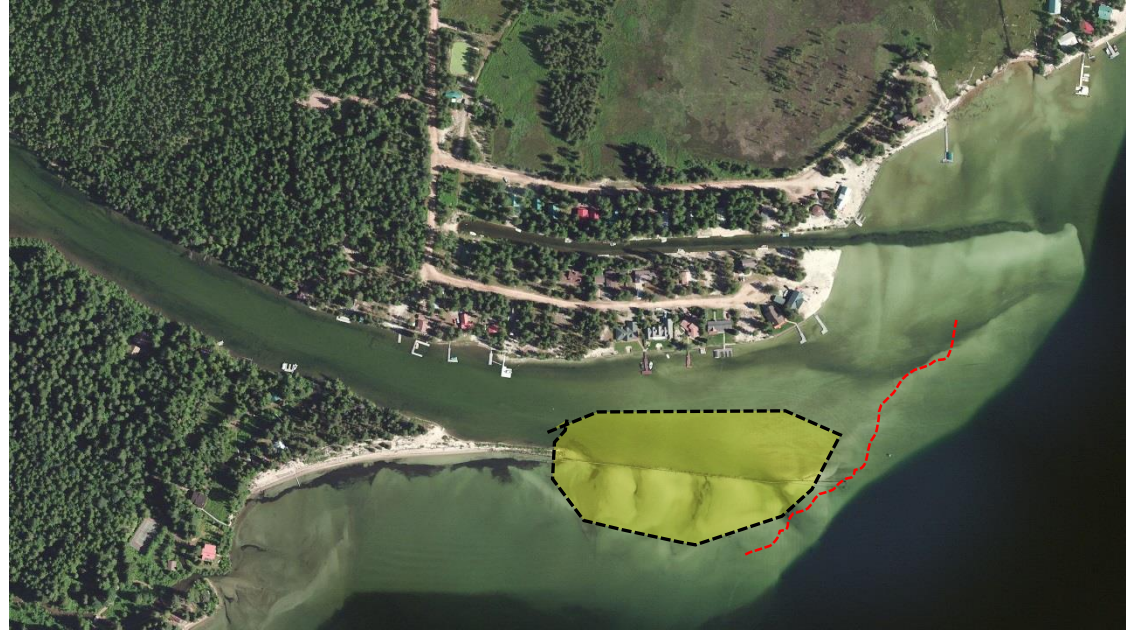
## Improvement Alternatives:

- 1) No Action (maintain existing)
  - No repairs, improvements or dredging
- 2) Removal of Breakwater
  - Complete Removal with dredging
- 3) Rehabilitate Existing Porous Breakwater
- 4) Replace Existing Porous Breakwater with Sediment Retention Feature
  - Rehab existing damaged areas, continue repairs in future, conduct dredging to restore navigation
- 5) In channel flow diversion
  - Construction new feature to replace breakwater and conduct dredging to restore navigation; see next slide for details
- 6) Partial in channel flow diversion

= Focus Area for Thorofare Improvements

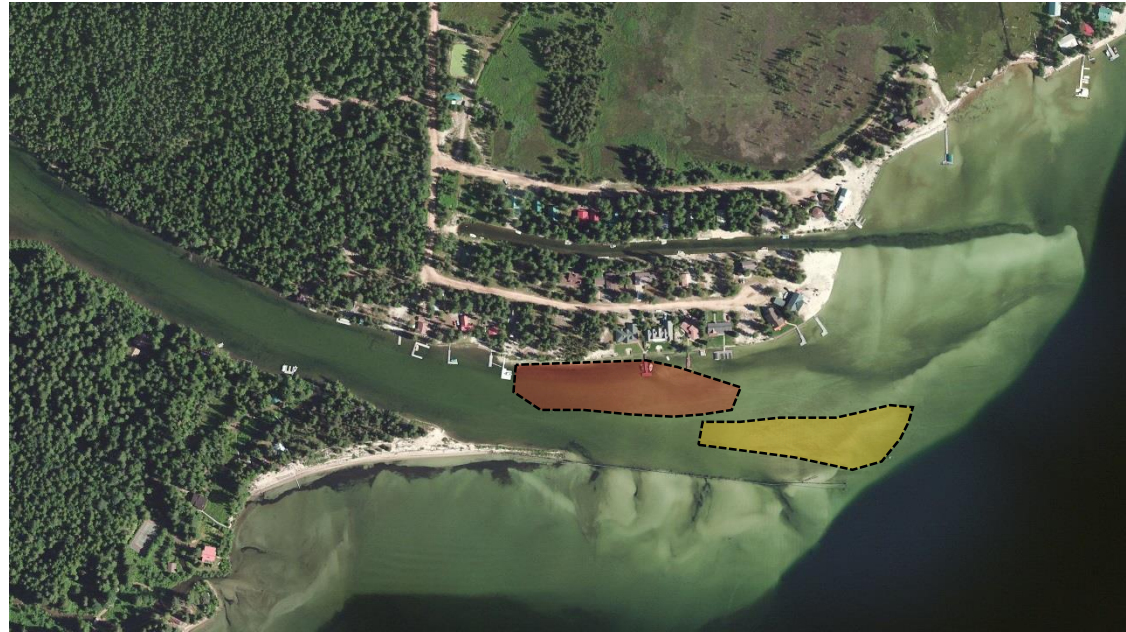
# THOROFARE – OTHER IMPROVEMENT ALTERNATIVES CONSIDERED BUT ELIMINATED

## 1) In Channel - LWD FEATURES

Navigable hazards for areas along north side of Thorofare

## 2) In Channel - NORTH SIDE GROINS

Requires connection to shoreline  
Impact to docks

## 3) NON STRUCTURAL (DREDGING)

Not sustainable, requires frequent maintenance dredging

= Non Structural (Dredging Only)

= In Channel Features (North Side Groins, In Channel LWD)

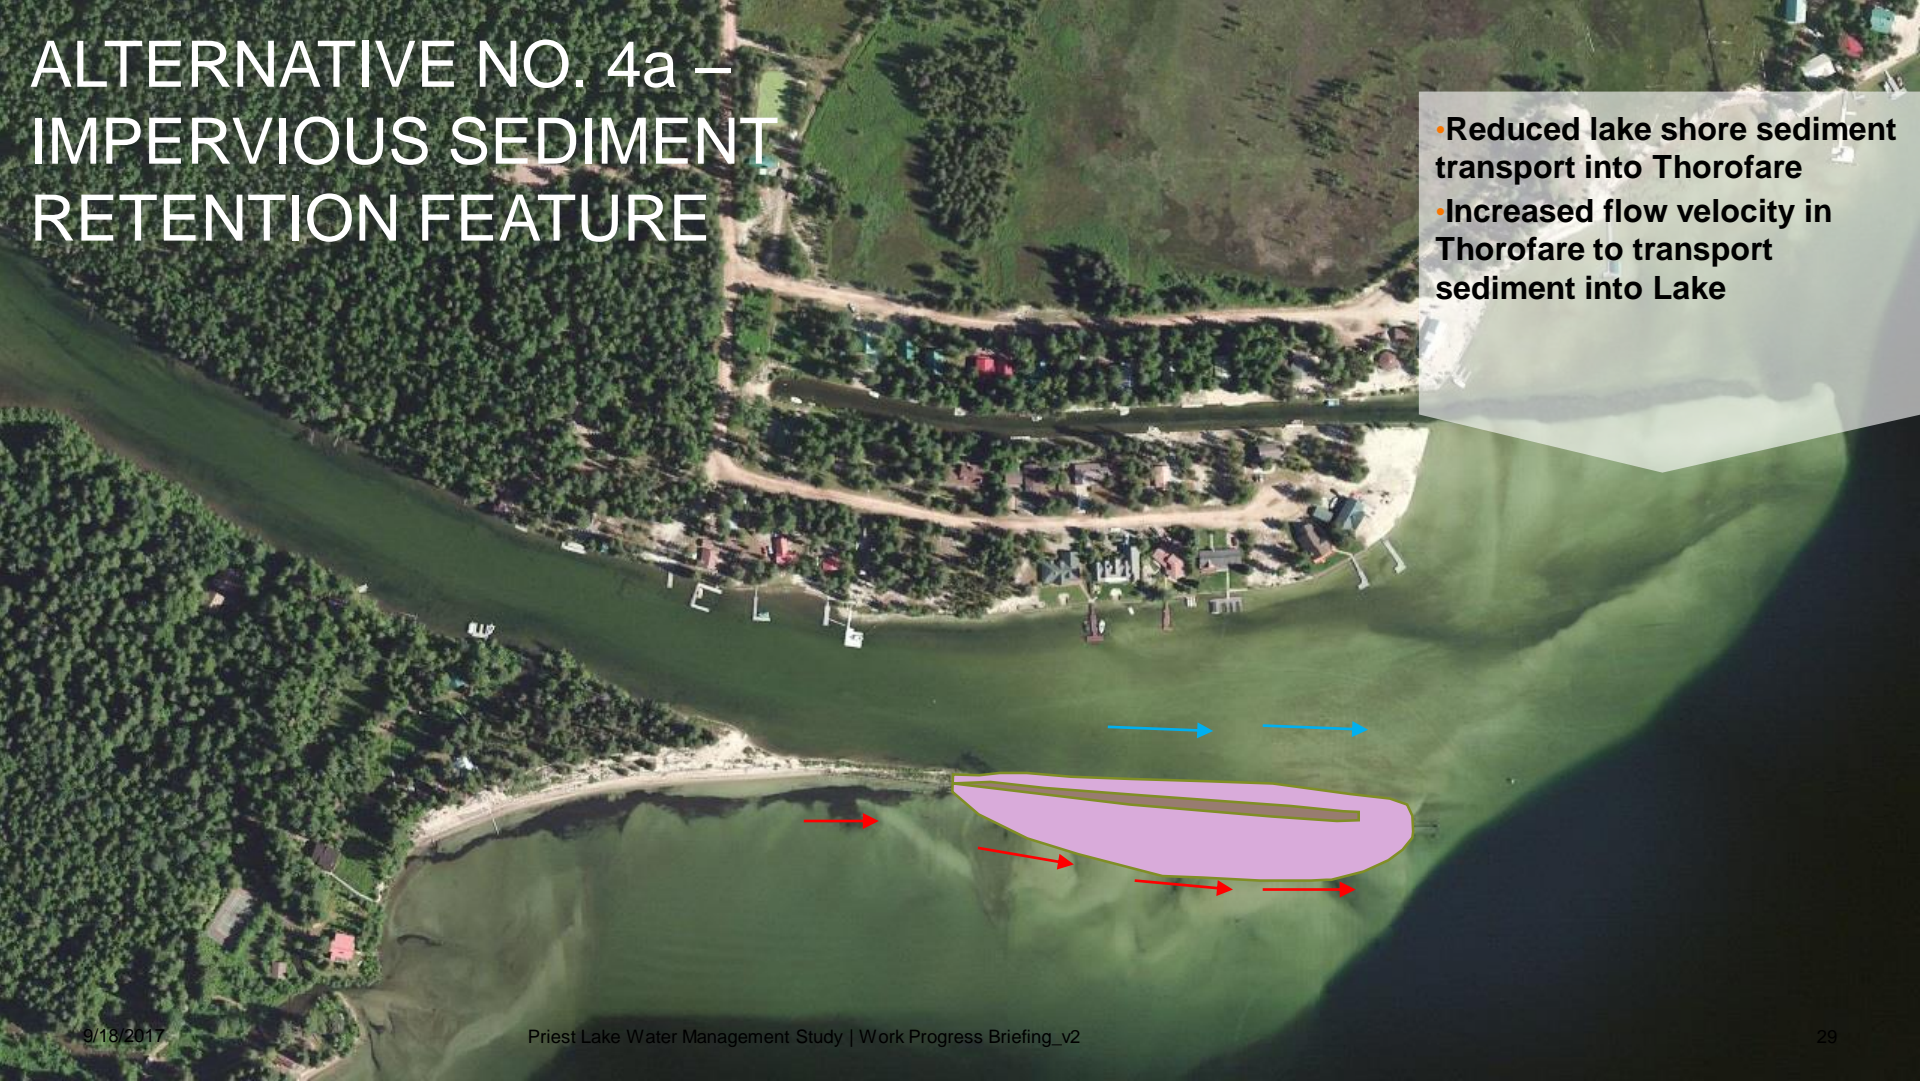
# ALTERNATIVE NO. 4a – IMPERVIOUS SEDIMENT RETENTION FEATURE

- Reduced lake shore sediment transport into Thorofare
- Increased flow velocity in Thorofare to transport sediment into Lake

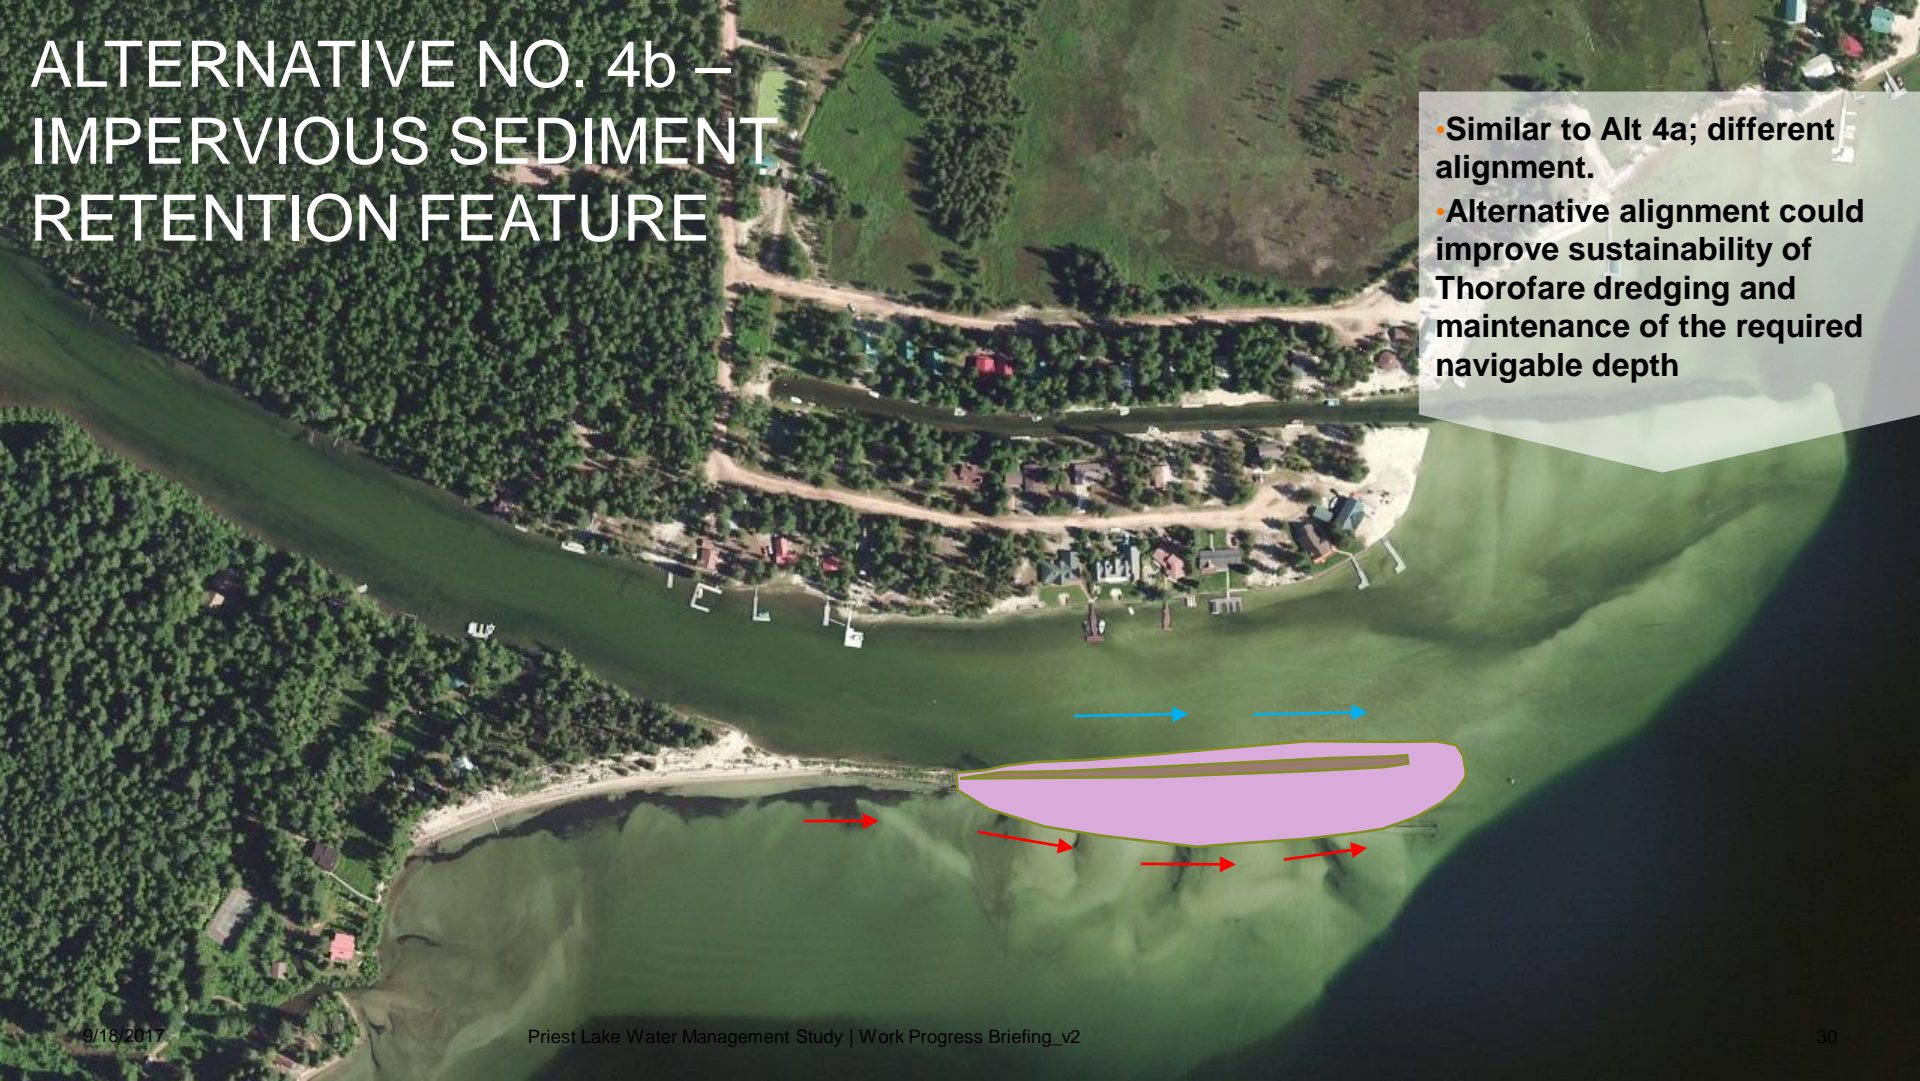
# ALTERNATIVE NO. 4b – IMPERVIOUS SEDIMENT RETENTION FEATURE

- Similar to Alt 4a; different alignment.
- Alternative alignment could improve sustainability of Thorofare dredging and maintenance of the required navigable depth

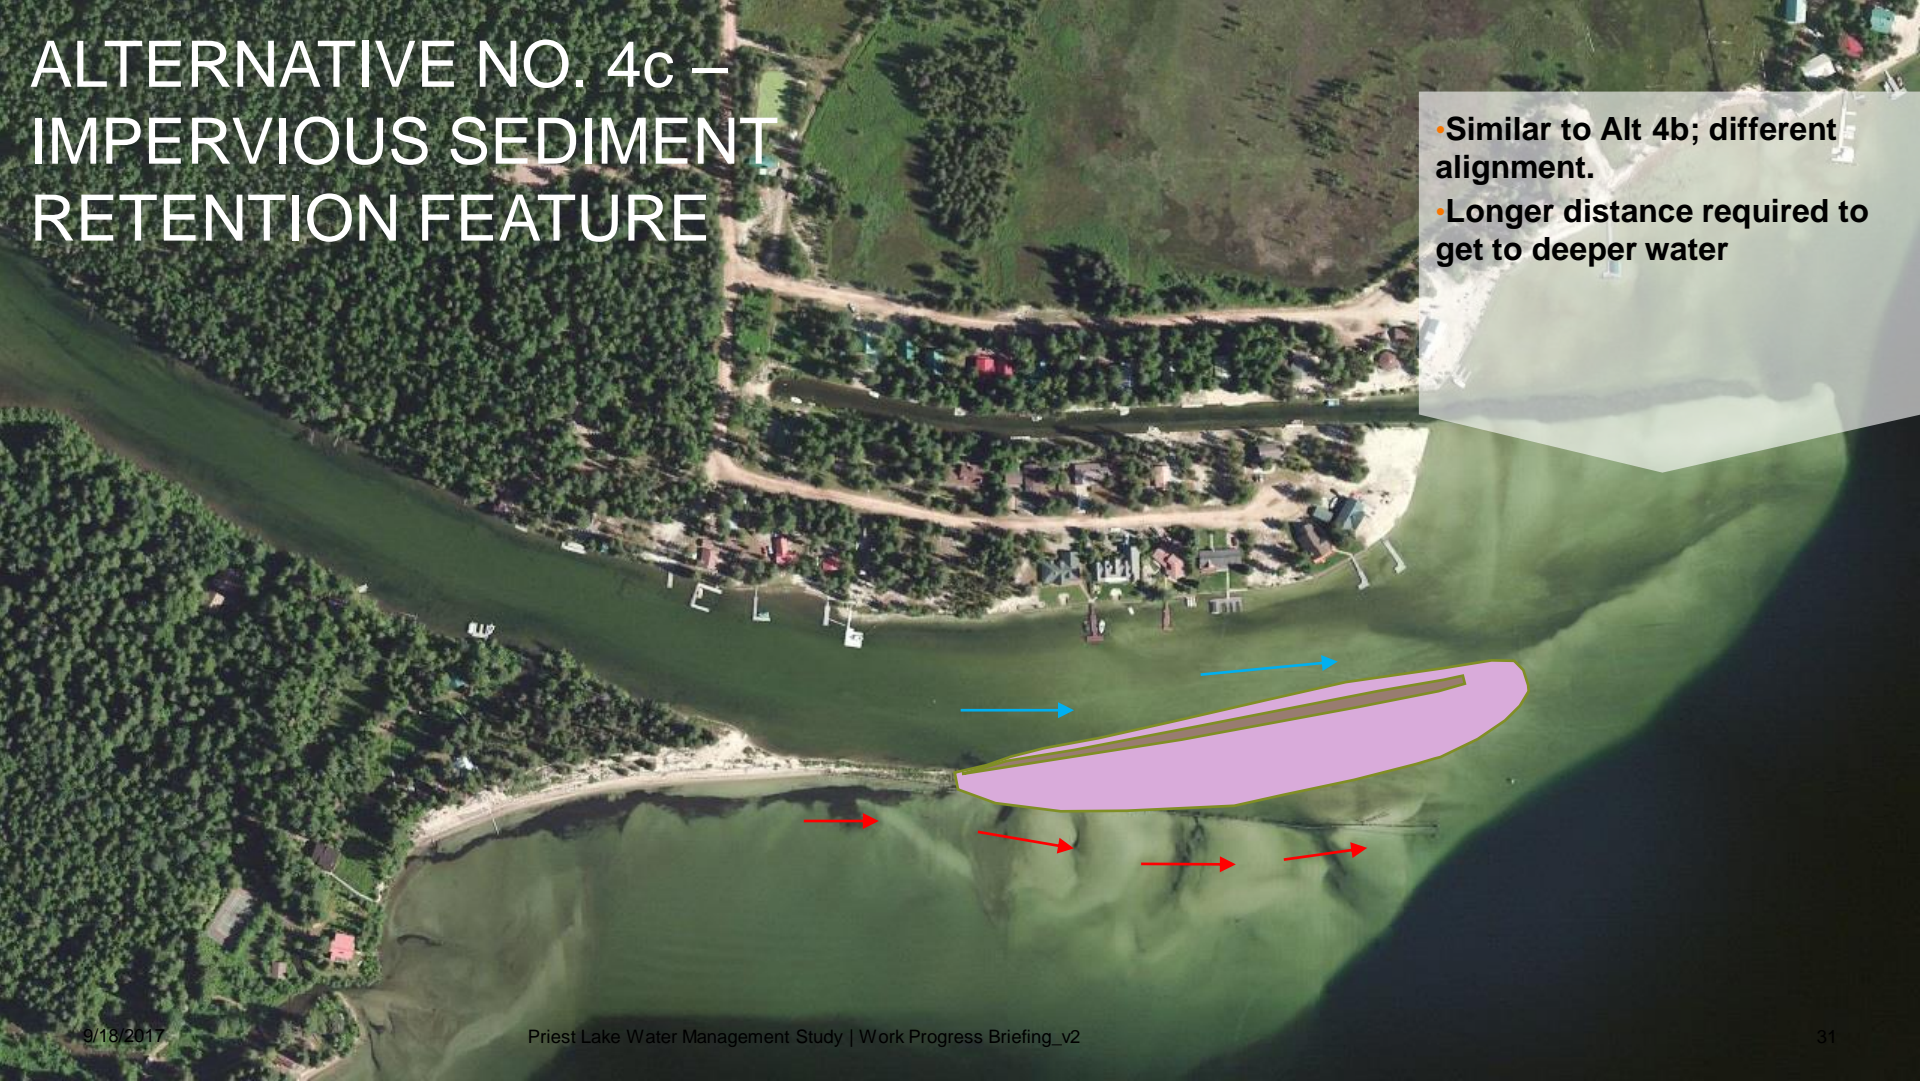
# ALTERNATIVE NO. 4c – IMPERVIOUS SEDIMENT RETENTION FEATURE

- Similar to Alt 4b; different alignment.
- Longer distance required to get to deeper water

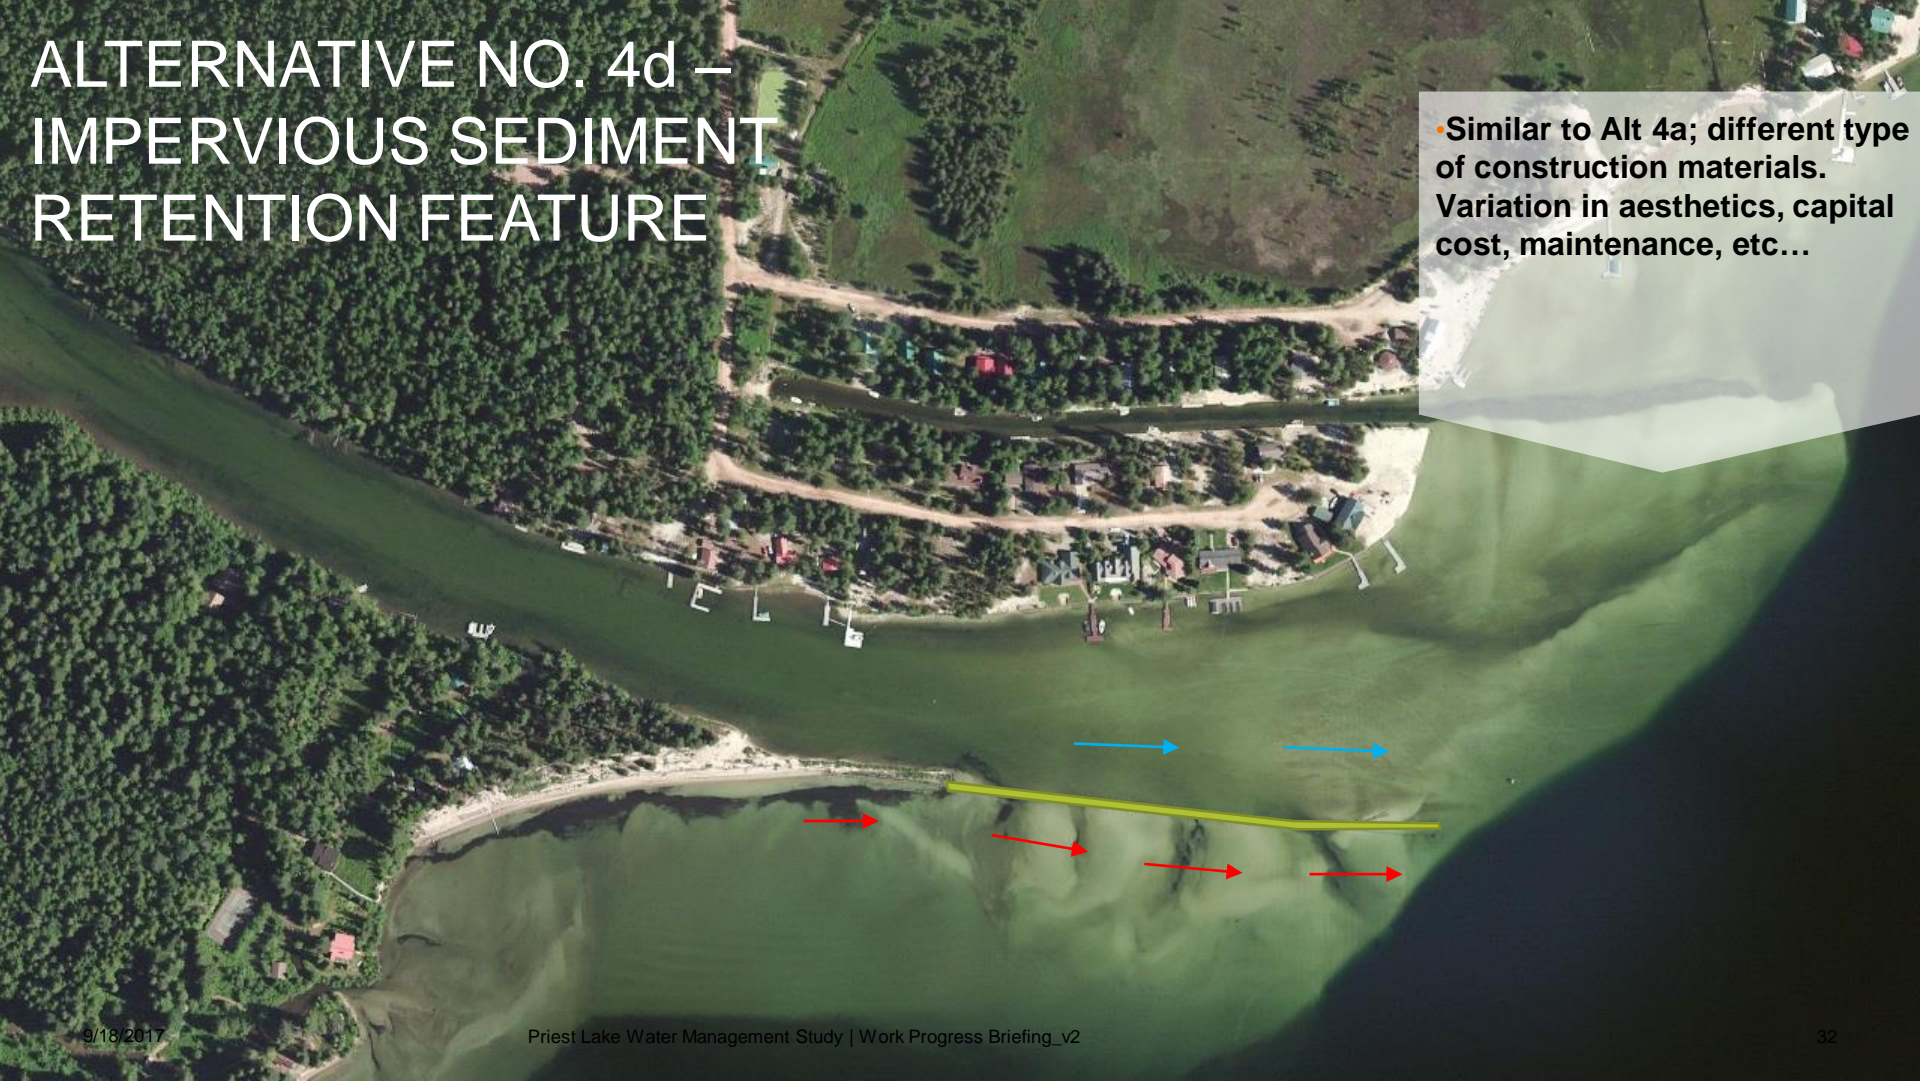
# ALTERNATIVE NO. 4d – IMPERVIOUS SEDIMENT RETENTION FEATURE

• Similar to Alt 4a; different type of construction materials. Variation in aesthetics, capital cost, maintenance, etc...

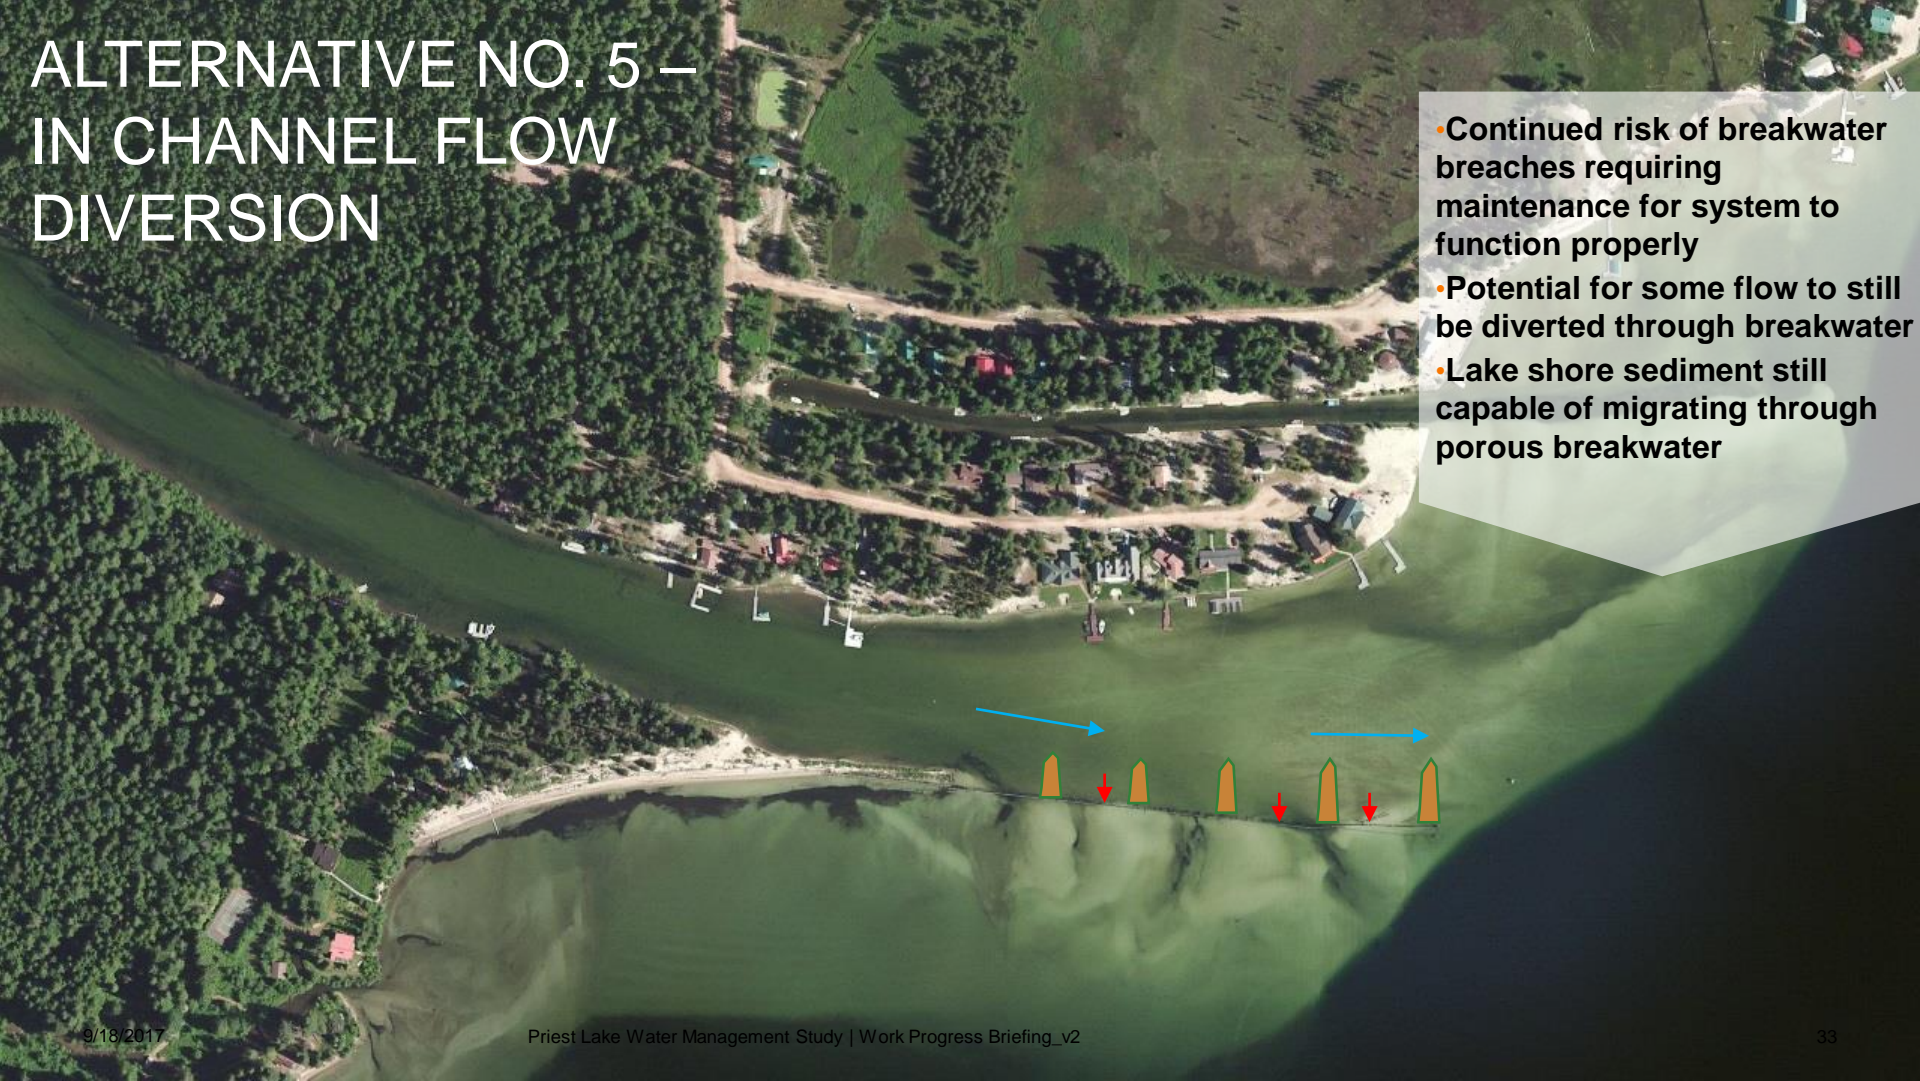
# ALTERNATIVE NO. 5 – IN CHANNEL FLOW DIVERSION

- Continued risk of breakwater breaches requiring maintenance for system to function properly
- Potential for some flow to still be diverted through breakwater
- Lake shore sediment still capable of migrating through porous breakwater
