# Priest Lake Water Management Study

Work Progress Briefing – 9/18/2017

IDAHO WATER RESOURCE BOARD

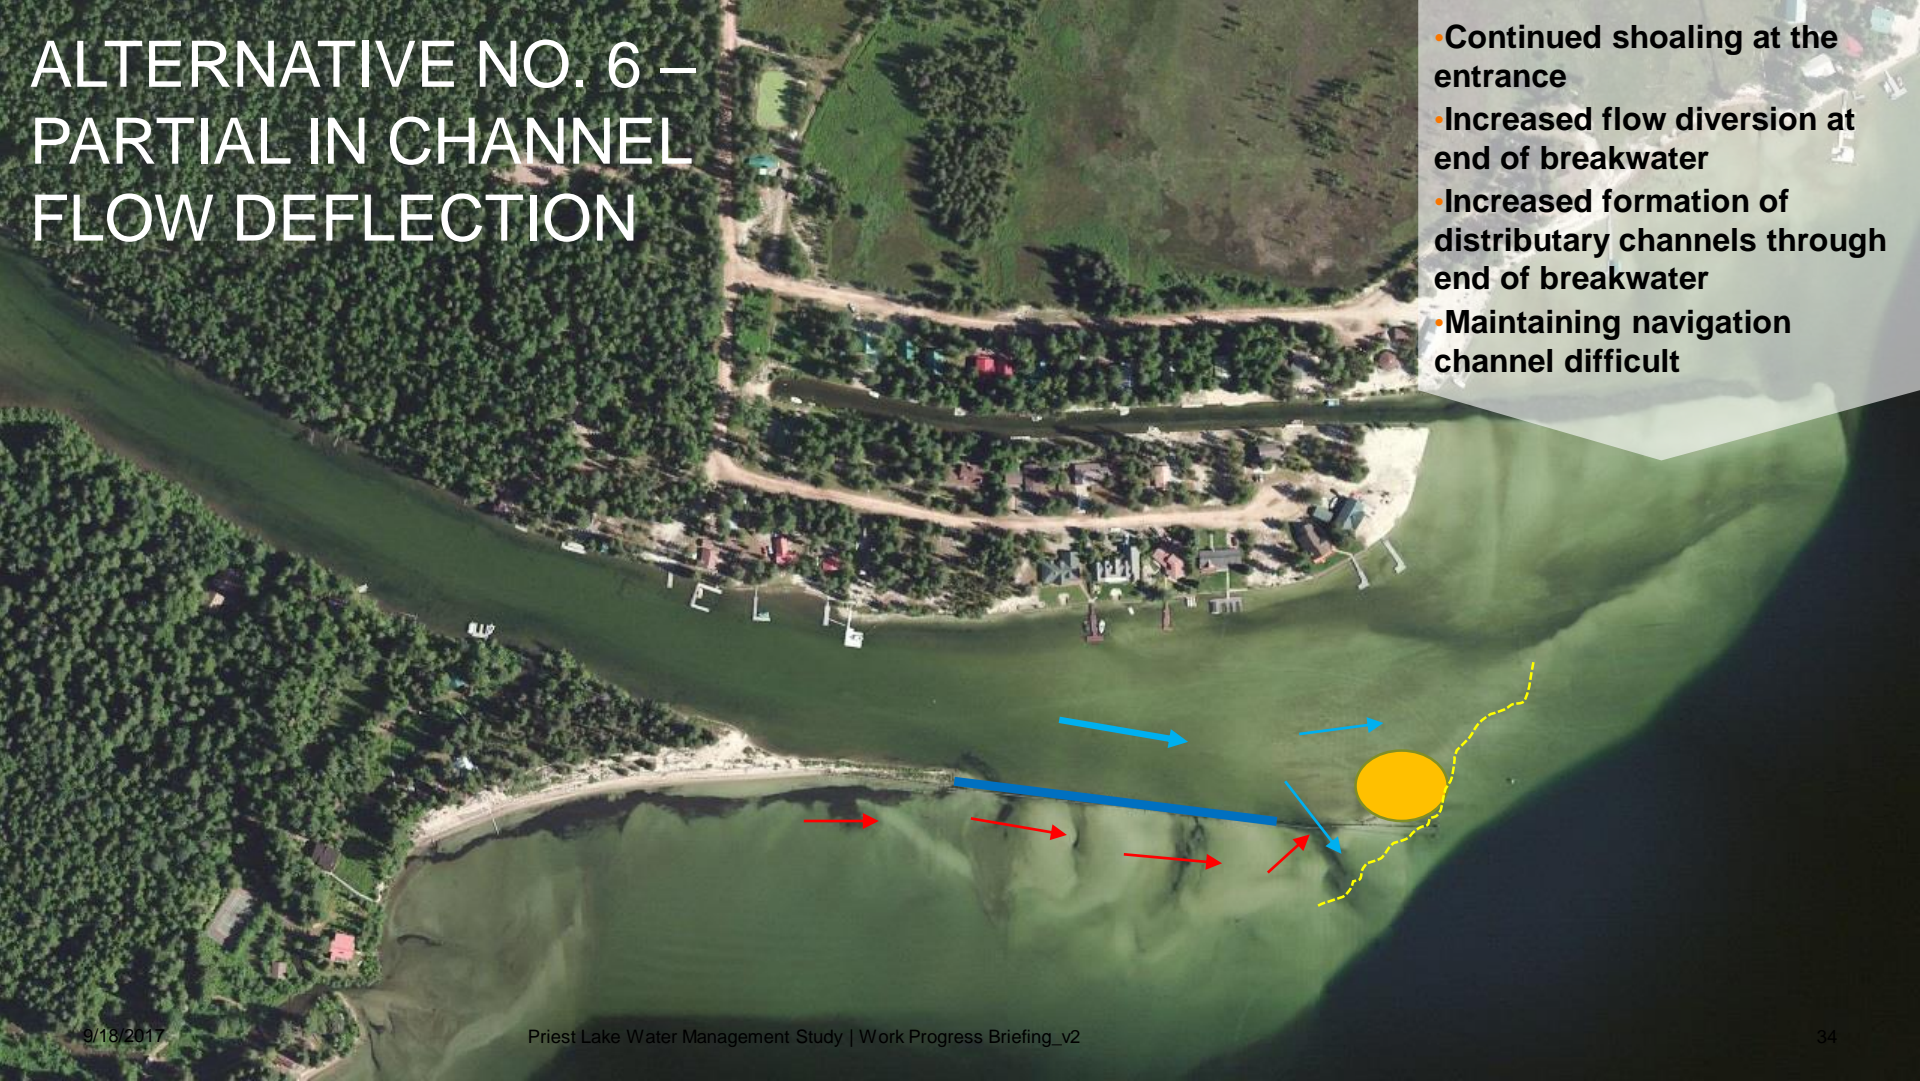
# ALTERNATIVE NO. 6 – PARTIAL IN CHANNEL FLOW DEFLECTION

- Continued shoaling at the entrance
- Increased flow diversion at end of breakwater
- Increased formation of distributary channels through end of breakwater
- Maintaining navigation channel difficult

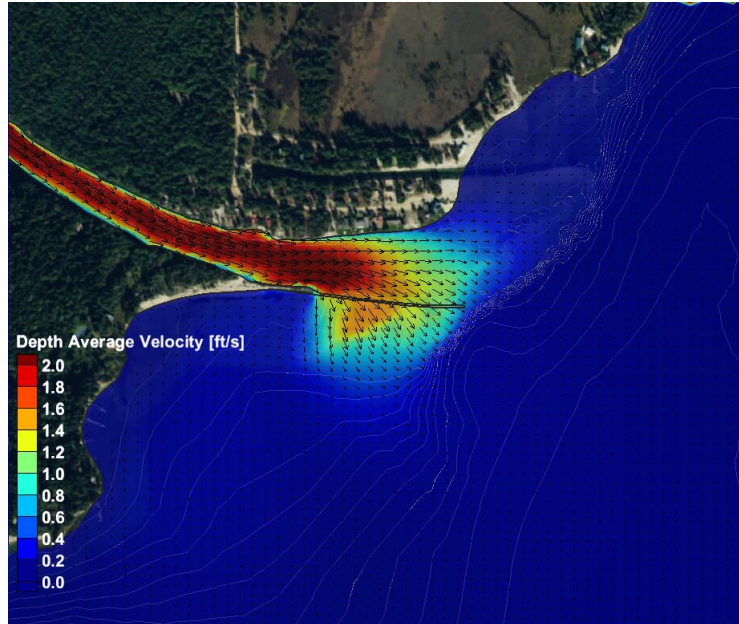
# MODELING RESULTS – HYDRAULICS

## Snapshot of depth-averaged velocity for Porous Breakwater vs. Solid Feature

- Sensitivity testing showed that Solid Breakwater compared to Porous Breakwater better confines the flow to Thorofare and as a result, higher velocities will occur in the Thorofare mouth
- Sensitivity testing showed that Solid Breakwater compared to Porous Breakwater transports more sediments along Thorofare and deposits them in deeper water
- Flow diversion in Thorofare doesn't occur with non-porous feature.
- Sediment retention feature to replace existing breakwater is best performing concept to meet project objectives, criteria and goals.
- Extension of Breakwater toward deeper water to be investigate further to evaluate cost/benefit.
- Slightly rotated breakwater to narrow Thorofare width to be investigated to further evaluate cost/benefit.

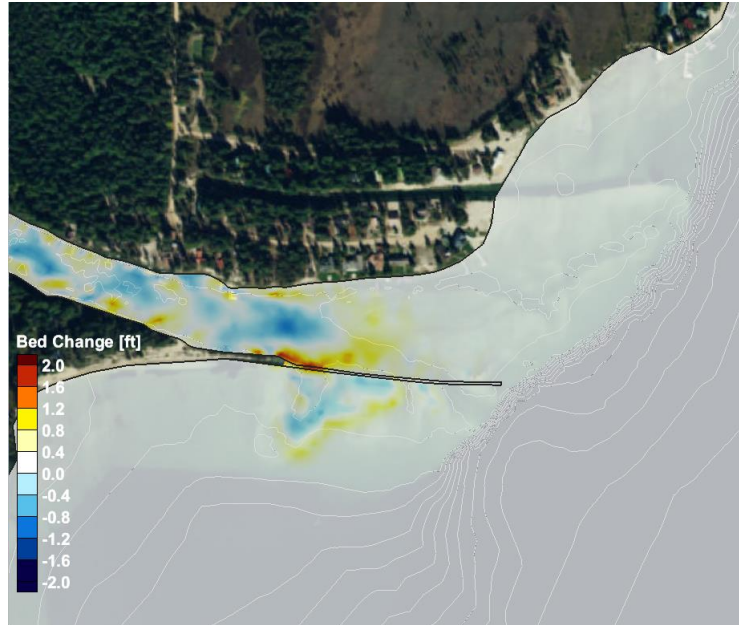
Porous Breakwater

# MODELING RESULTS – SEDIMENT TRANSPORT

Maximum Bed Change (sedimentation/erosion) during the simulation period

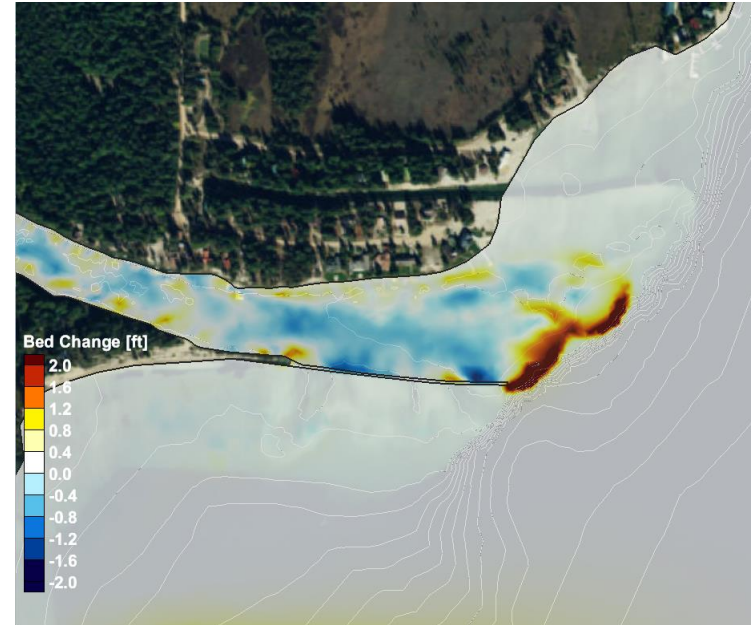
Solid Feature

Solid Feature: transports material and deposits them in deeper water past the feature end.

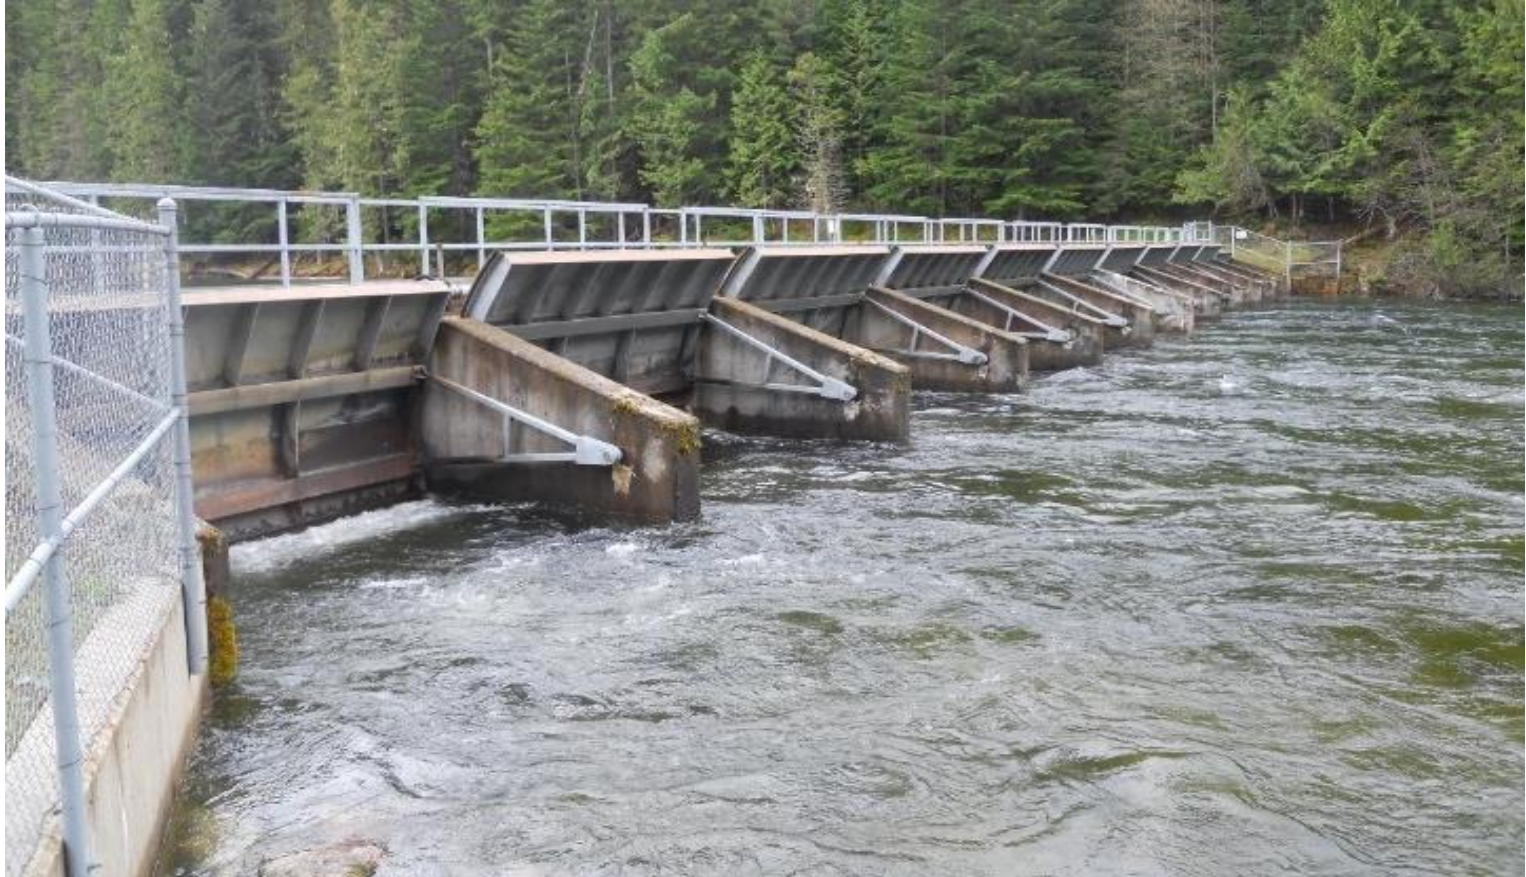
# OUTLET STRUCTURE EXISTING CONDITIONS (May 2017 High Flow)

- Constructed in 1978
- Radial gates manually operated on 11 equally sized spillway bays
- Repairs to downstream scour protection in 1979 ~larger stone installed to increase scour protection
- Gates are 7' tall with 0.15' freeboard

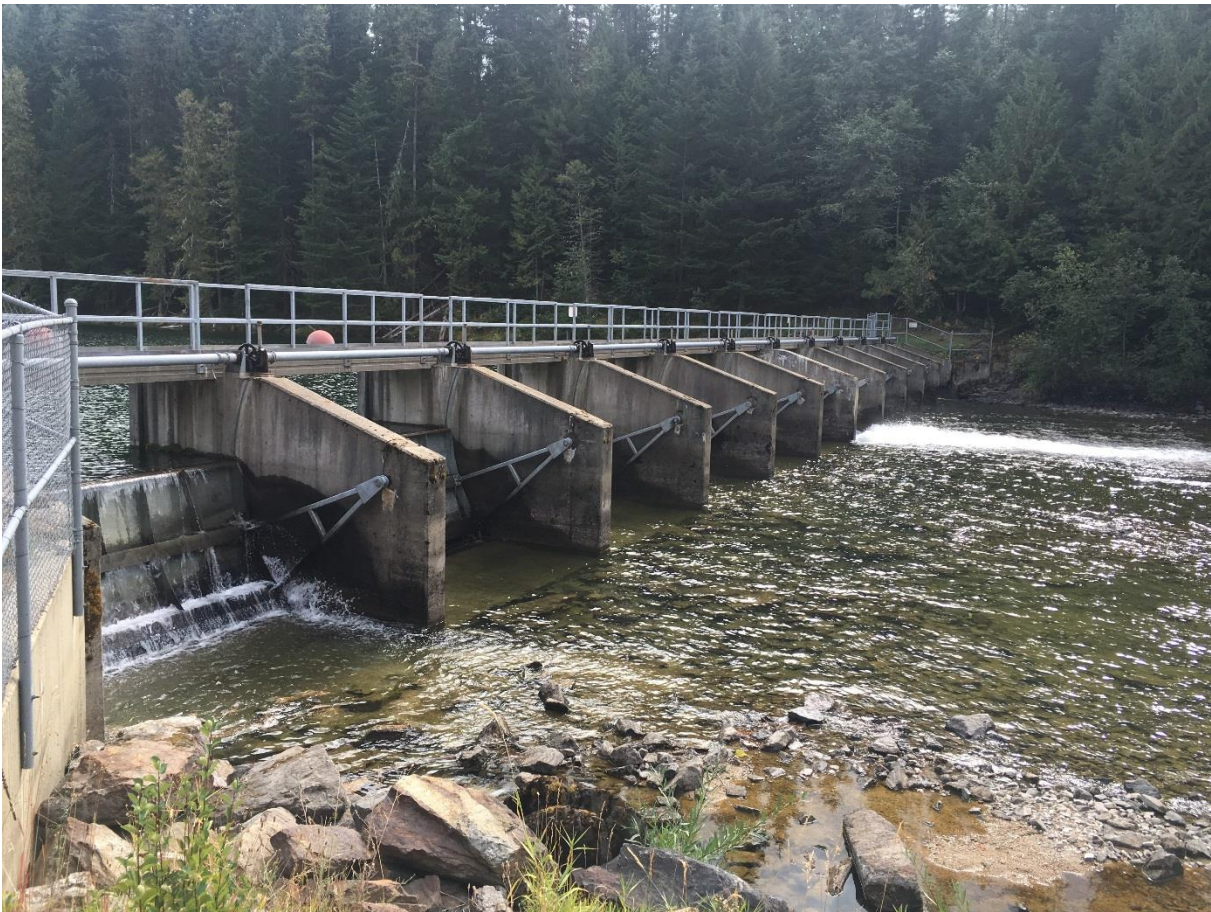
# OUTLET STRUCTURE EXISTING CONDITIONS (Sept 2017 Low Flow)

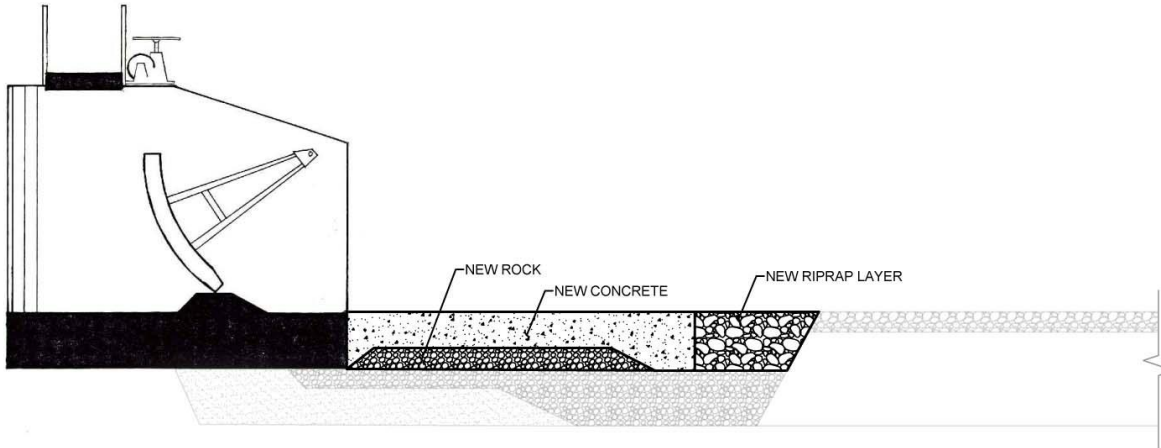
## ALT #2 – EXTEND CONCRETE APRON

Evaluated 6 concepts; Alt #2 Recommended

1. USBR Type IVa Stilling Basin
2. **Extend Concrete Apron**
3. New Larger Riprap
4. Grouted Riprap
5. Notched Ramp/Slab
6. Gate Retrofit

- Improved Stilling Basin Hydraulics
- Improved gate operational flexibility
- Lower Risk of scour
- Potential for improvement to dam stability (sliding resistance)

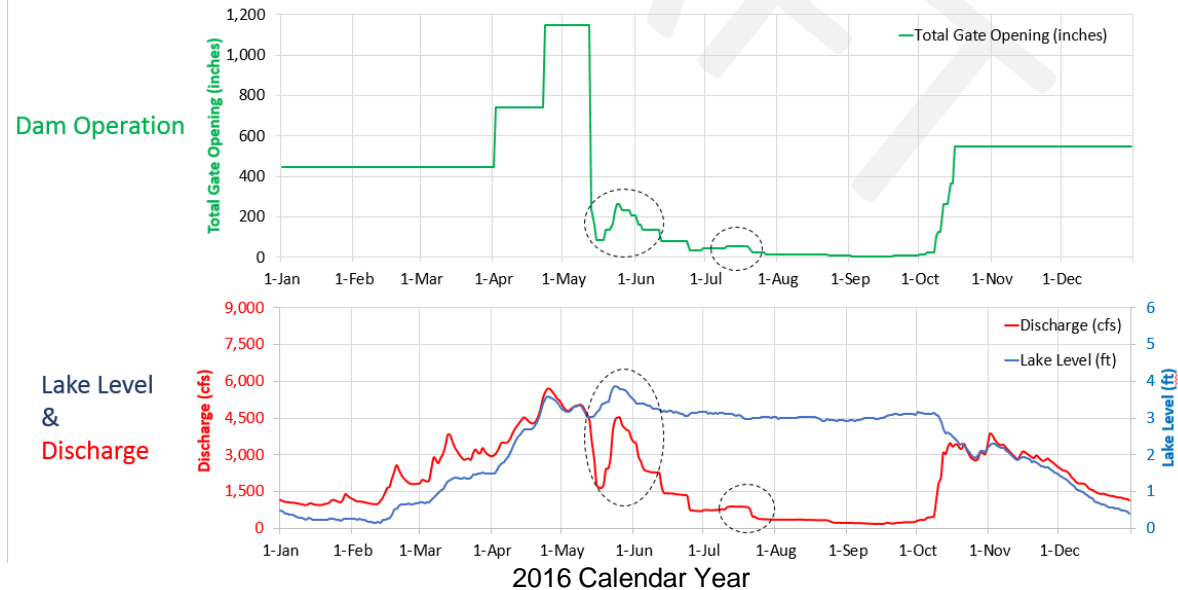
# OUTLET STRUCTURE – GATE OPERATIONS

- Winter. Gates fully open
- Spring. Gate opened and managed to achieve 3.0' gage by July 1.
- Summer. Small number of gates used to manage pool and discharge.
- Fall. Opened in Oct to release storage between early Oct and Nov 1.

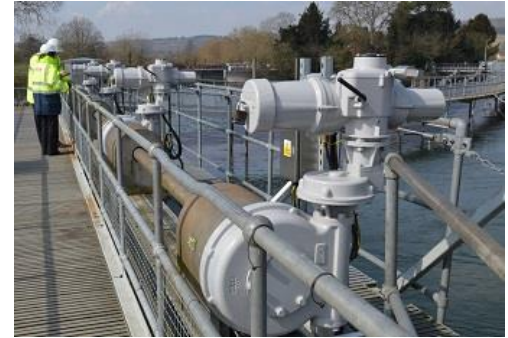
## Powered Operation & Automation Considerations

- Concepts
  - Retrofit with motor and gearbox to existing or a modified drive with starter panel
  - Valve Actuator – self contained unit; remote operation
- Alternative Concept
  - Provide power operation with remote monitoring but not remote operation
  - Focus improvements on more refined onsite real time operations of the dam
  - Improve discharge and pool measurement and monitoring system for gate operations and to improve rating curve

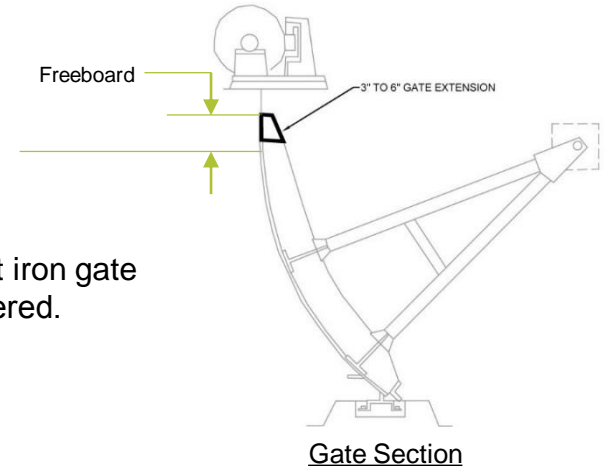
## Hoist

- Slight reduction in factor of safety; more detailed analysis in next phase and review of capacity of system.
- Not significant increase in load and within safety factor.

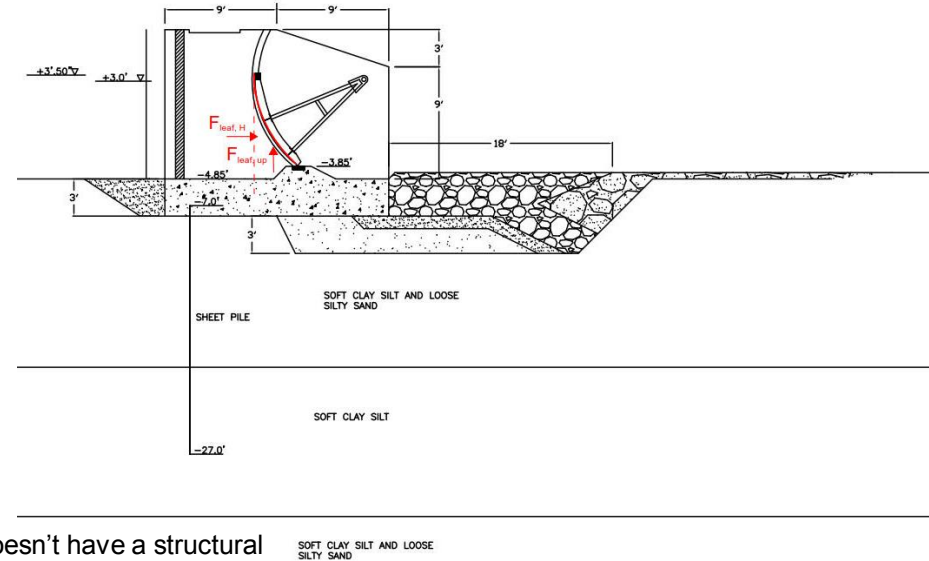
## Dam Stability Analysis

- Criteria: As outlined in the Priest Lake Basis of Analysis.
- Standards: IDWR and USBR.
- Available Data:
  - Construction Plans
  - Borings
  - Inspection Reports
- Review of Historical Data

- Sliding Stability
  - Sliding stability is of concern and relies upon sheet pile wall that doesn't have a structural connection to outlet structure. Increased pool will increase sliding load and thereby further reduce Factor of Safety. New improvements to stilling basin and scour protection likely needed.
- Seepage - Sheet pile wall provides hydraulic cutoff within center of structure; review at river bank ends of structure.
- Overturning - Ok.
- Bearing Pressure - Ok, within allowable.
- Resultant location on base - Ok, eccentricity within middle 1/3 of base
- Seismic - TBD

- Structure Stability
  - Improvement for stability likely needed to meet current standards to not rely upon sheet pile wall for sliding resistance.
  - Sheet pile wall does provide reduction in seepage.
- Stilling Basin
  - Improvements needed to mitigate risk of scour and corresponding impact on dam stability.
  - Alternative – Scour apron
- Gates
  - Increase height of gate for 3” to 6” pool raise looks feasible.
  - Modification to gate will be needed at top of existing gate (plate extension)
  - Gate Structure and Trunnion: Likely ok, additional analysis in next phase needed to finalize.
- Gate Operations
  - Power operation should be considered

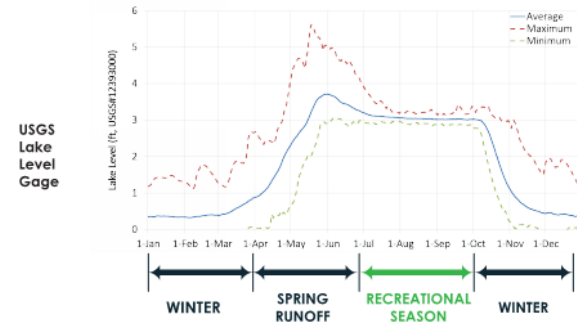
## ANNUAL LAKE LEVEL VARIATION (1980 - PRESENT)

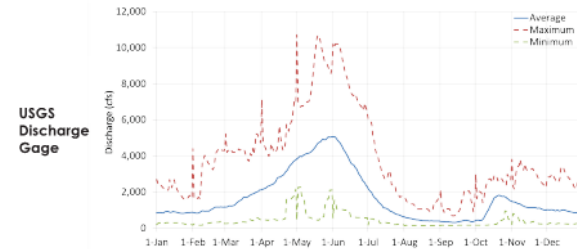
## ANNUAL DISCHARGE PATTERN (1980 - PRESENT)

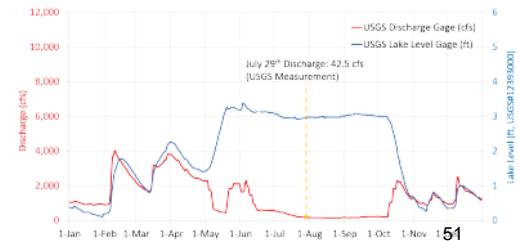
## 2015 LAKE LEVEL & DISCHARGE PATTERN

- In 2015, drought conditions made maintaining the required summer lake levels & minimum discharge from the dam very difficult. The discharge from the dam was reduced below the current policy of minimum 60 cfs to maintain the lake level and meet statutory requirements.
- In 2016, which had seemed to be a typical year, the same issue occurred and a crisis was nearly averted.
- These incidents highlighted the need for improvements to lake level management and measures that may need to be taken during dry or marginally dry years.

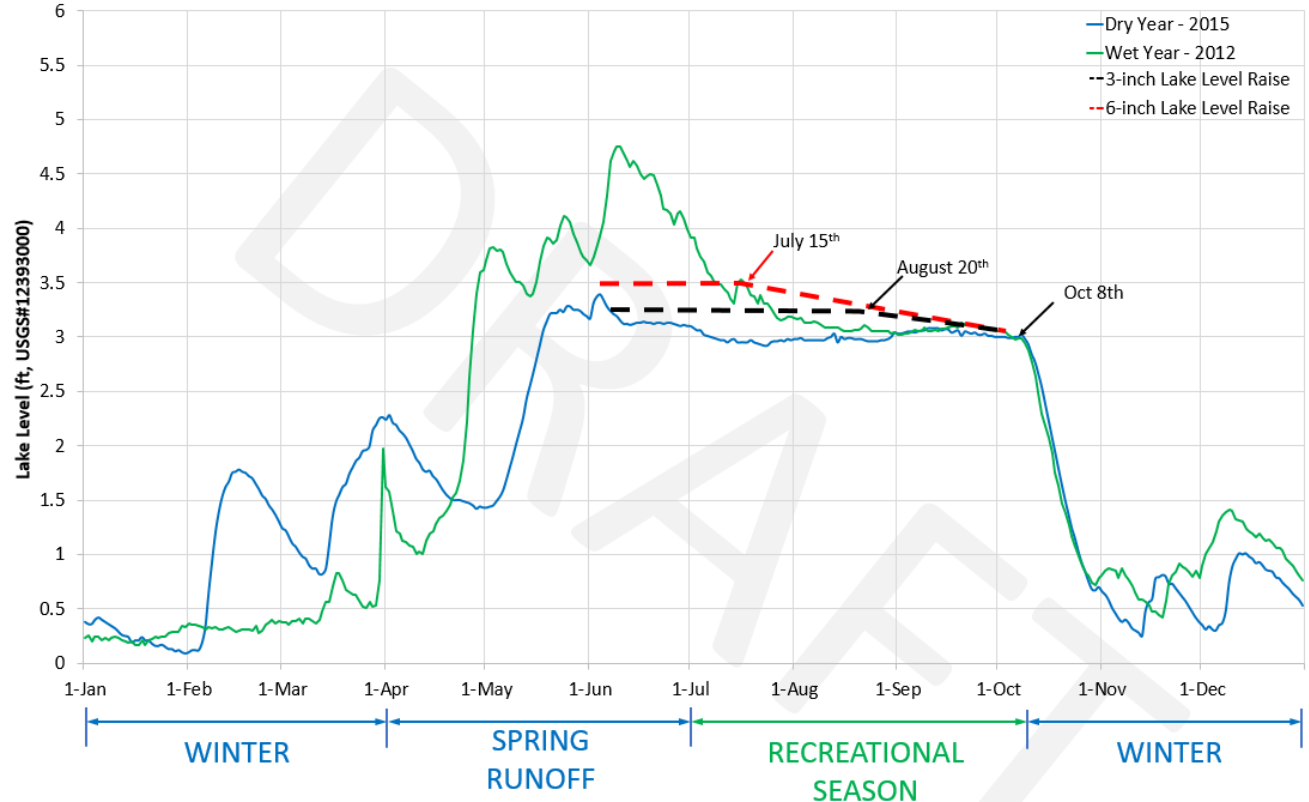
# PRIEST LAKE WATER LEVEL - BACKGROUND

- It is typical for the lake level to be higher than required 3.0' during the recreational season.
- Water level chart shows that in 2012, lake level was 6-in higher than 3.0' required level till July 15<sup>th</sup>.
- Water level chart also shows that in 2012, lake level was 3-in higher than the 3.0' required level till July 20<sup>th</sup>.
- Temporary pool raise during dry years can be thought of as managing lake level similar to natural lake level in wet years with a slight increase during month of August
