# Aquifer Water Quality

Rathdrum Prairie Advisory  
Committee, Meeting #2

January 29, 2010

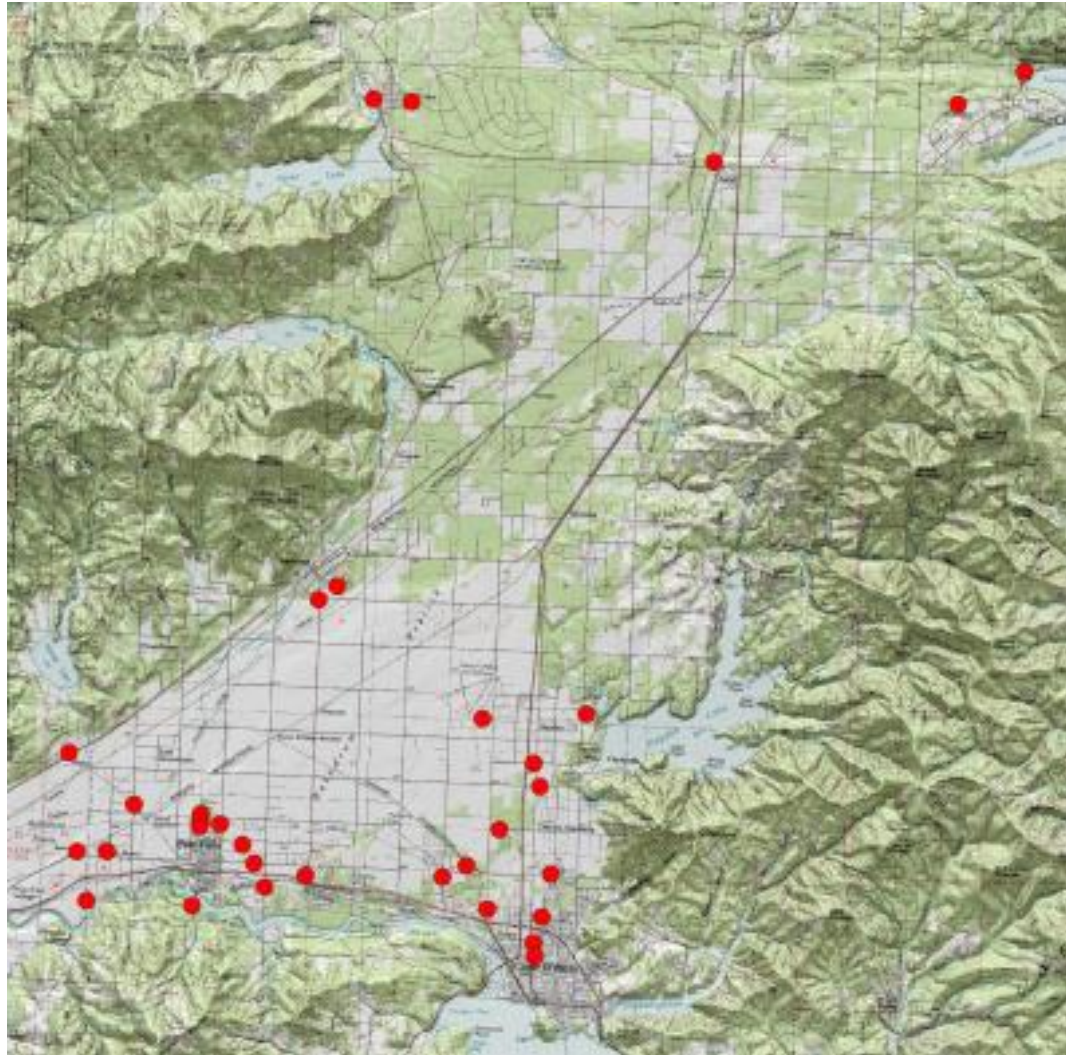
# [ Monitoring Well Locations ]

- Same select 27 wells tested three times a year
- High quality water maintained

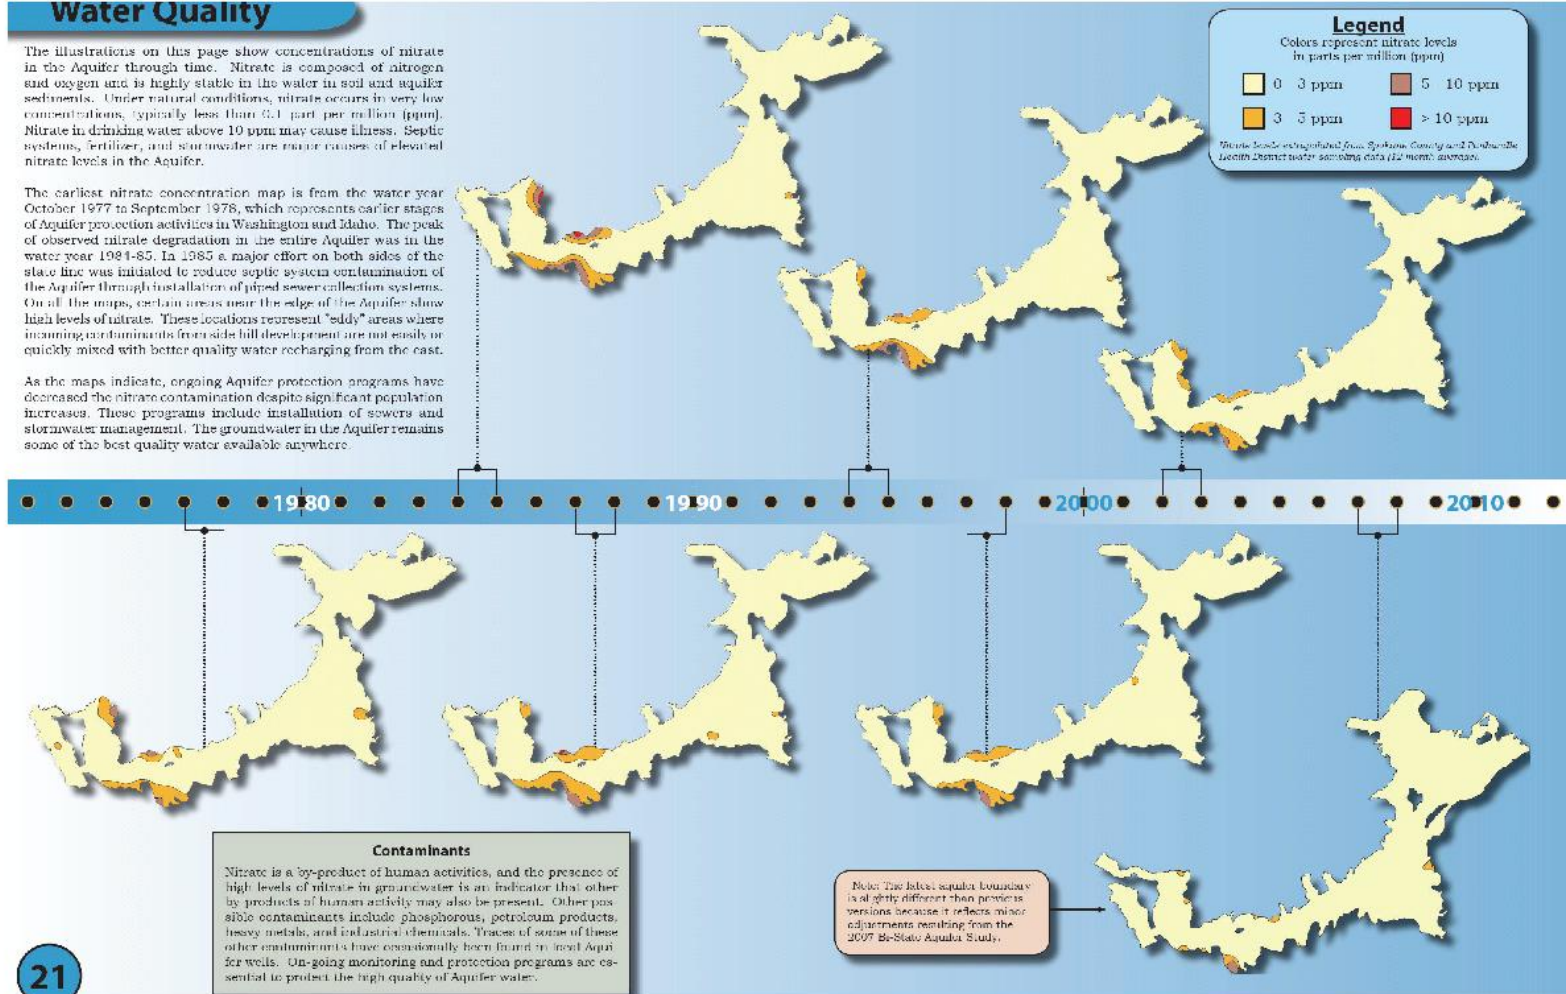
# Water Quality Timeline

The illustrations on this page show concentrations of nitrate in the Aquifer through time. Nitrate is composed of nitrogen and oxygen and is highly stable in the water in soil and aquifer sediments. Under natural conditions, nitrate occurs in very low concentrations, typically less than 0.1 part per million (ppm). Nitrate in drinking water above 10 ppm may cause illness. Septic systems, fertilizer, and stormwater are major causes of elevated nitrate levels in the Aquifer.

The earliest nitrate concentration map is from the water year October 1977 to September 1978, which represents earlier stages of Aquifer protection activities in Washington and Idaho. The peak of observed nitrate degradation in the entire Aquifer was in the water year 1984-85. In 1985 a major effort on both sides of the state line was initiated to reduce septic system contamination of the Aquifer through installation of piped sewer collection systems. On all the maps, certain areas near the edge of the Aquifer show high levels of nitrate. These locations represent "eddy" areas where incoming contaminants from side hill development are not easily or quickly mixed with better quality water recharging from the east.

As the maps indicate, ongoing Aquifer protection programs have decreased the nitrate contamination despite significant population increases. These programs include installation of sewers and stormwater management. The groundwater in the Aquifer remains some of the best quality water available anywhere.
